## **ALASKA BASELINE EROSION ASSESSMENT**

### **Erosion Information Paper - Chignik, Alaska**

Current as of December 17, 2007

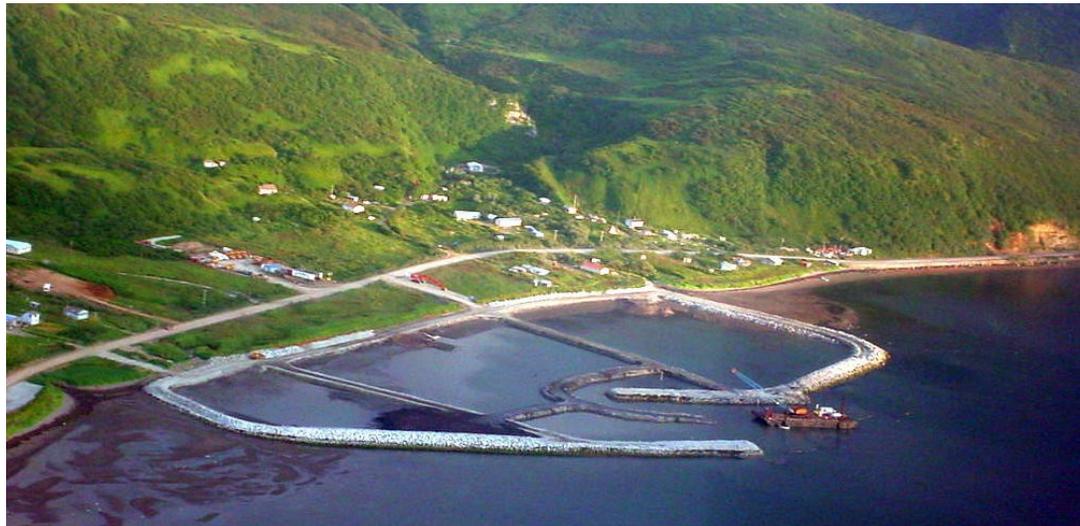
The survey reported that in 2002 or 2003, the owners of the fish processor paid for the placement of several hundred yards of armor rock near the processor. There was also a problem with erosion in 2002 by the boat harbor. Before the harbor construction began, approximately 20 feet

**Photo 3: Aerial view of Chignik small boat harbor under construction by the Corps of Engineers; scheduled for completion Dec. 2008, summer 2003.**

of coastline property was lost. Dredging of the harbor is planned and there is a bid out for this work.

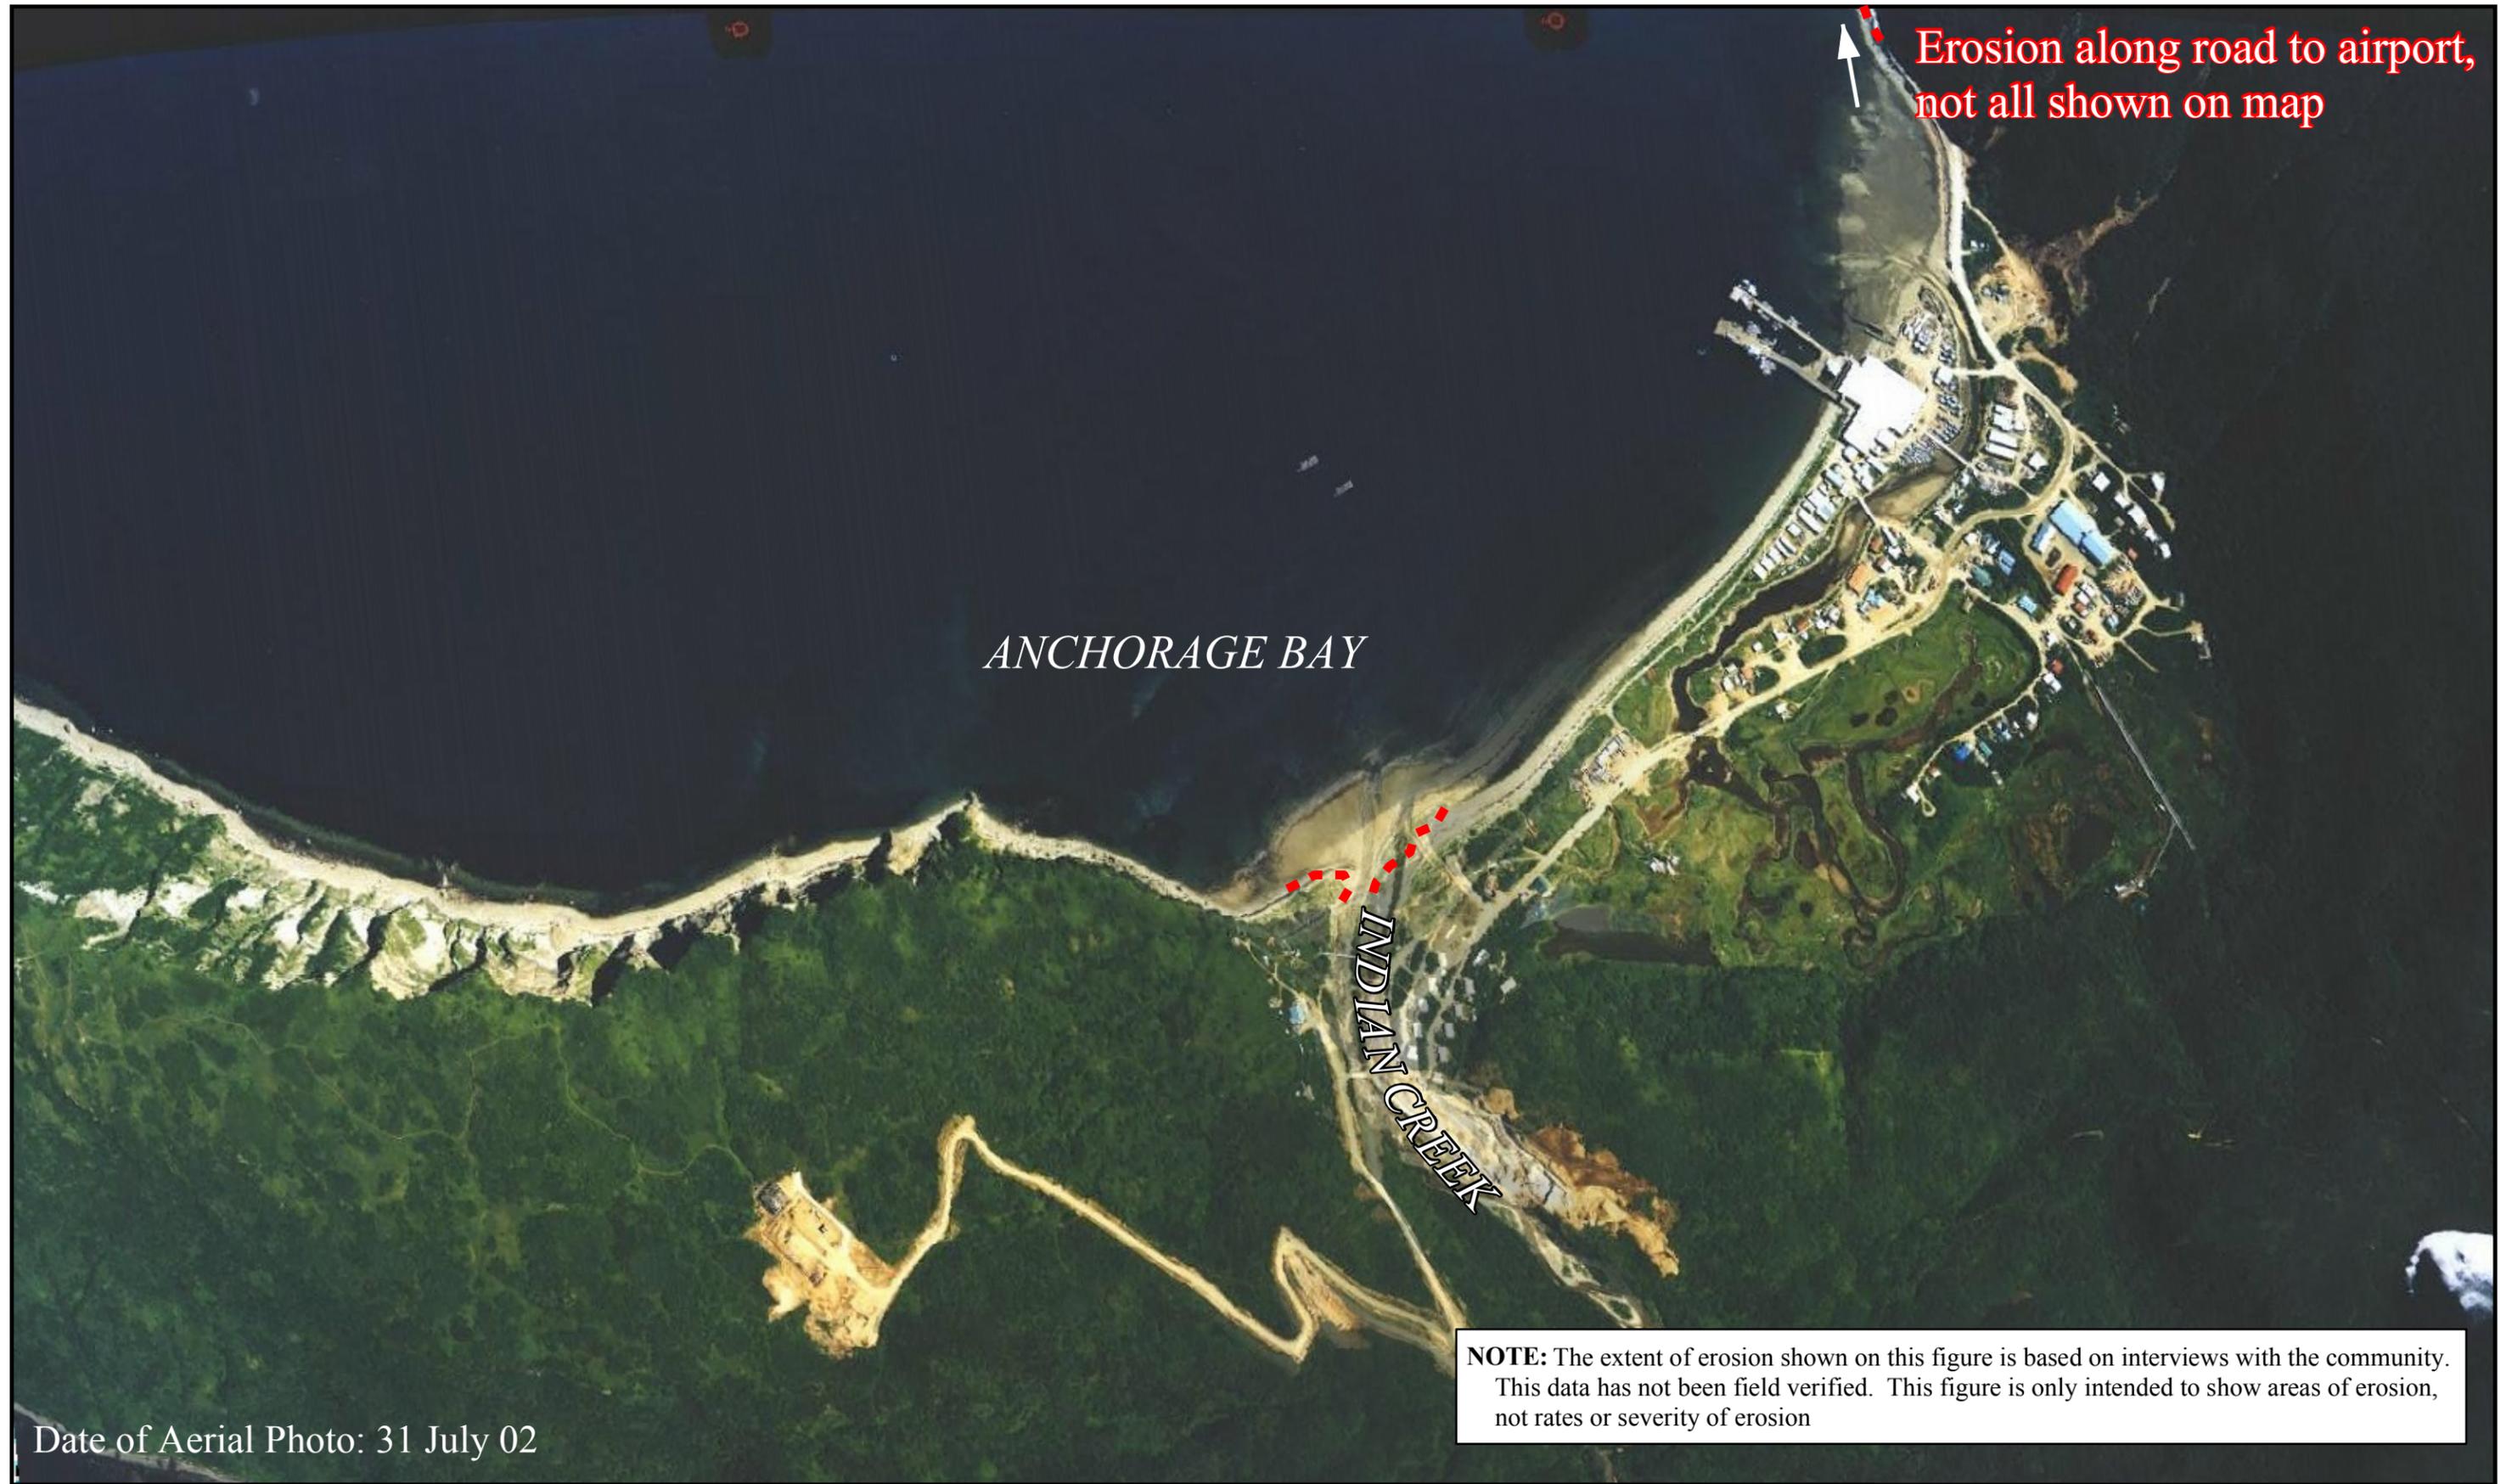
Alaska Baseline Erosion  
Chignik, Alaska

The main road to the Chignik airport and near the mouth of Indian Creek are the main areas at risk from ongoing erosion. The community reports that 6 to 7 areas along the airport road eroded in the past. Combined high winds and tide caused the loss of about 4 to 5 feet of bank along the road near the developed community during a 2002 storm. Following that event, the State of Alaska contributed about \$8,000, the Federal Emergency Management Agency contributed about \$1,500, and the city of Chignik provided equipment and labor to place rocks along the bank and to build up the road with gravel. There are also plans to place armor rock along a section of this road in spring of 2008 with Alaska Department of Transportation and Public Facilities assistance.

- - - Linear Extent of Erosion
