U.S. Army Corps  
of Engineers  
Alaska District

## ***ALASKA BASELINE EROSION ASSESSMENT***

### **Erosion Information Paper - Chistochina, Alaska**

Current as of February 25, 2009

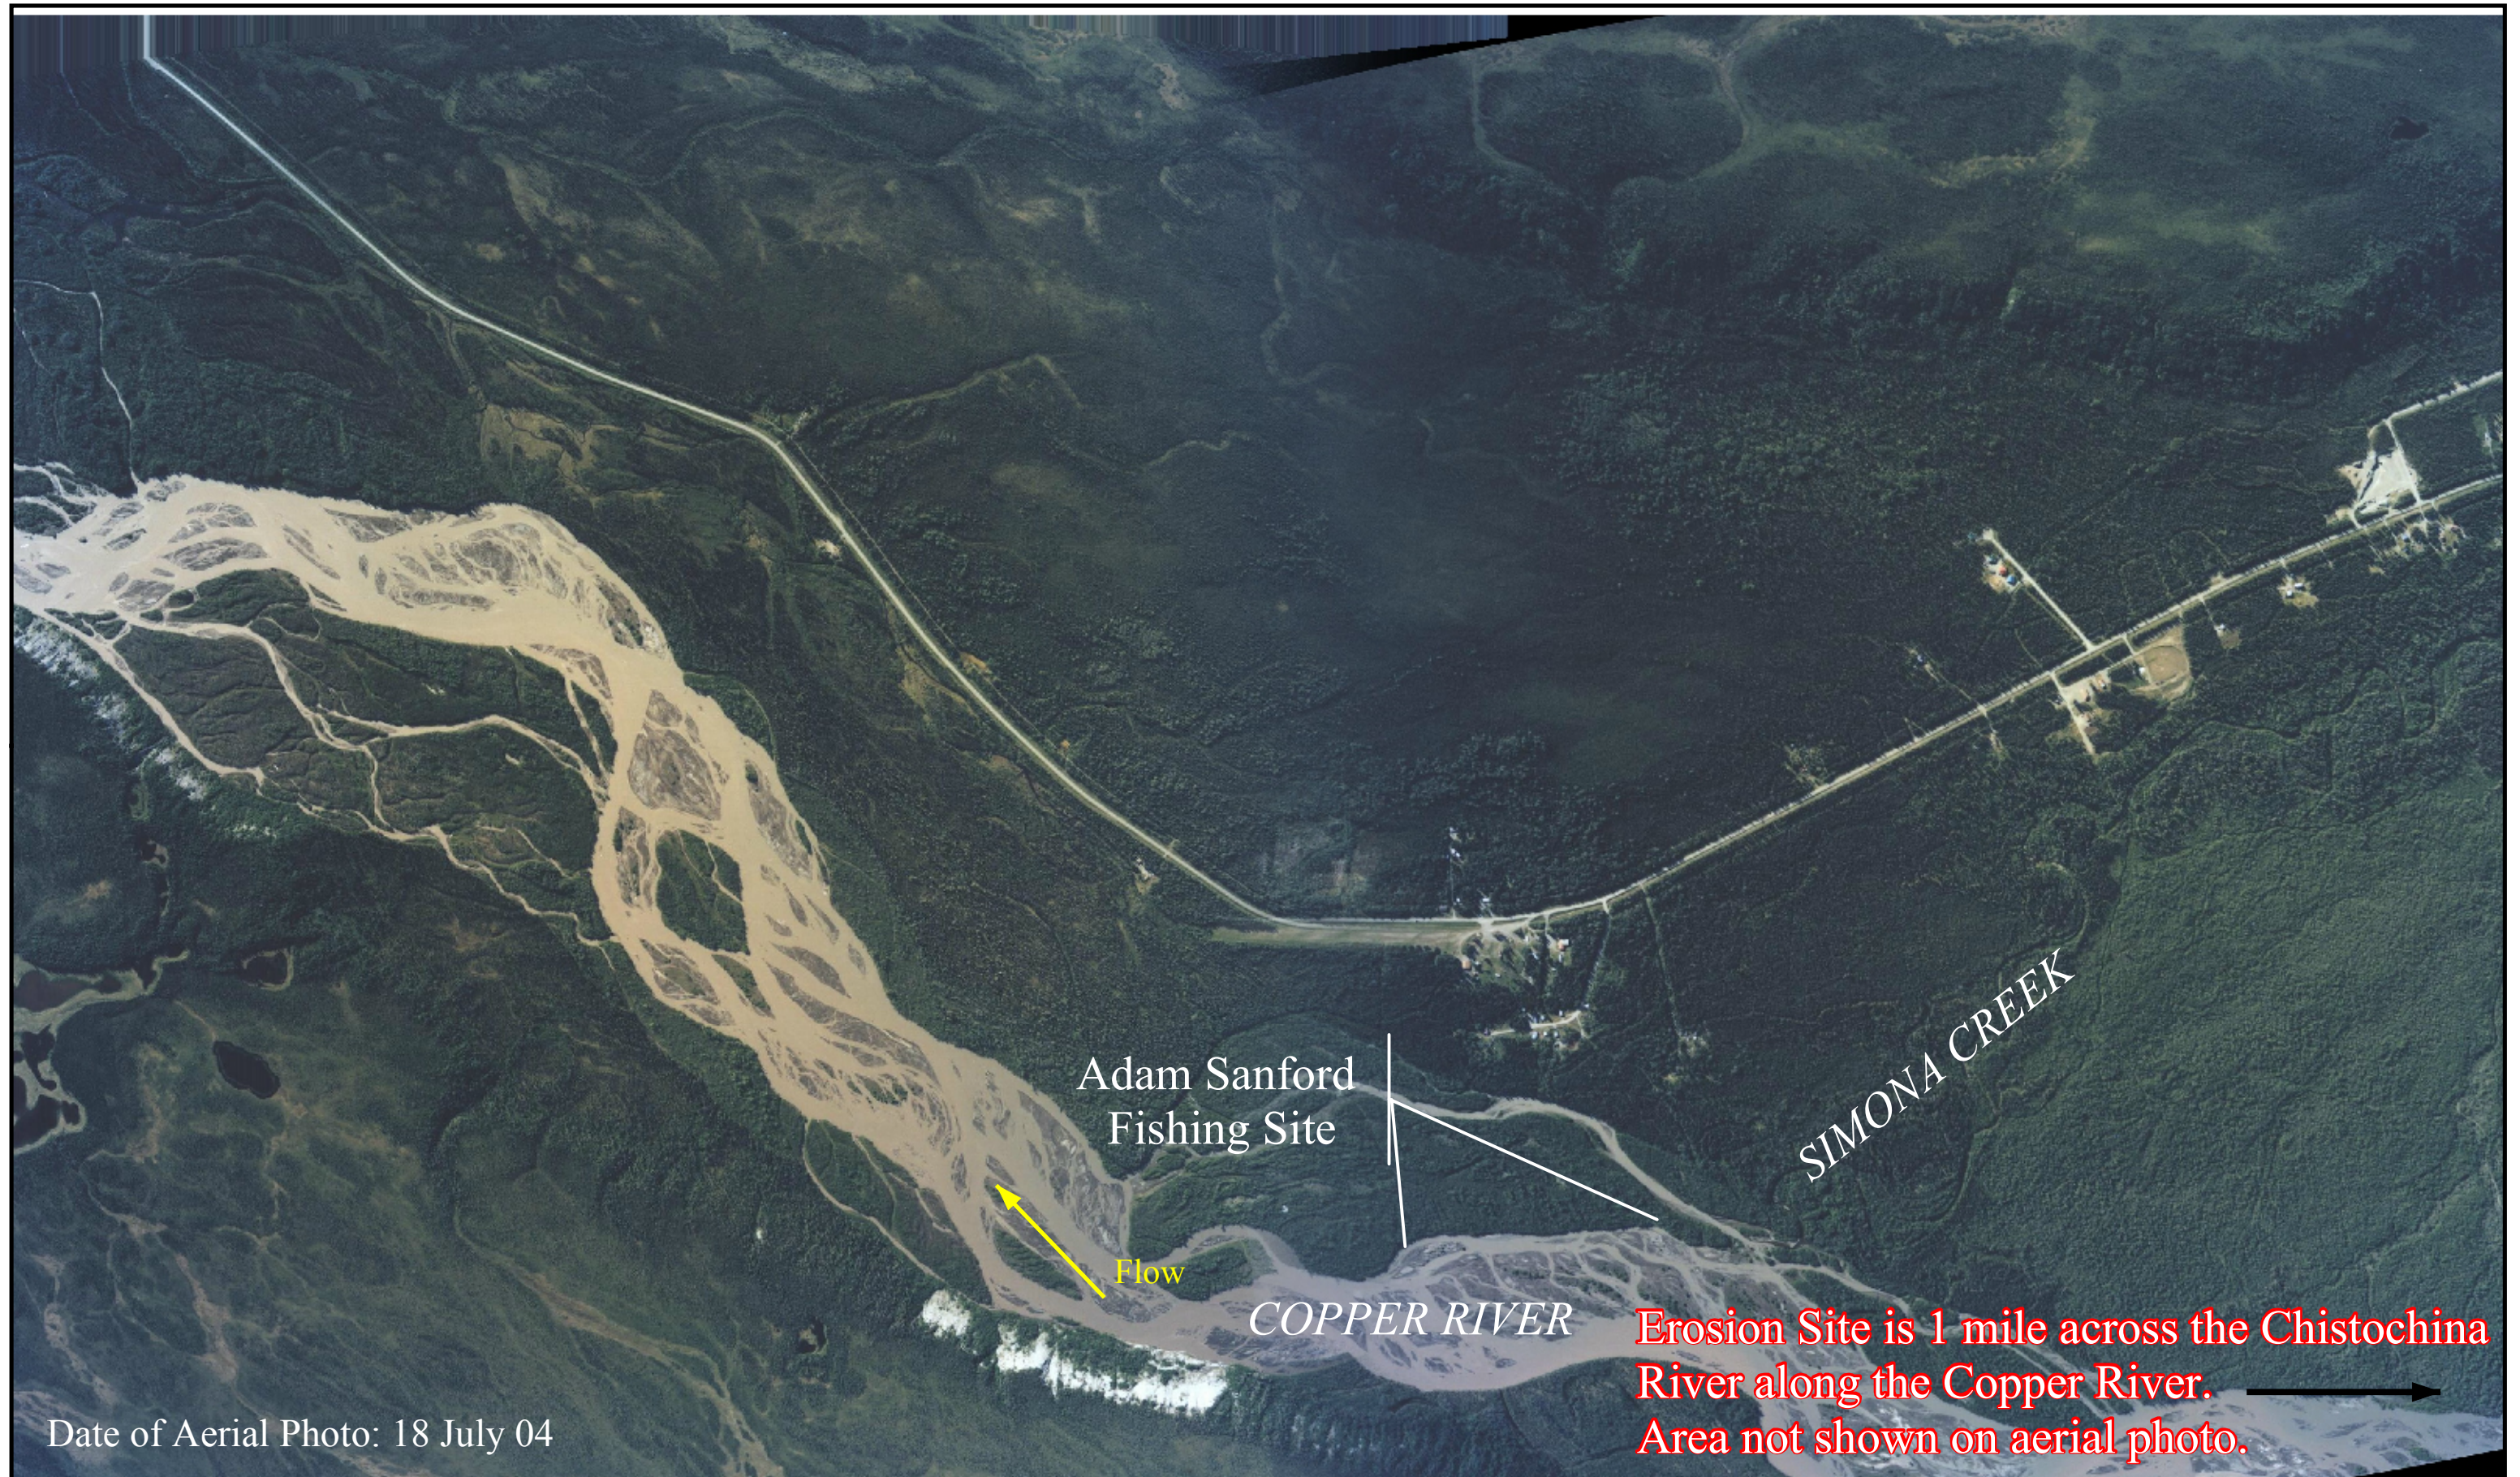
An area used as a fish camp along the northern bank of the Copper River is eroding. Seasonal fluctuations in river flow, water levels, spring ice break up, water runoff, and vehicle traffic along the bank reportedly cause and contribute to erosion. The affected area is about 500 feet long and 15 to 20 feet high. Erosion events typically follow winters with heavy snow collection and accompany high runoff during spring break up. Major events were estimated to have eroded inland about 50 feet inland along the 1000-foot stretch of riverbank during an unspecified period. The main access road had to be rerouted twice during the three years prior to 2007. Major erosion again occurred in 2007, but resident at that time were unable to access the site to assess the amount of damage. As of this writing, an additional rerouting of the road has occurred. Ten years ago, flooding along Sinona Creek caused significant erosion.

No photos of erosion were provided by the community or other sources. Attached is a diagram depicting the linear extent of erosion.
