U.S. Army Corps
of Engineers
Alaska District

ALASKA BASELINE EROSION ASSESSMENT

Erosion Information Paper - Circle, Alaska

Current as of February 20, 2008

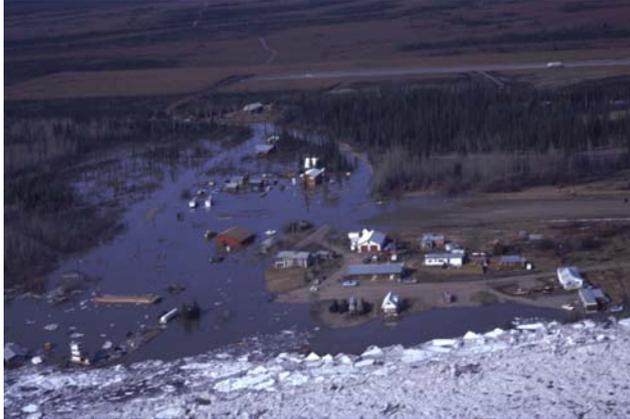
Photo 1: Circle and the Circle airfield during spring breakup

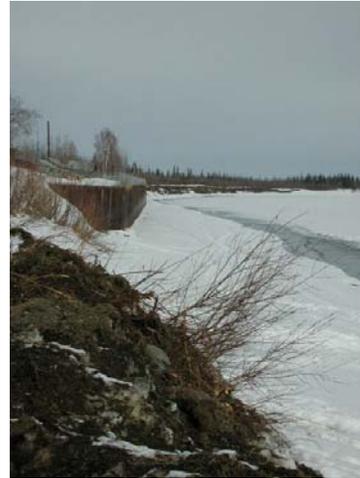
Property below the central part of the community was lost to considerable erosion in 1989. Some residents lost 25 feet of property with erosion periodically accelerated by seasonally high river levels. A steel sheet-pile retaining wall, funded by a state legislative grant, was constructed along the front of the community in 1989. The wall was redesigned after an ice-jam sheered off many of the anchor bolts. The costs for the sheet pile projects were estimated at hundreds of thousands of dollars with the State's *Capital Projects Database* indicating \$149,461 spent by DOT/PF in Circle for flooding and erosion in 1990. The retaining wall has prevented further erosion.

Photo 2: Sheet pile erosion protection in Circle Flooding, photo courtesy of Michael L. Bird, 1997. photo courtesy of Michael L. Bird, 2001.

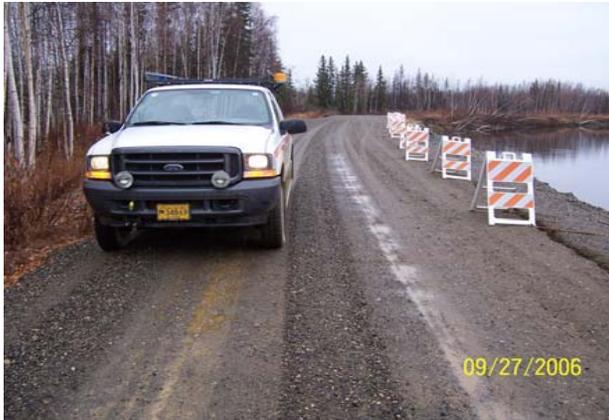
Photo 3: Steese Highway 13 miles before it ends at Circle is cut down to 1 lane by Birch Creek, photo courtesy of DOT/PF Central Maintenance, 2006.

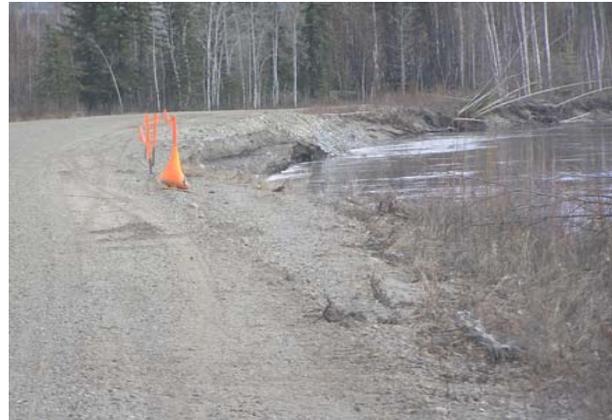
Milepost 147 of the Steese Highway is a chronic problem area where for the last 20 years an estimated 6 feet of bank erodes annually. Loss of the Steese Highway would limit access to both Circle and Fort Yukon. Many Fort Yukon residents and business representatives travel to Circle before taking a boat to Ft. Yukon. The state has been applying for permits to correct the problem for the past 4 years.

Photo 4: Birch Creek at Steese Highway, Mile 147, photo courtesy of DOT/PF Central Maintenance, 2006.
