## **ALASKA BASELINE EROSION ASSESSMENT**

### **Erosion Information Paper - Coldfoot, Alaska**

Current as of February 13, 2008

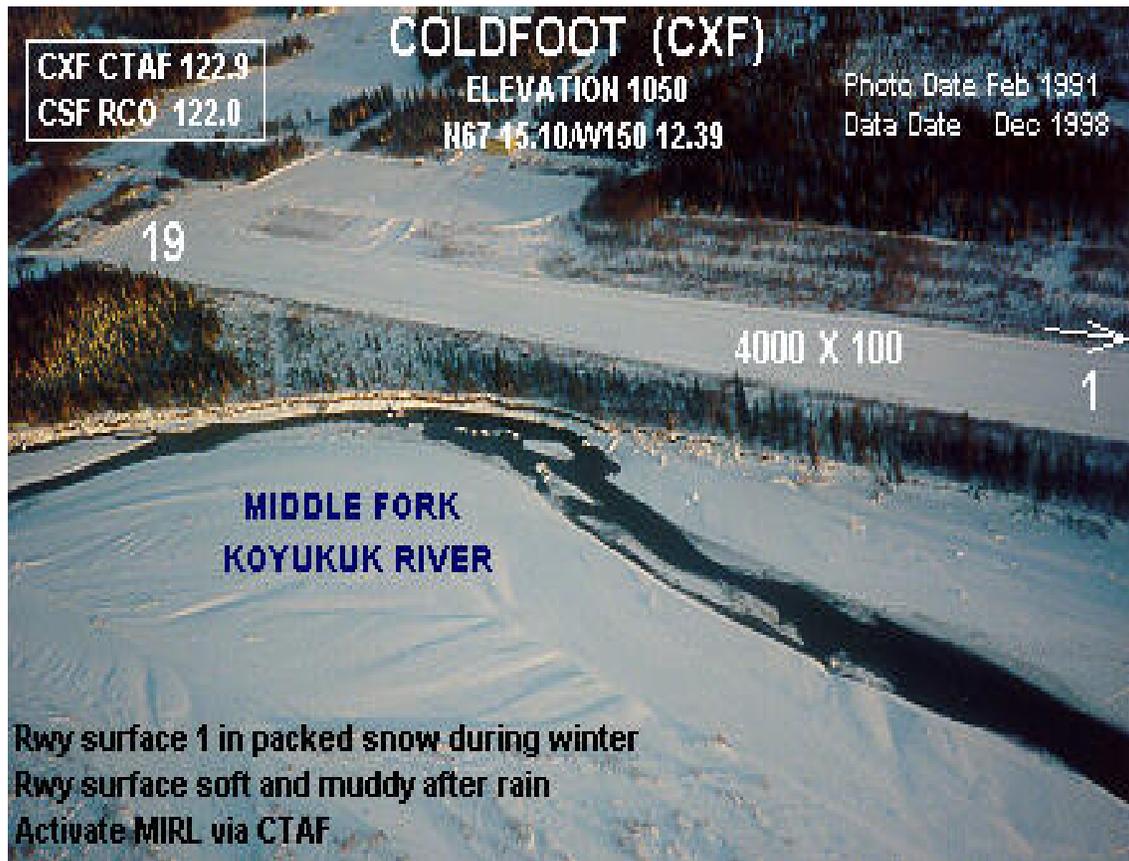
A 1991 photo of erosion near the airport provided by DOT&PF is attached. A diagram depicting the linear extent of erosion is attached.

Photo 1: Aerial view of Coldfoot airfield looking west across the middle fork Koyukuk River; Photo courtesy of AK DOT/PF, 1991.

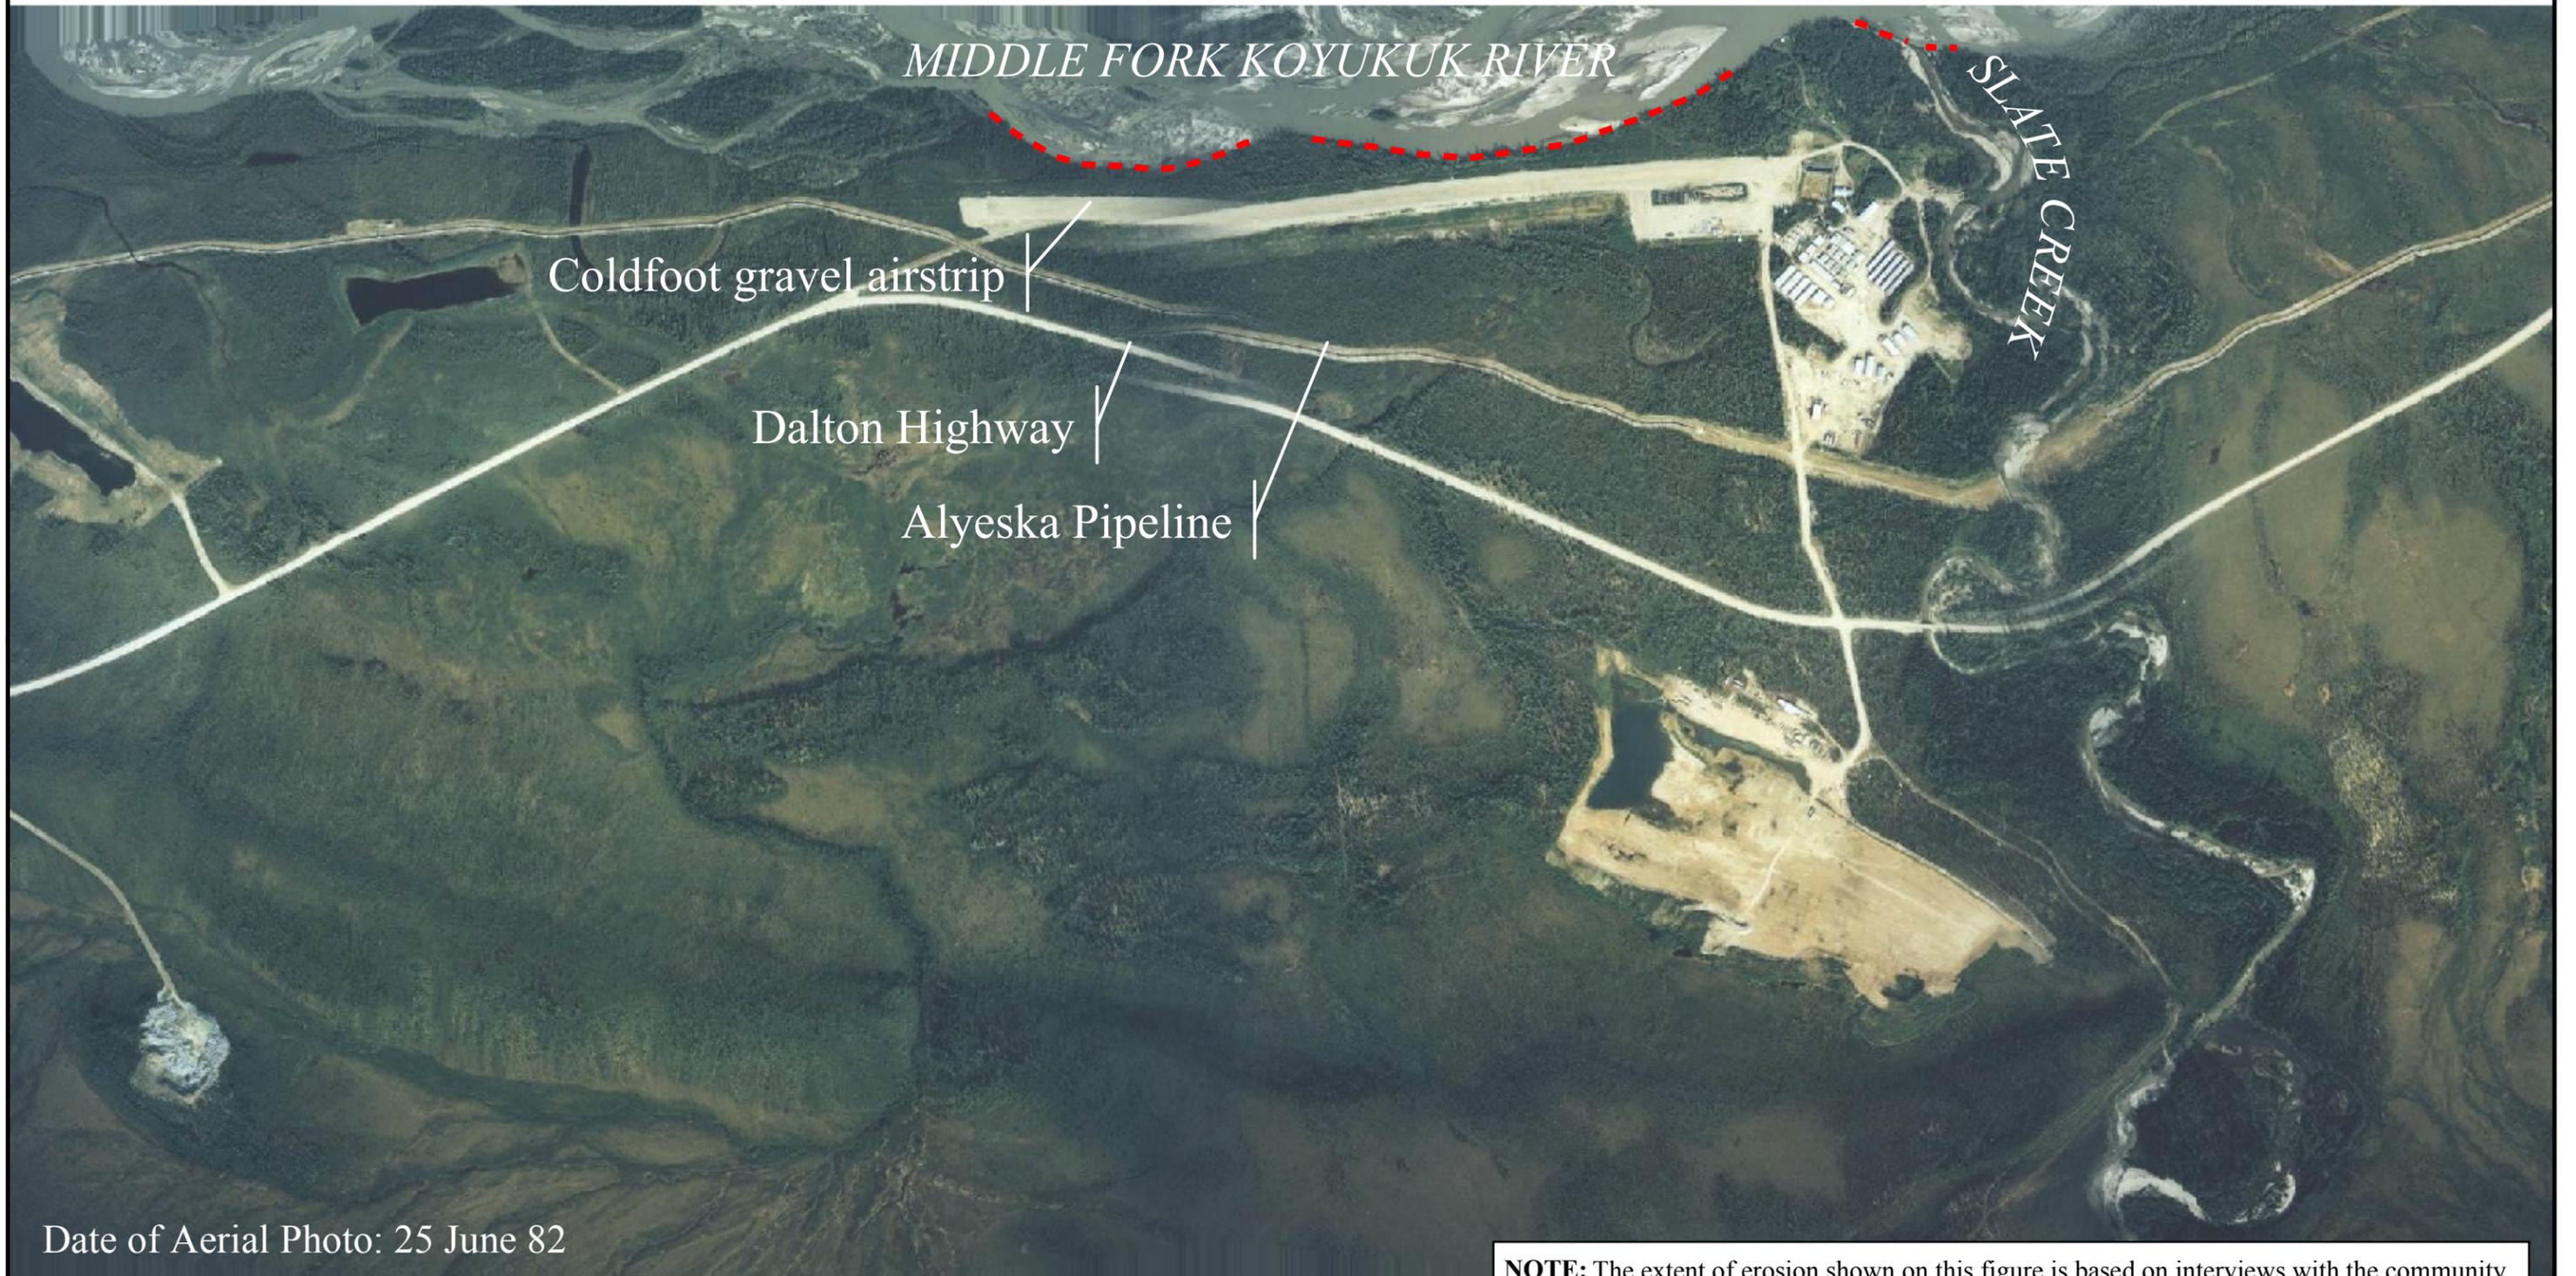
Alaska Baseline Erosion  
Coldfoot, Alaska

--- Linear Extent of Erosion
