U.S. Army Corps
of Engineers
Alaska District

ALASKA BASELINE EROSION ASSESSMENT

Erosion Information Paper - Cordova, Alaska

Current as of November 15, 2007

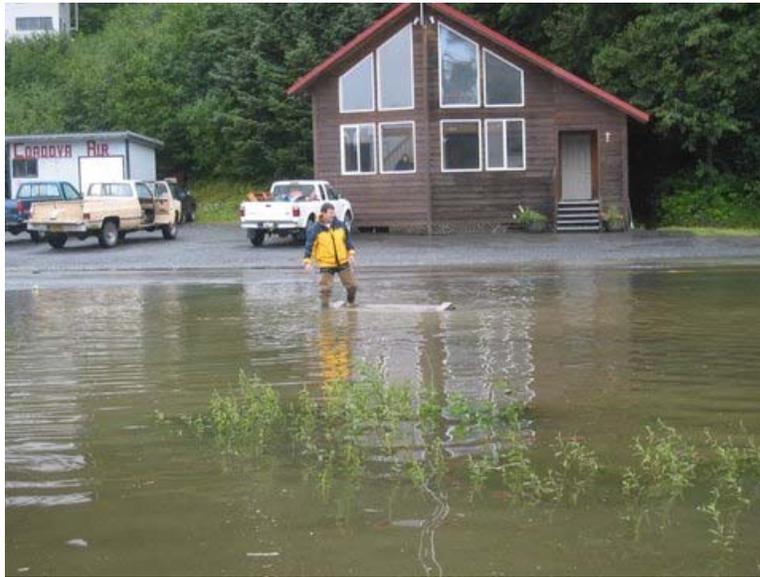
Photo 1: Shoreline erosion near Cordova's Eyak Lake Airport is a concern, December 2002.

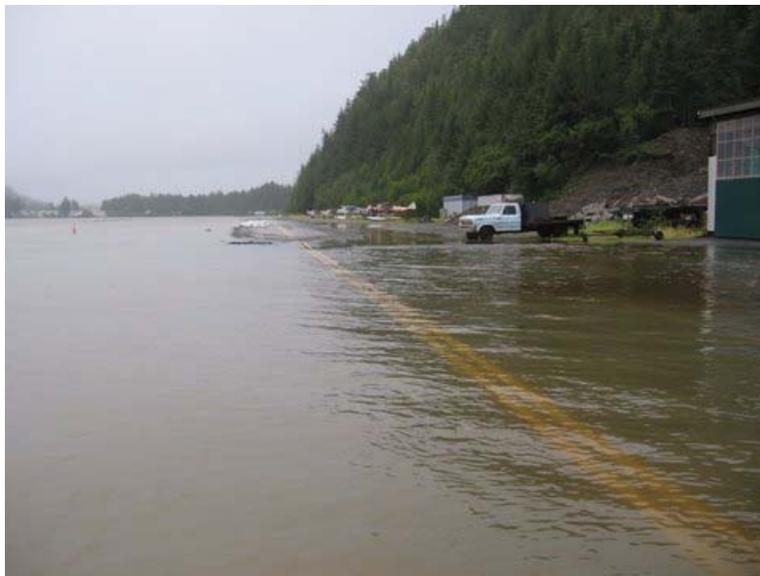
Photo 2: Eyak Lake Airport and other areas along shoreline of Eyak Lake have had some erosion as a result of flooding, 2006.

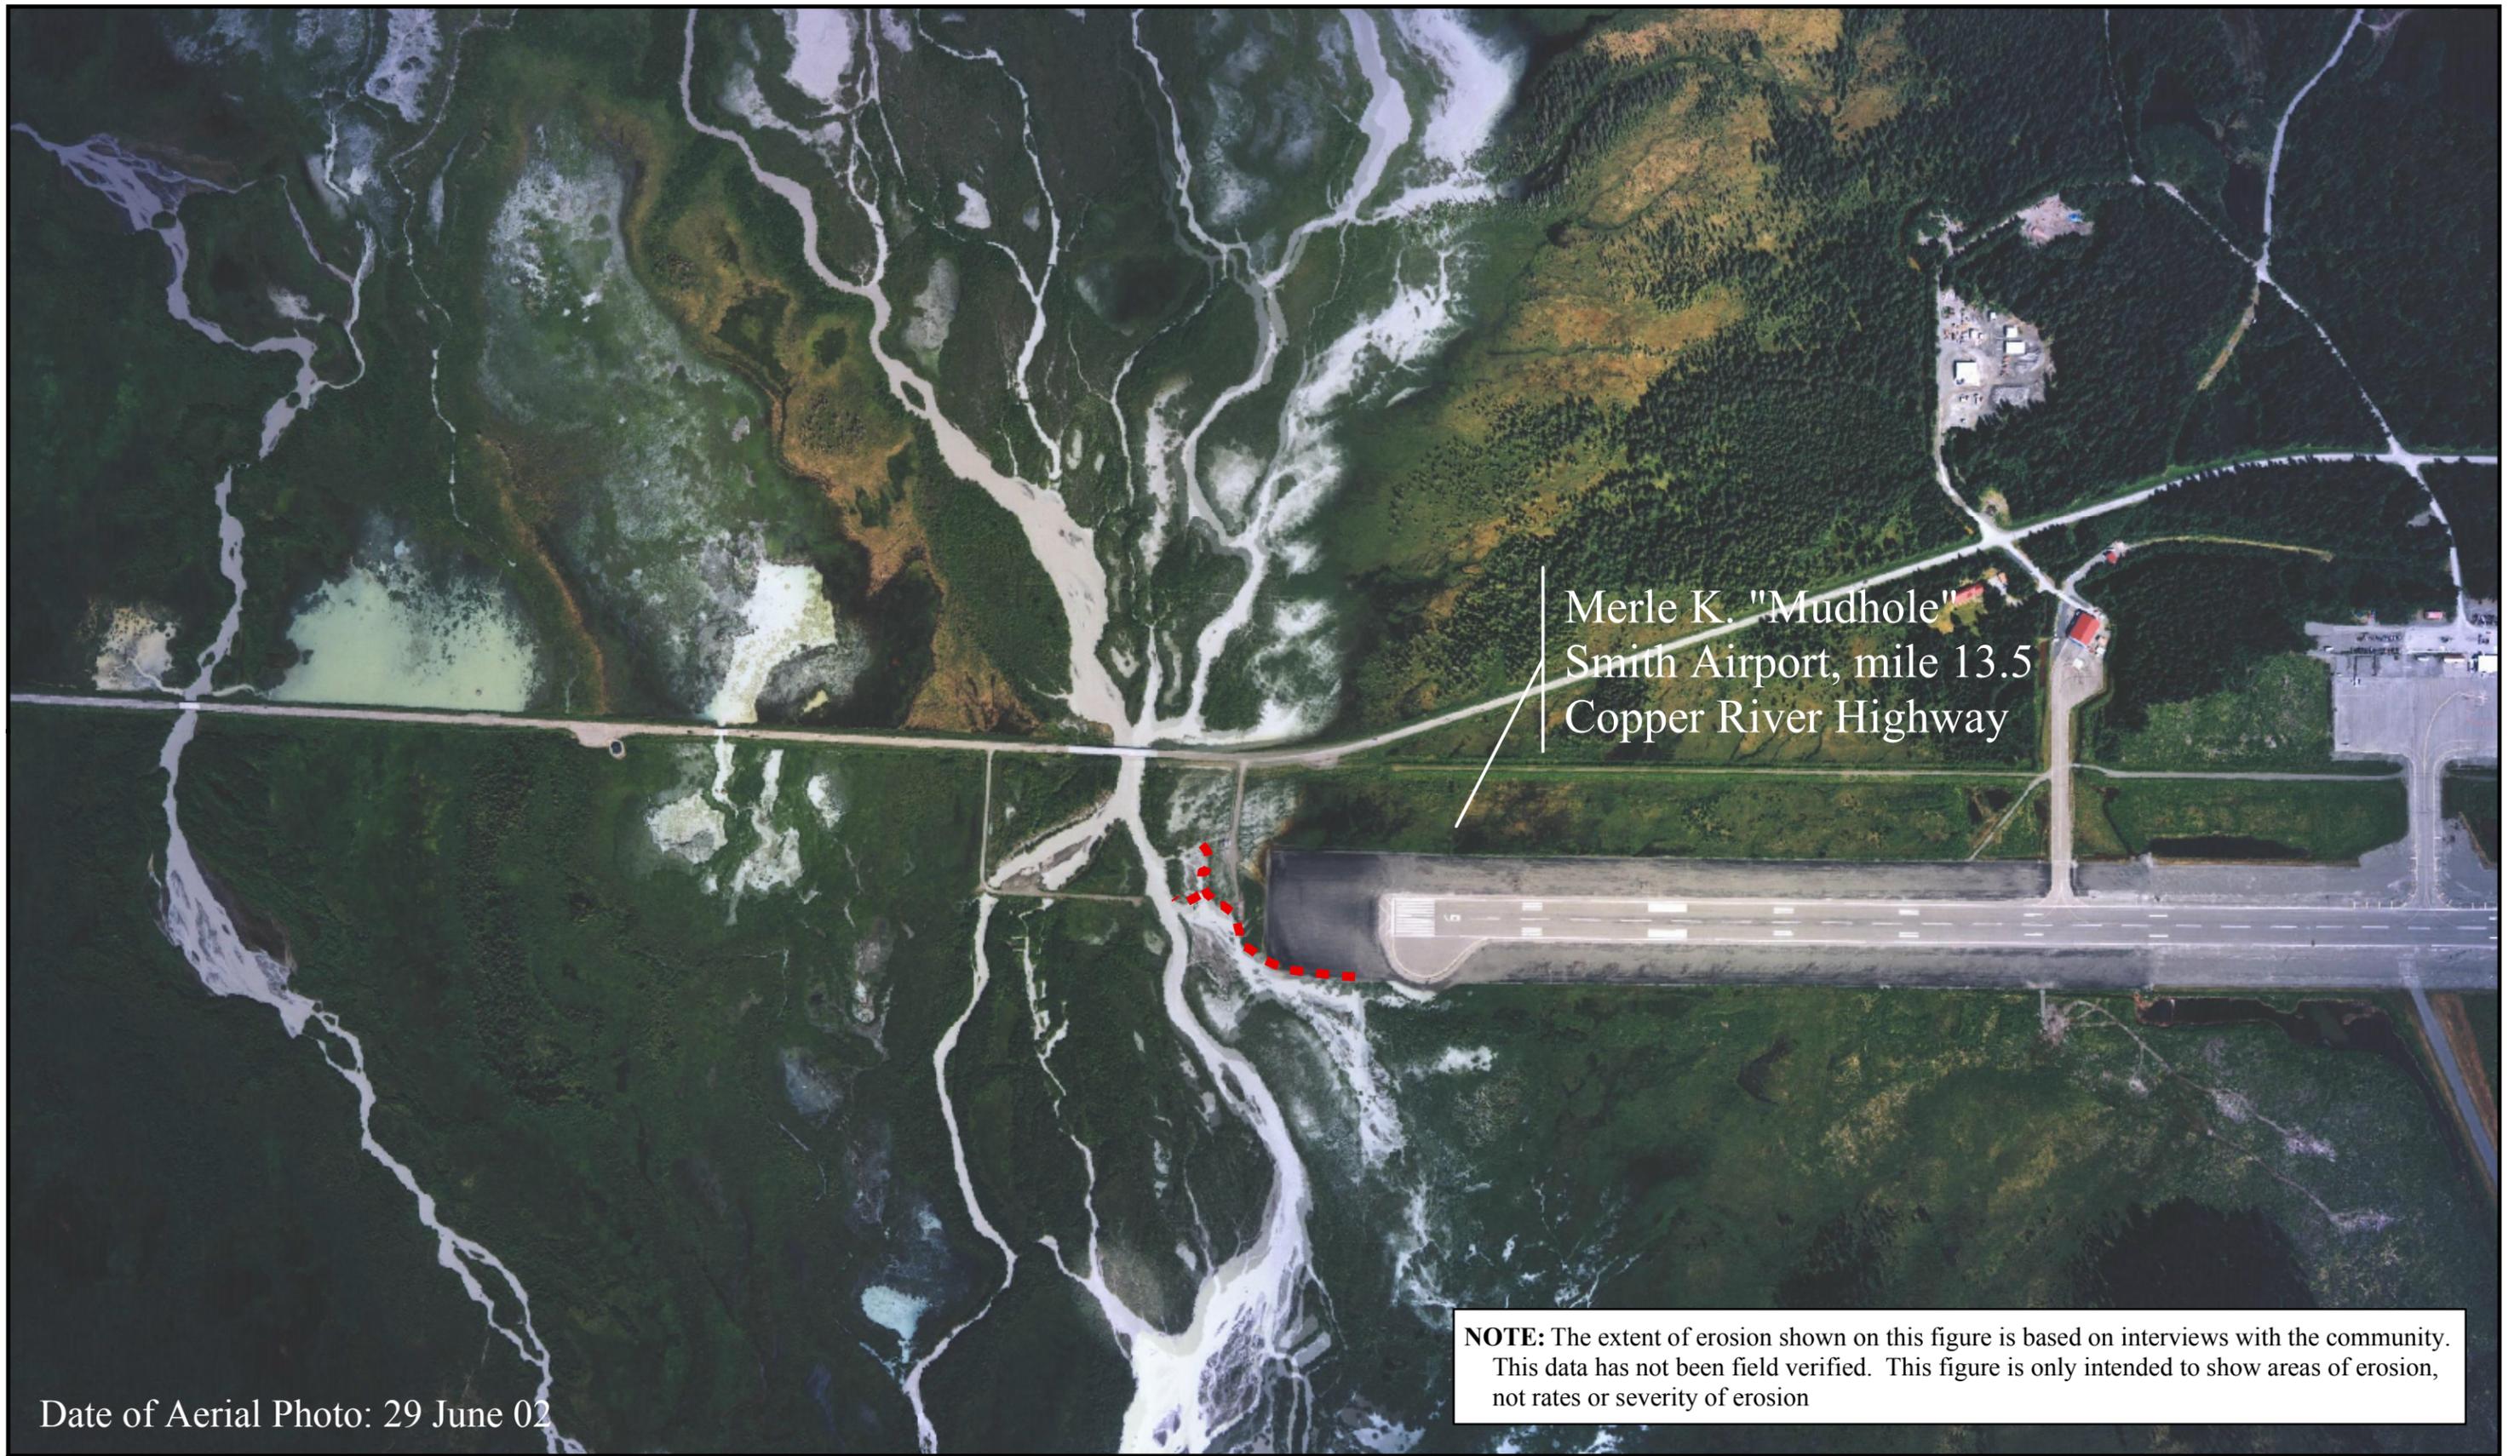
Merle K. "Mudhole"
Smith Airport, mile 13.5
Copper River Highway

Photos are provided by the city of Cordova showing the flooded area where erosion occurred along Eyak lake. Also, attached is a diagram showing the approximate linear extent of erosion along the end of the Merle K. "Mudhole" Smith Airport.
