U.S. Army Corps
of Engineers
Alaska District

ALASKA BASELINE EROSION ASSESSMENT

Erosion Information Paper - Crooked Creek, Alaska

Current as of March 27, 2008

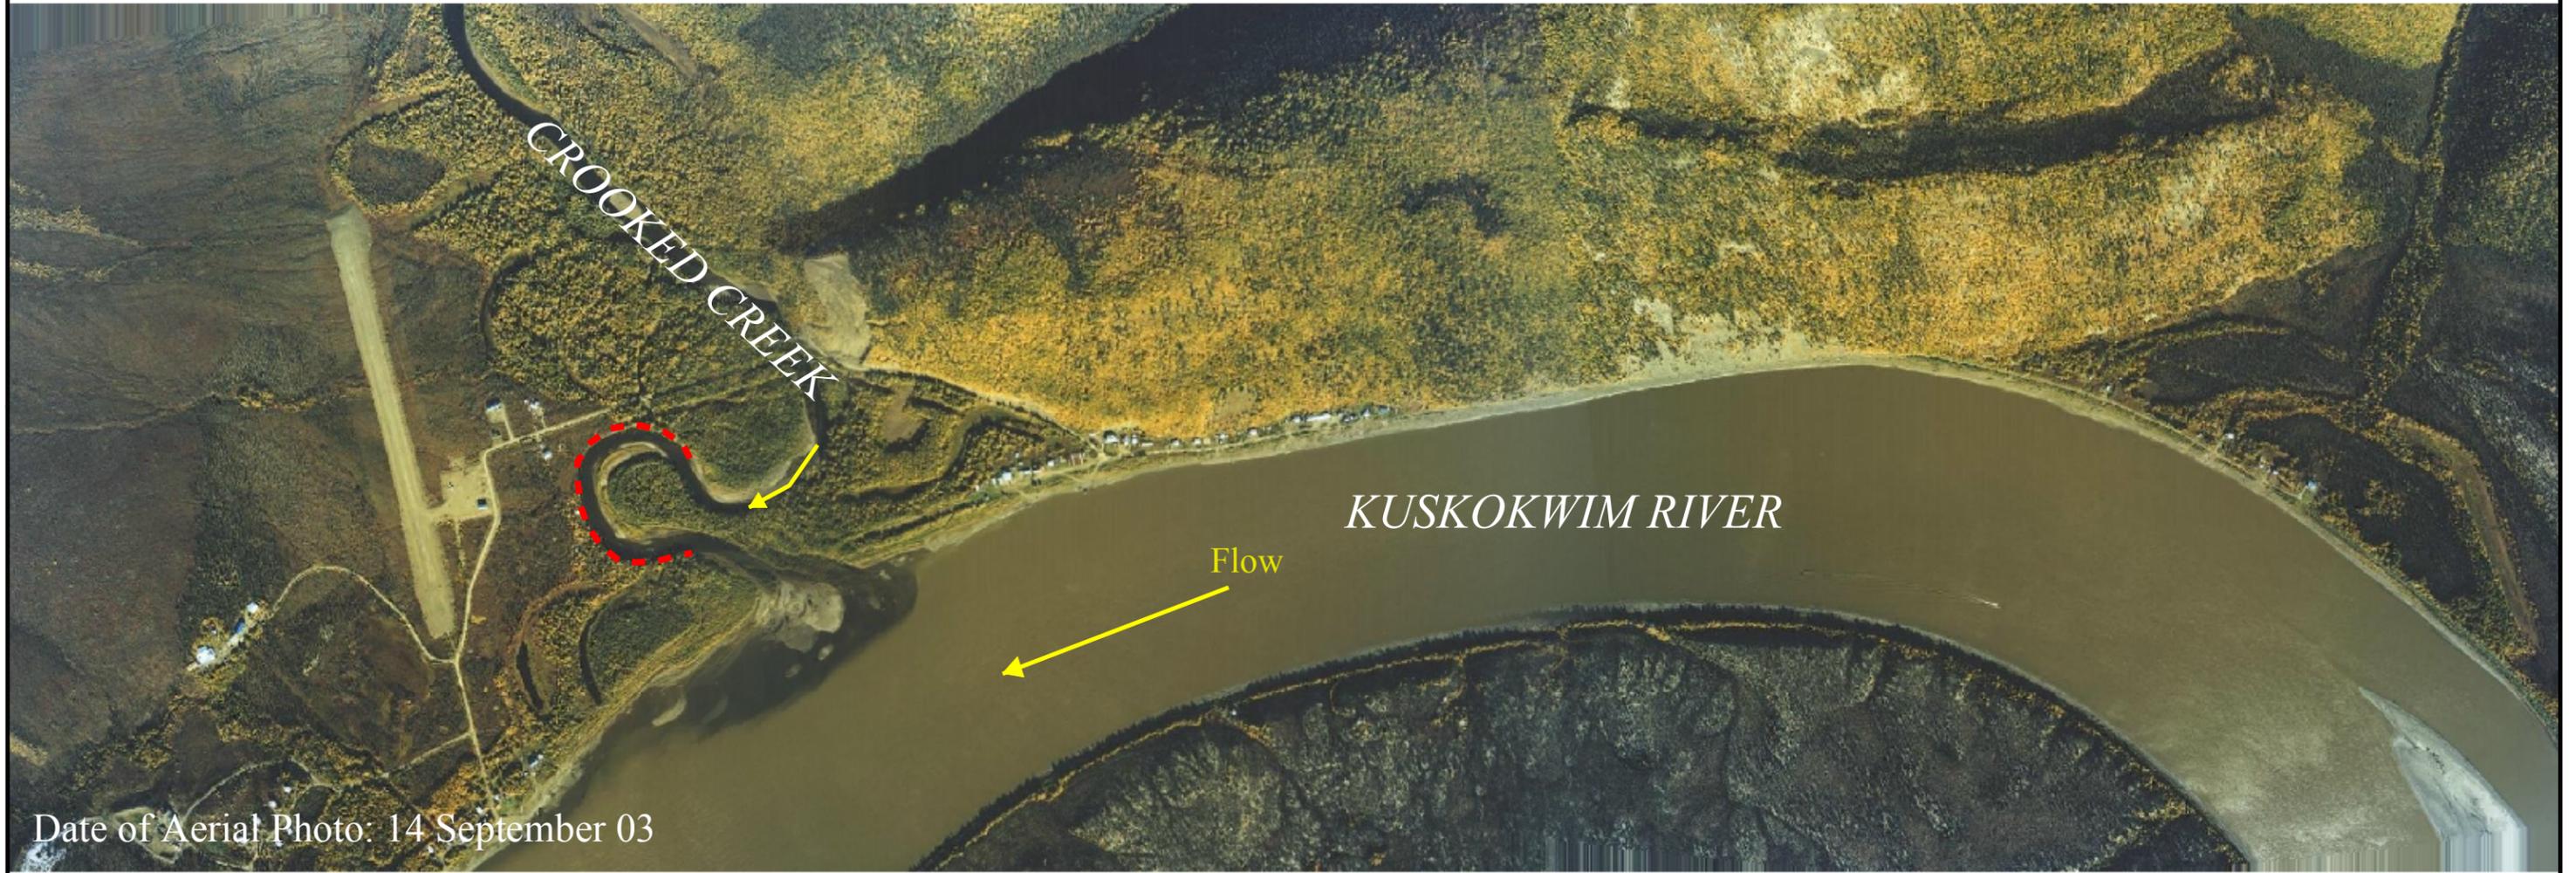
No photos were provided by community or other sources. The attached diagram shows the linear extent of erosion.
