U.S. Army Corps
of Engineers
Alaska District

ALASKA BASELINE EROSION ASSESSMENT

Erosion Information Paper - Deering, Alaska

Current as of November 15, 2007

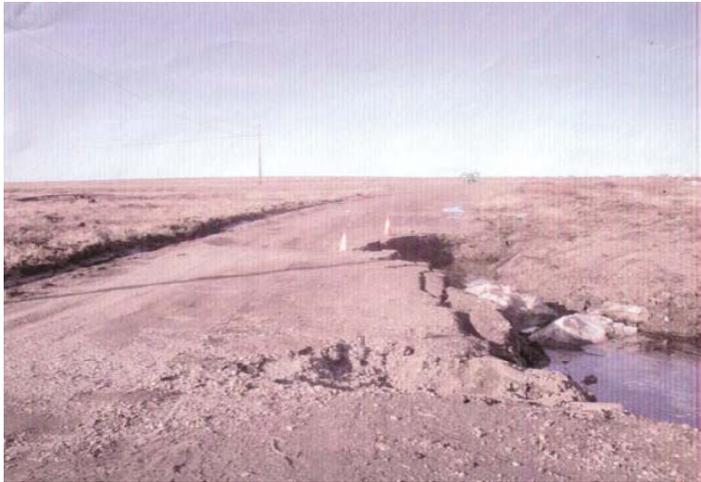
Photo 1: Erosion of road at the airport caused by Inmachuk River, No photo date available.

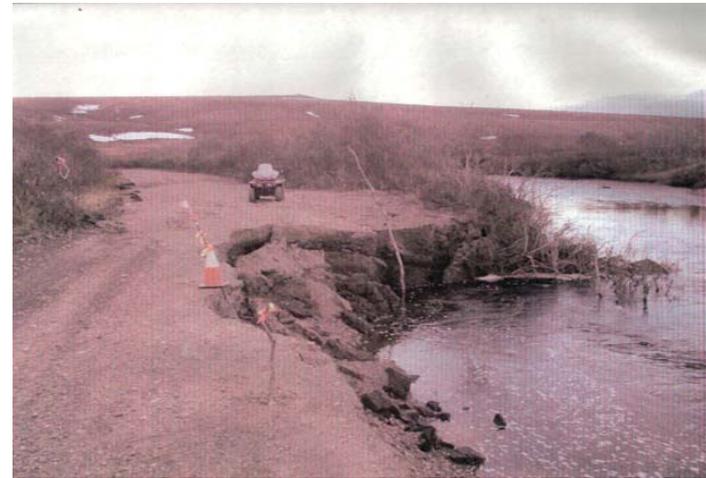
Photo 2: Erosion on road past airport, No photo date available.

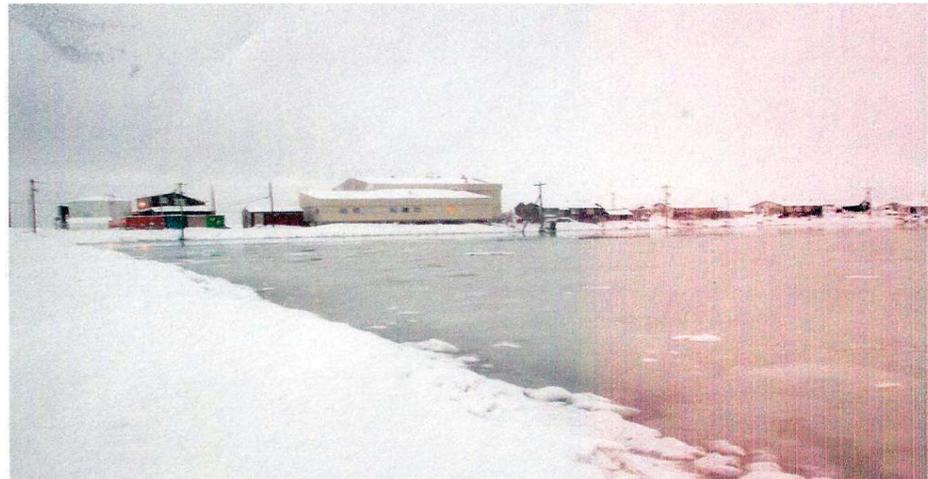
Storm surges and wind-driven waves cause significant coastal flooding at least once every 40 to 60 years. A major flood in 1973 caused extensive damage to many homes and a number of residents were temporarily evacuated to a mining camp 22 miles upriver. The city also reports winter flooding behind the city. The dates of the winter floods and the extent of damages were not reported.

Photo 3: Winter flooding behind city, No photo date available.
