**U.S. Army Corps
of Engineers
Alaska District**

ALASKA BASELINE EROSION ASSESSMENT

Erosion Information Paper - Delta Junction, Alaska

Current as of December 10, 2007

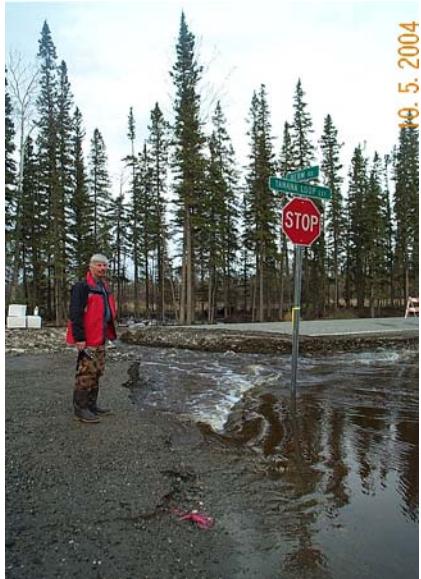
Photo 1: Tanana Loop & Berm Road in Delta Junction, May 2004.

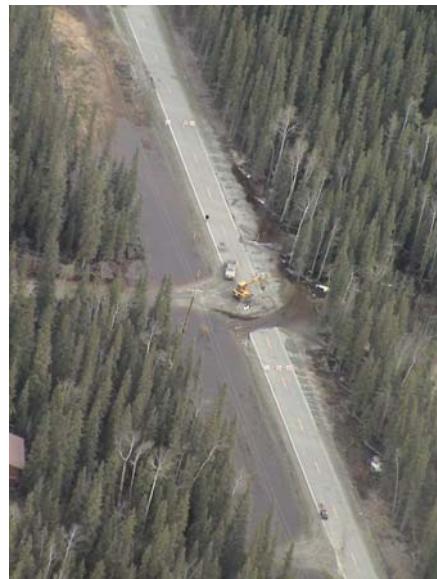
Photo 2: Aerial view of road breach to release flooding, May 2004.

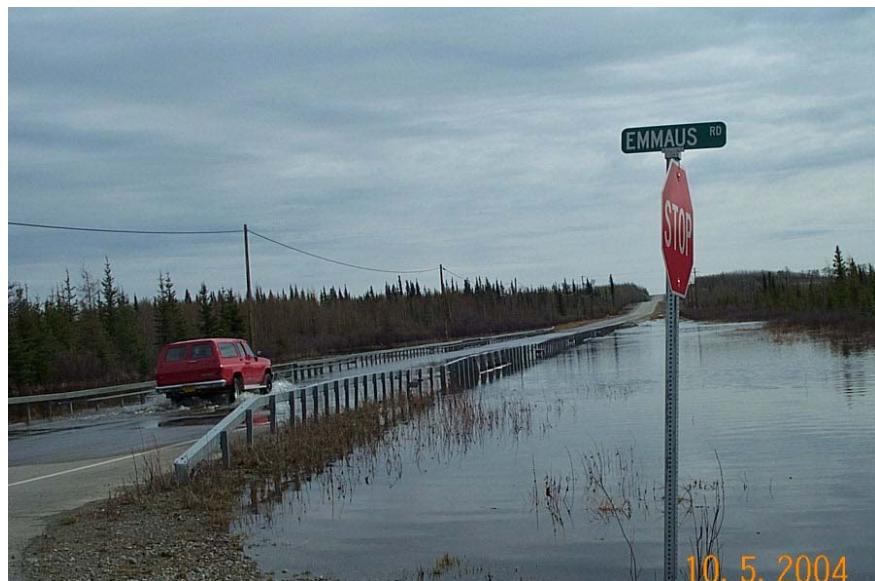
The Delta River Riverbank also erodes Delta Junction. Causes of the erosion are primarily natural river flow and water level fluctuations, exacerbated by ice-massing and spring and summer snowmelt. The 1983 Alaska Department of Transportation and Public Facilities *Task Force on Erosion Control* report states that during the summer of 1983, the riverbank eroded several feet a day in some locations. The community survey estimates 2 to 5 feet of bank erodes per year along the Delta River near its intersection with the Tanana River. The river has moved inland from 30 to 50 feet in some locations. Flooding and erosion in some areas can occur annually. One location on Emmaus road and two locations on Nistler road was washed out during a flood event in May 2004.

Photo 3: Emmaus Road at Nistler Road, May 2004.

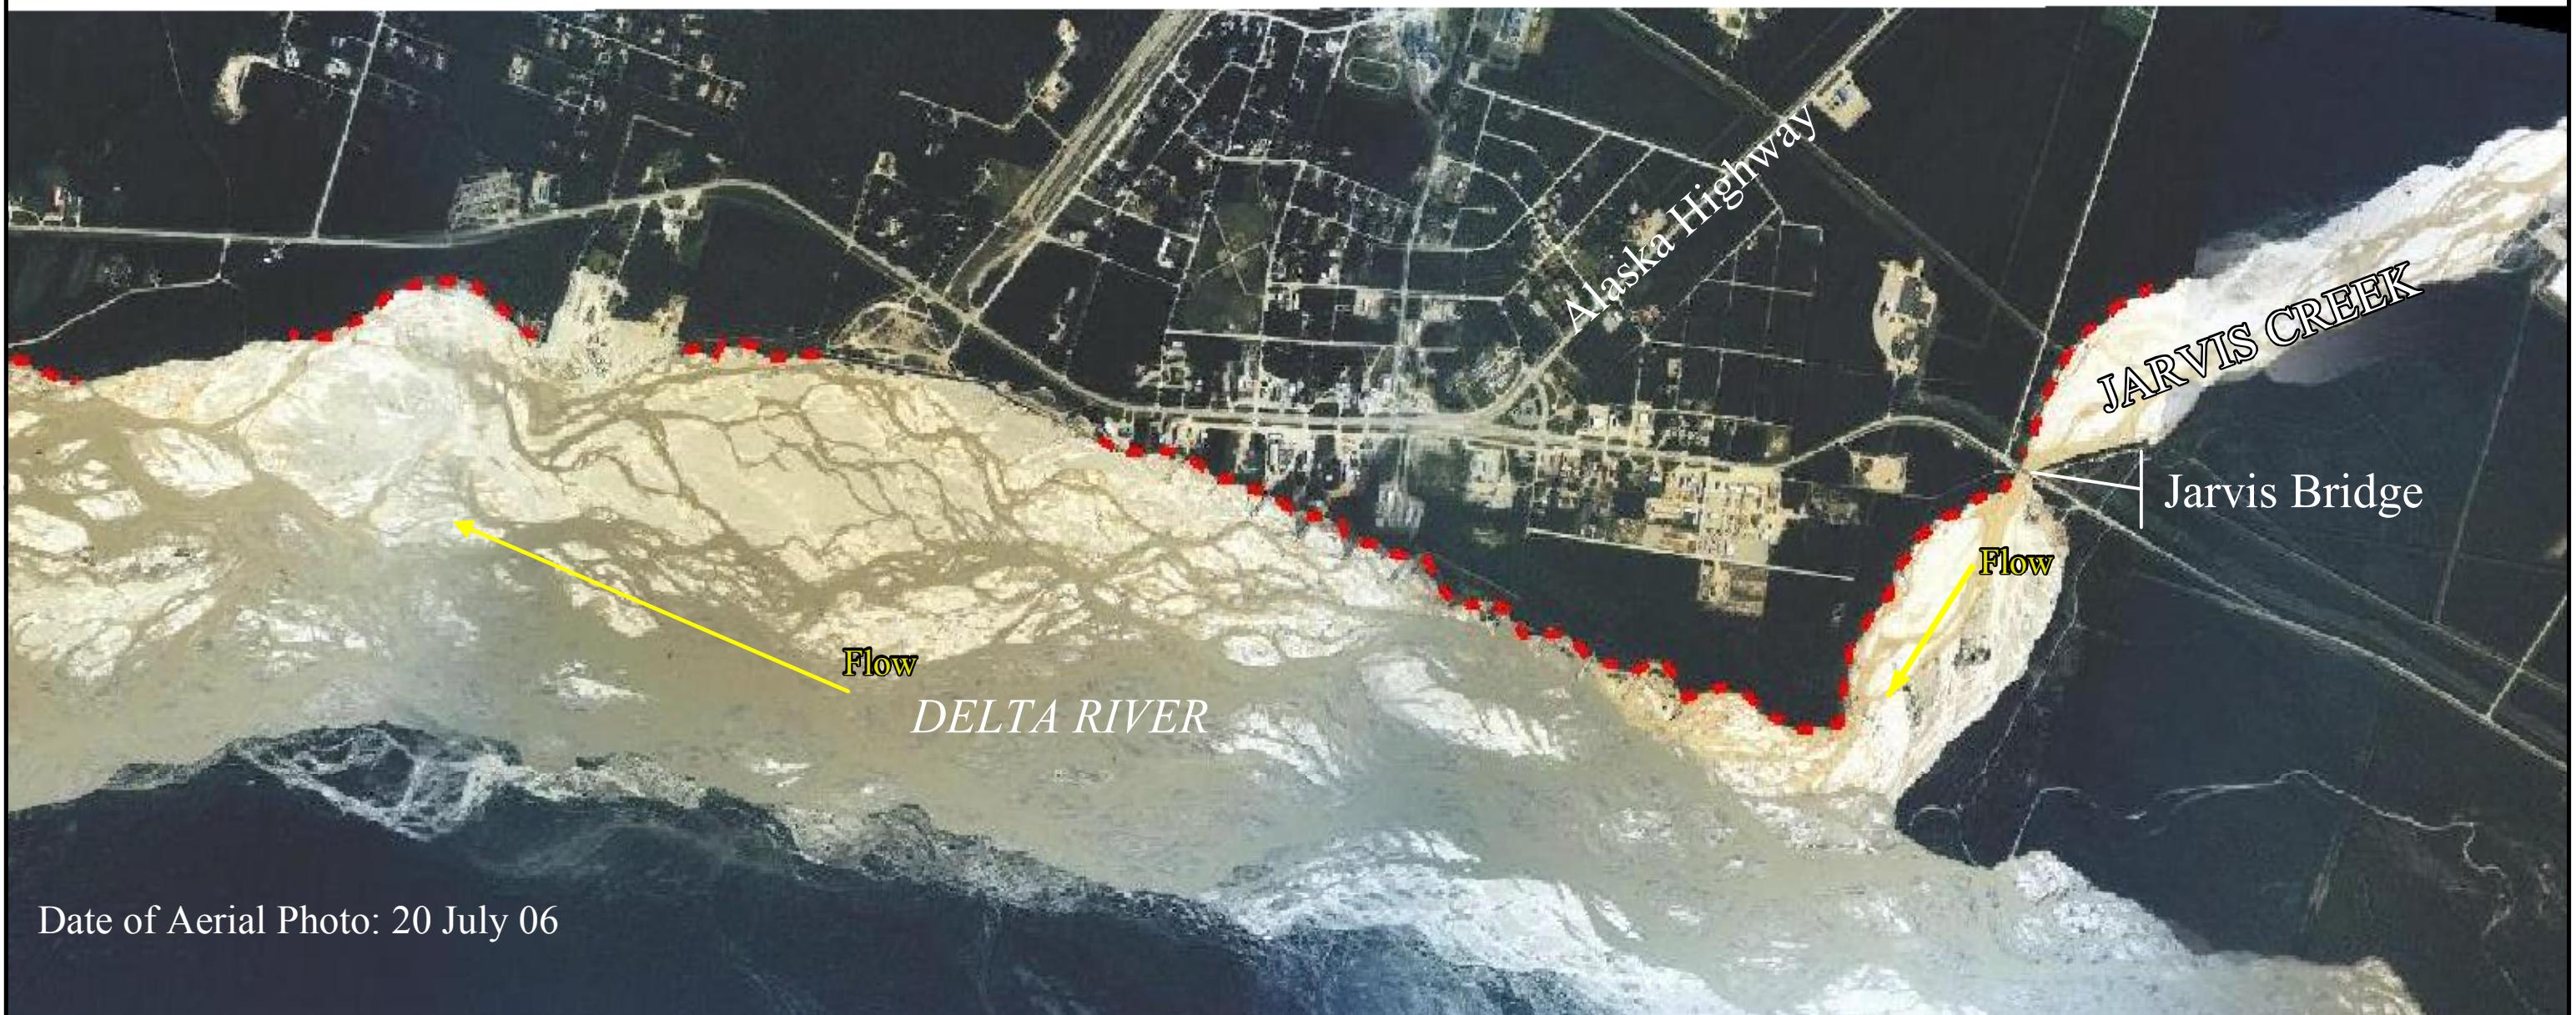
Alaska Baseline Erosion
Delta Junction, Alaska

NOTE: The extent of erosion shown on this figure is based on interviews with the community. This data has not been field verified. This figure is only intended to show areas of erosion, not rates or severity of erosion
