ALASKA BASELINE EROSION ASSESSMENT

AVETA Report Summary– Dillingham, Alaska

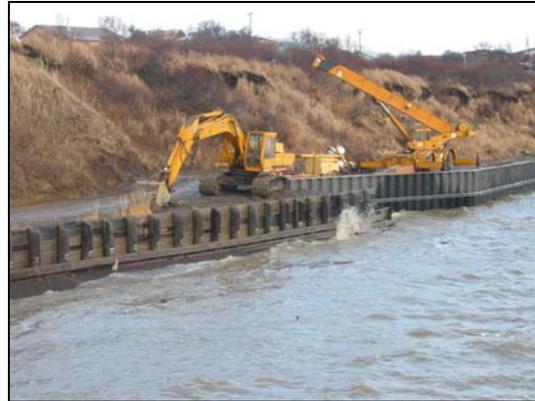
Corps shore protection at Snag Point

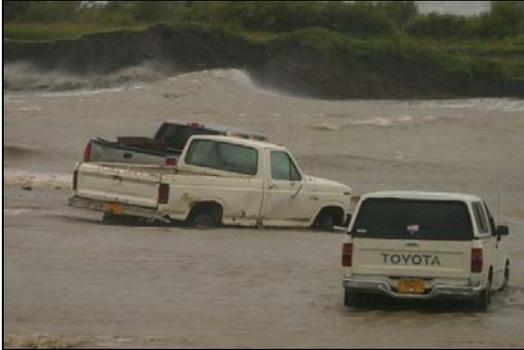
Storm waves entering Dillingham Harbor

A project to protect Dillingham Harbor and the surrounding facilities is nearing completion of the planning phase and the beginning of the design phase. Typical annual storms are causing land to erode along the west bank of Dillingham Harbor. As seen in the photos above, the waves enter the harbor and continually erode the west bank. The east bank has already been protected by a Corps project. Erosion at the west side of the harbor entrance is also fueled by wave action in conjunction with high tides. Currently, the west bank of Dillingham Harbor is eroding at an average rate of 11 feet per year. If left unchecked, the continued erosion would lead to a significant decrease of harbor protection. In addition to reduced bank protection for the harbor, floats, and commercial fishing fleet, land as well as the majority of the fuel supply for the area would be lost.

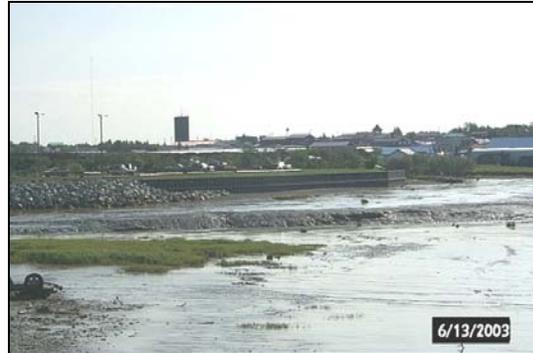
Corps protection on harbor east bank
