U.S. Army Corps
of Engineers
Alaska District

ALASKA BASELINE EROSION ASSESSMENT

Erosion Information Paper - Diomedes, Alaska

Current as of December 9, 2007

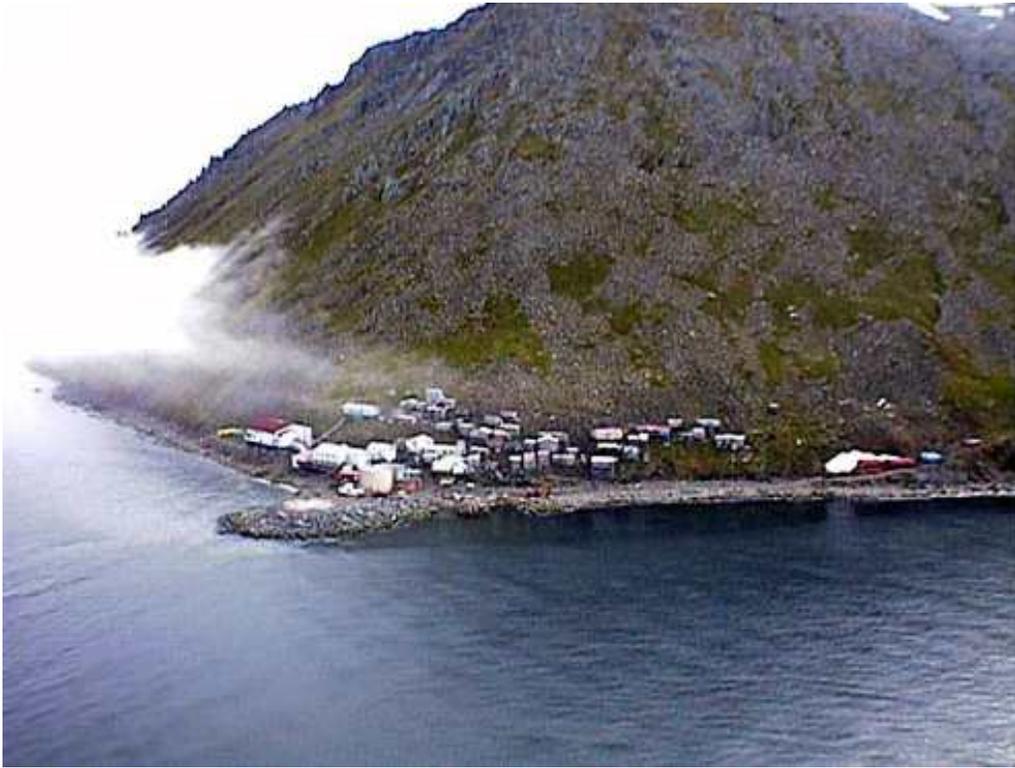
Photo 1: Aerial view of Diomedede; DCCED photo library©, 1998.

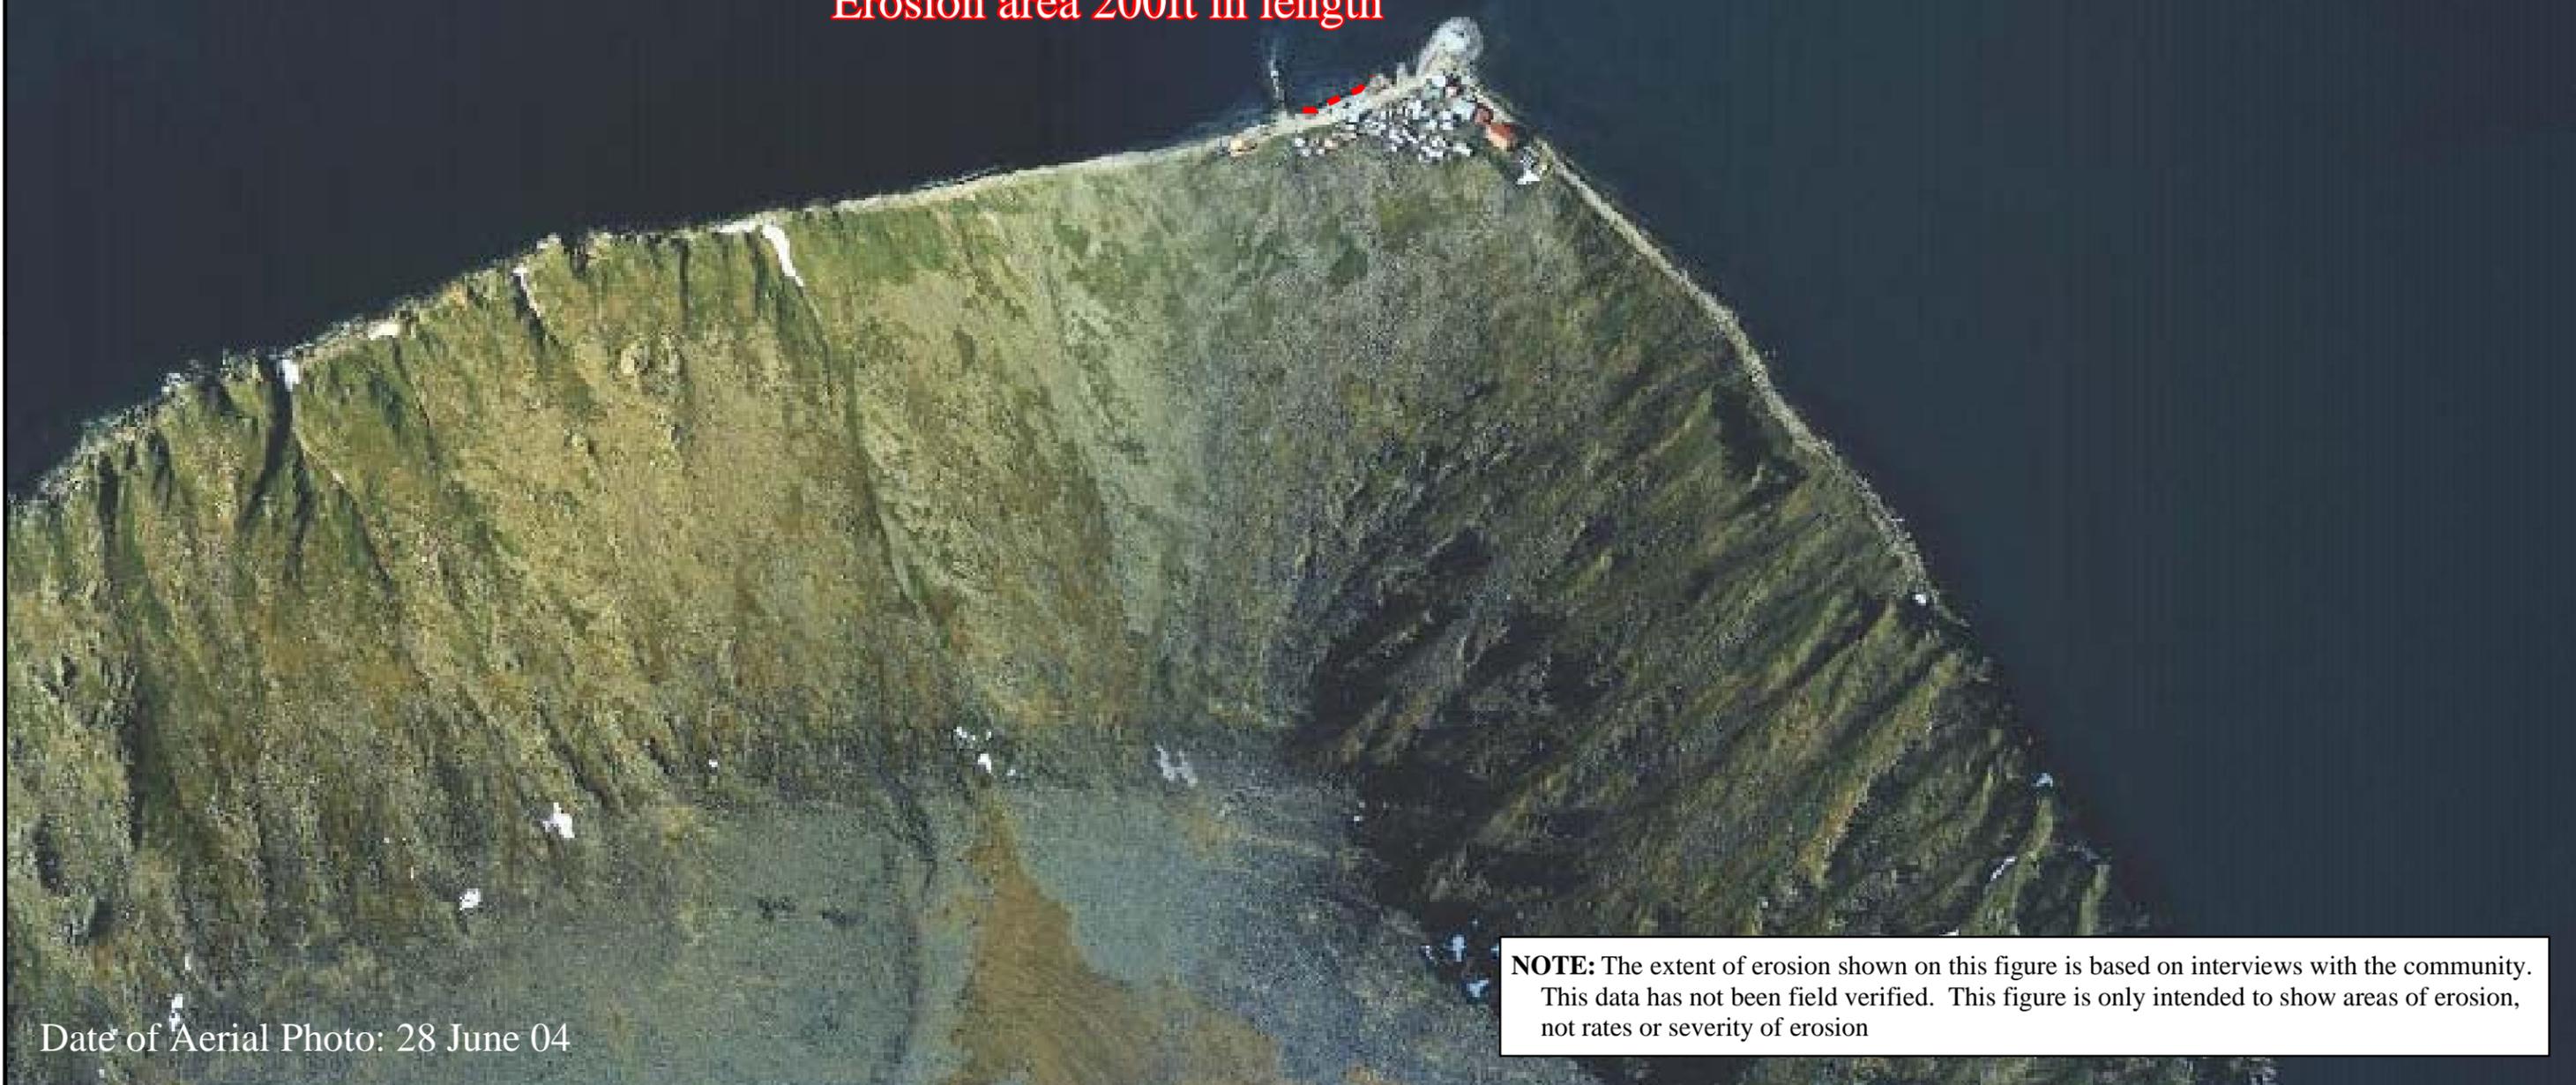
Based on the community survey, Diomedes' coast is eroded by the Bering Sea. High tides, storm surges in the fall, wind and waves, melting permafrost, and late-forming coastal cause or contribute to the erosion. The south side beach in front of the old tank farm near the village corporation office is being eroded. The Survey reported major erosion events in 1990, 2003, and 2005. In 2005, the shoreline eroded 3 feet.

Erosion area 200ft in length
