U.S. Army Corps
of Engineers
Alaska District

ALASKA BASELINE EROSION ASSESSMENT

Erosion Information Paper – Eagle City and Eagle Village, Alaska

Current as of January 21, 2008

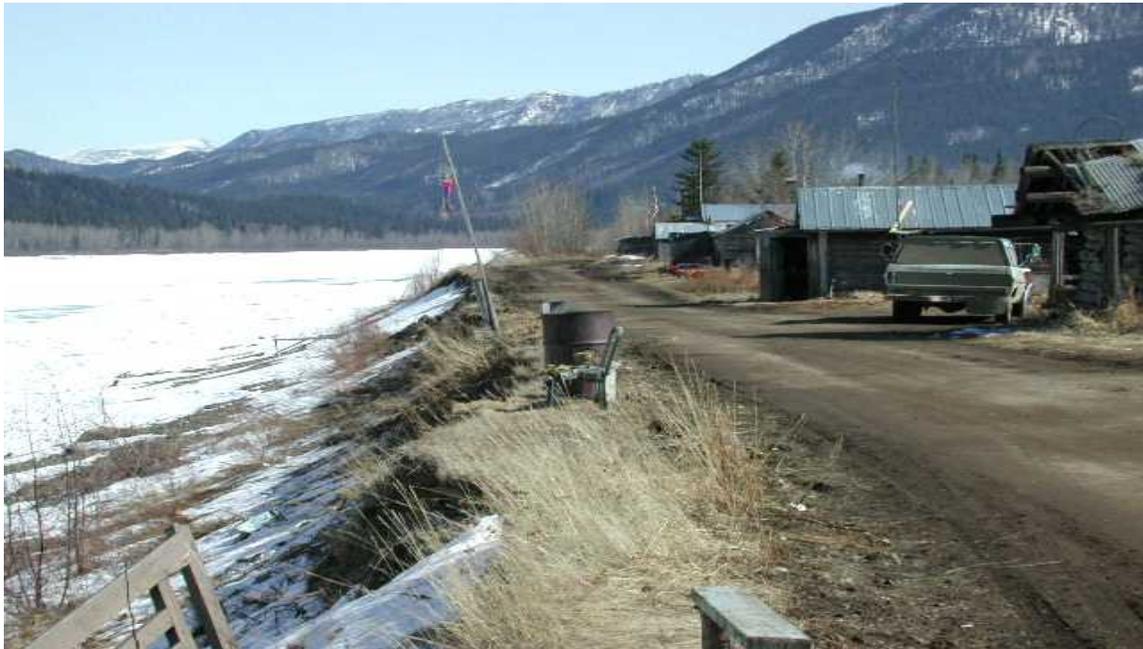
Village of Eagle. Several residences, some outbuilding and sheds, the community well house, Charlie's Hall community building, Front Road, the clinic, the tribal work force office, the church, and the remains of the historic school house are all estimated at less than 100 feet from the top of the bank. Items identified farther back from the river include fuel storage tanks, and a

Photo 1: In Eagle village some homes are located close to the Yukon River shoreline; photo courtesy of the Division of Homeland Security and Emergency Management, 2001.

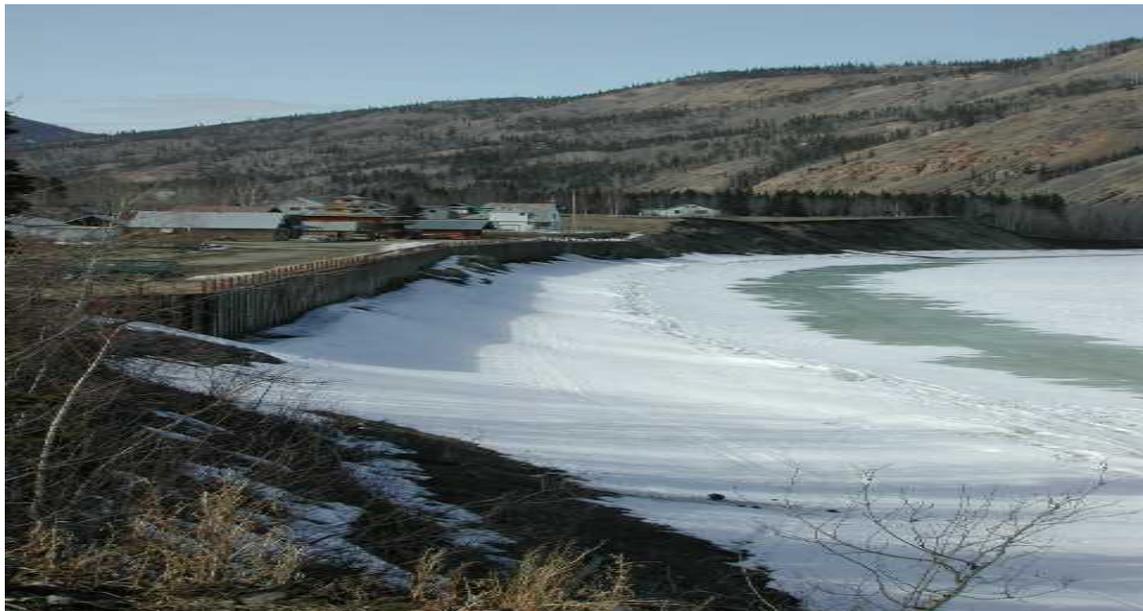
City of Eagle. An approximately 950-foot-long sheet pile retaining wall was installed in 1994, which reduced the erosion rate in the area. Six hundred feet of riverbank downstream from the end of the sheet pile is currently eroding, however the upstream end of the sheet pile appears to be controlling the erosion. The sheet pile retaining wall was constructed at a cost of about \$1.3 million as an Emergency Watershed Protection project. Structures and facilities presently threatened by the approximately 600-foot eroding area along the river bank downstream from the sheet pile structure include the Episcopal Church, the airstrip, and the National Park Service Yukon-Charley Rivers National Preserve headquarters buildings.

Photo 2: Sheet pile retaining wall along the city of Eagle shoreline protects the bank from erosion. The unprotected high bluff area is in the background, beyond the end of the sheet pile wall; photo courtesy of the Division of Homeland Security and Emergency Management, 2001.
