U.S. Army Corps
of Engineers
Alaska District

ALASKA BASELINE EROSION ASSESSMENT

Erosion Information Paper - Eek, Alaska

Current as of November 10, 2007

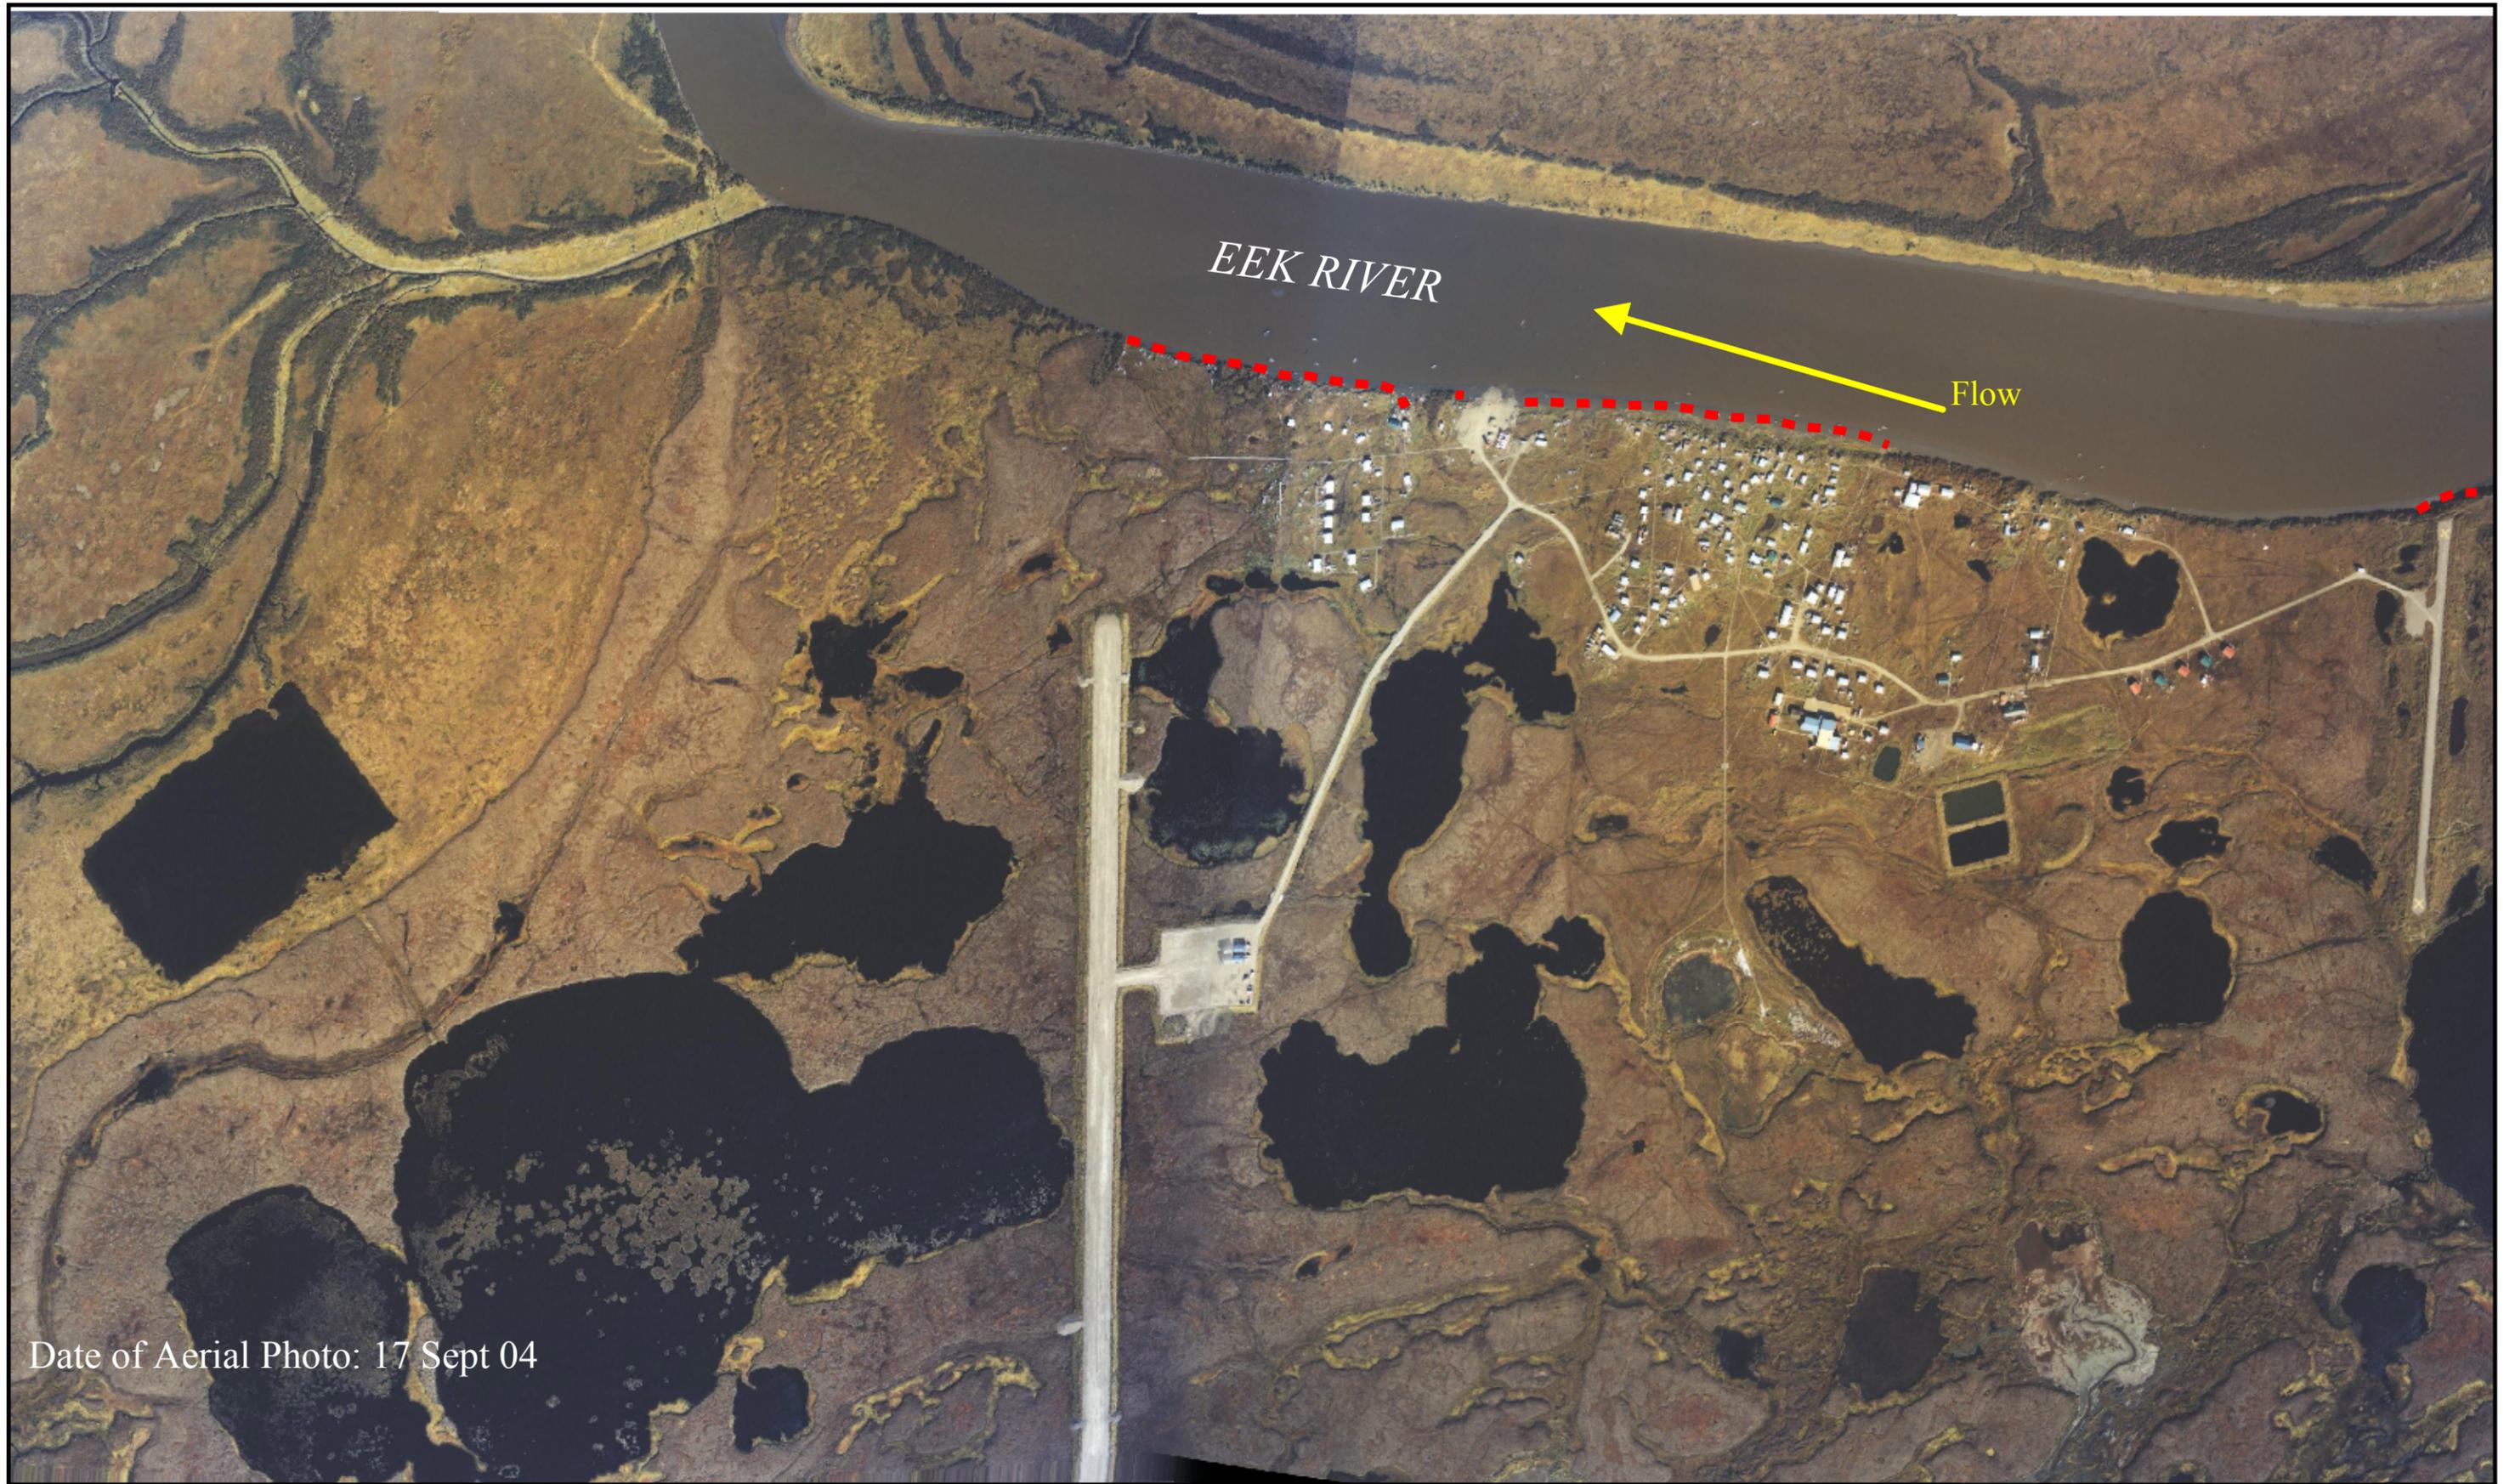
No photos have been provided by the community or other sources. A diagram showing the linear extent of erosion is attached.

--- Linear Extent of Erosion
