U.S. Army Corps  
of Engineers  
Alaska District

## **ALASKA BASELINE EROSION ASSESSMENT**

### **Erosion Information Paper - Egegik, Alaska**

Current as of March 3, 2009

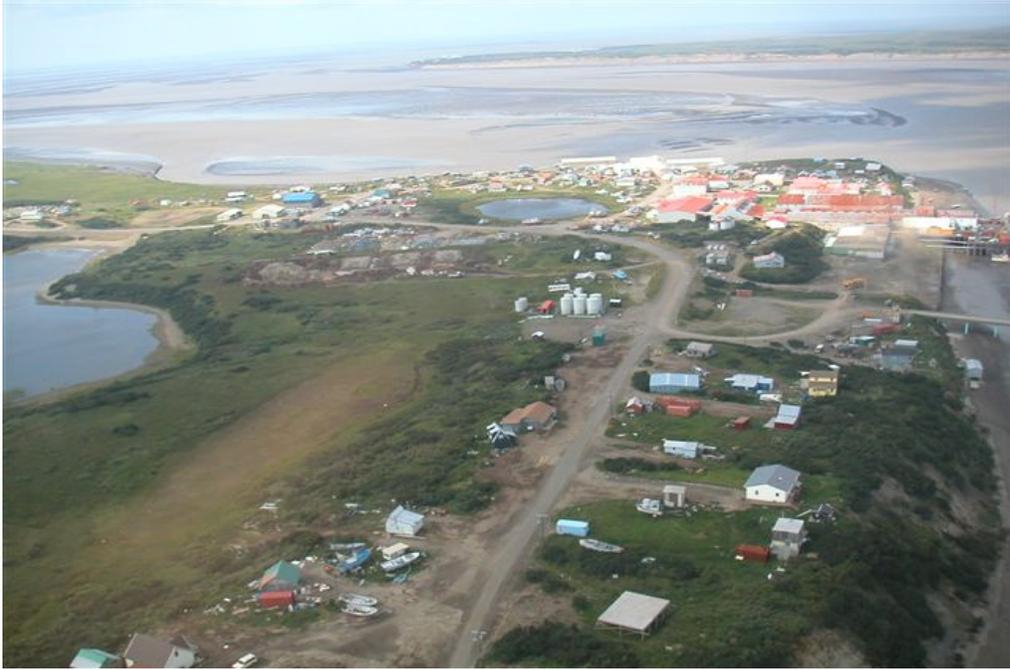
**Photo 1: Aerial view of Egegik, photo courtesy of the Becharof Corporation, 2005.**

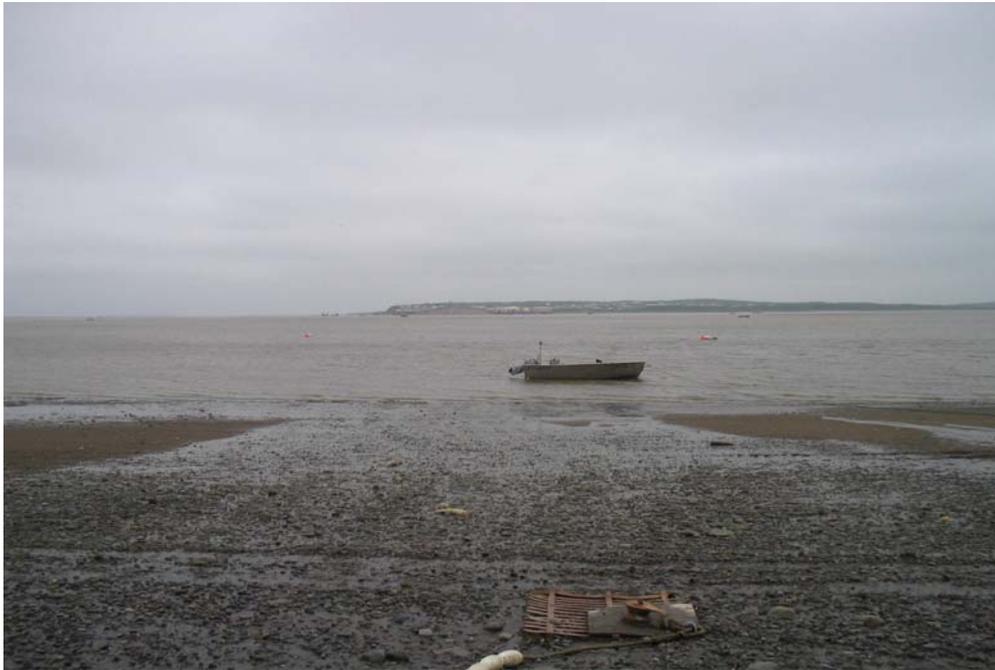
**Photo 2: Looking across the Egegik River with the community  
In the background, photo courtesy of the Becharof Corporation, 2005.**
