U.S. Army Corps
of Engineers
Alaska District

ALASKA BASELINE EROSION ASSESSMENT

Erosion Information Paper - Ekuk, Alaska

Current as of February 23, 2009

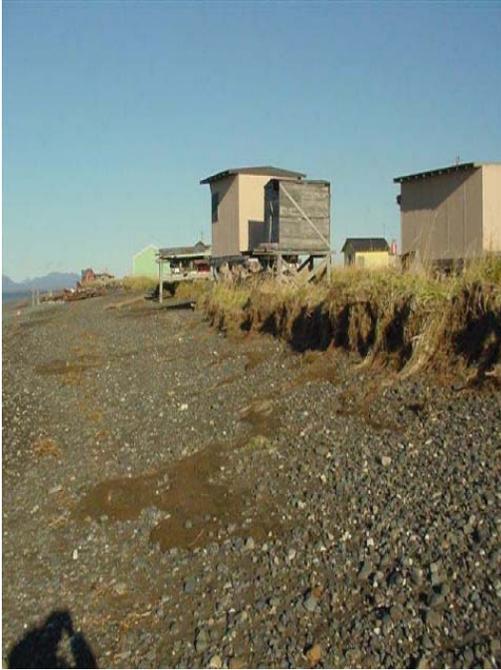
Photo 1: Seasonal buildings used by set-net fisheries at Ekuk, 2007.

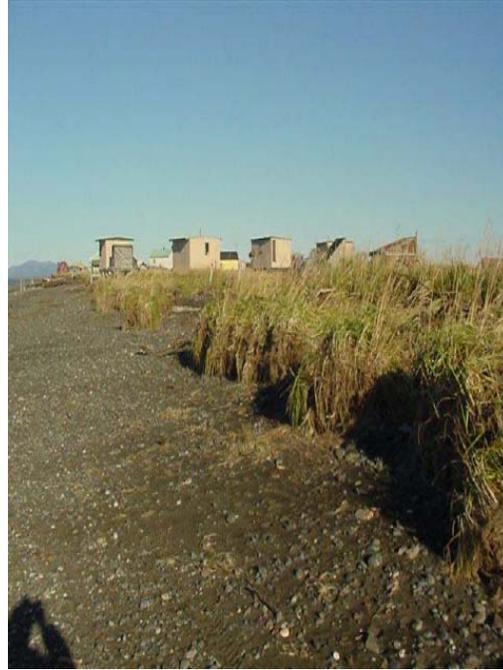
Photo 2: Eroding shoreline at Ekuk, 2007.

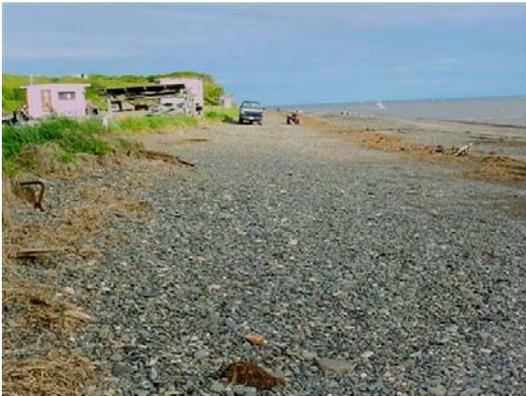
Photo 3: Ekuk shoreline, date unknown.

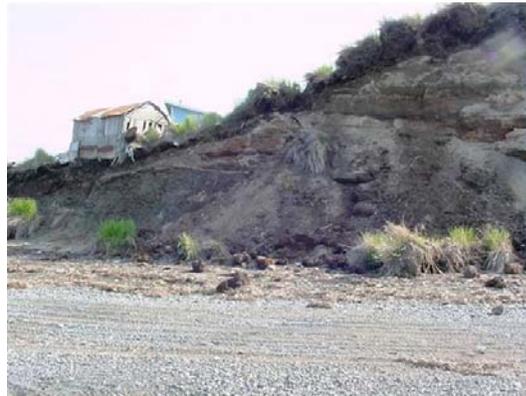
Photo 4: Building falling over edge, date unknown.
