U.S. Army Corps
of Engineers
Alaska District

ALASKA BASELINE EROSION ASSESSMENT

Erosion Information Paper - Emmonak, Alaska

Current as of August 5, 2007

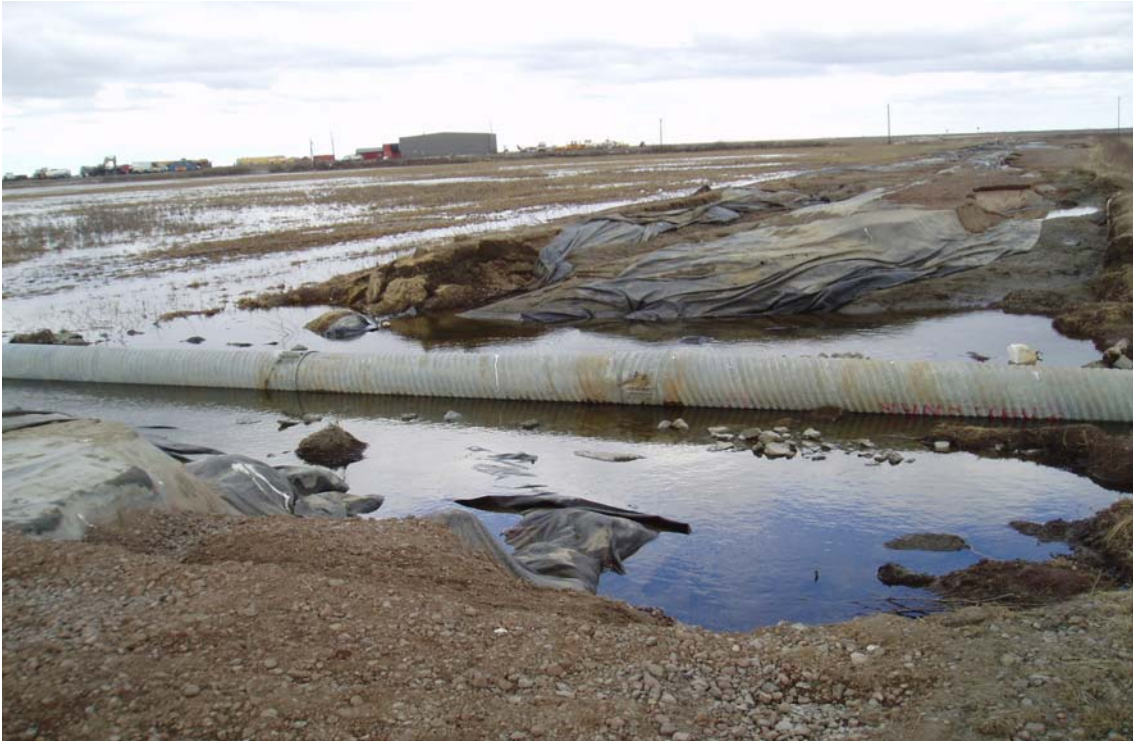
Airport Way is the main road to the airport. The road was washed out during a flood-erosion event in 2005, making the riverside road the only access to the airport. Airport Way remains threatened by active erosion. Utility lines that service the airport are along the threatened road. The Alaska Department of Transportation and Public Facilities (DOT&PF) plans to reconstruct the road in 2008 or 2009, at an estimated cost of \$1.4 million.

Photo 1: Airport Way Washout and Exposed Culvert, May 2005.

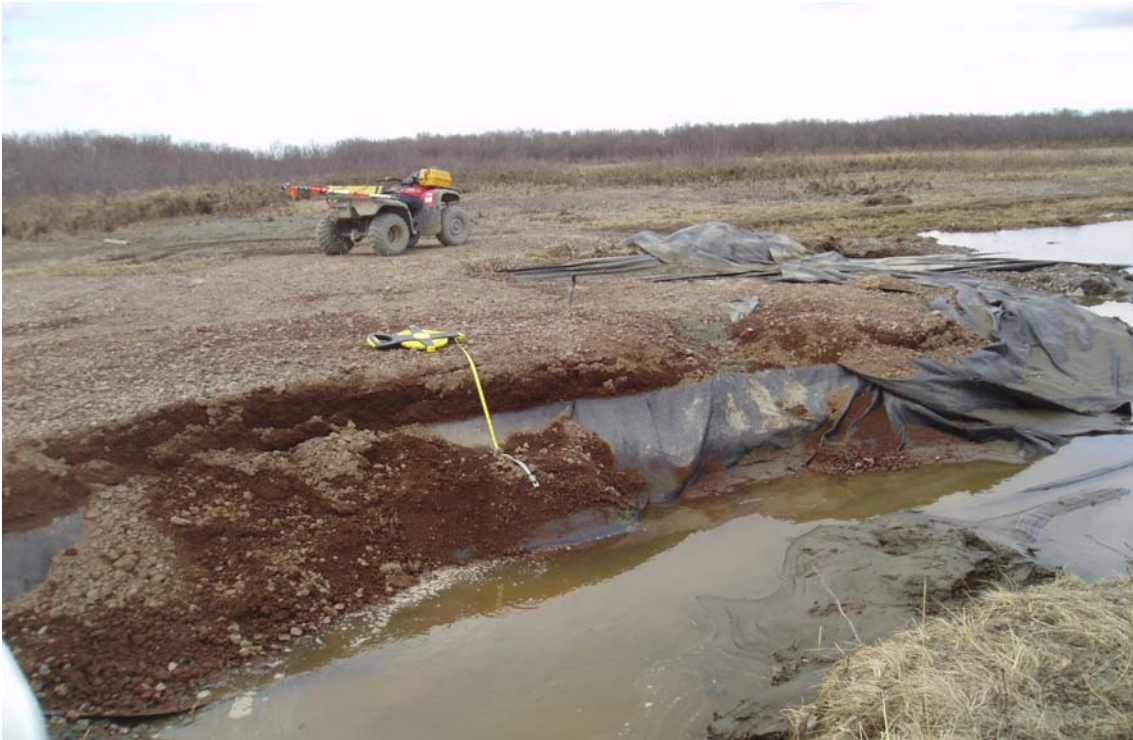
Photo 2: Airport Way Erosion / Washout, May 2005.

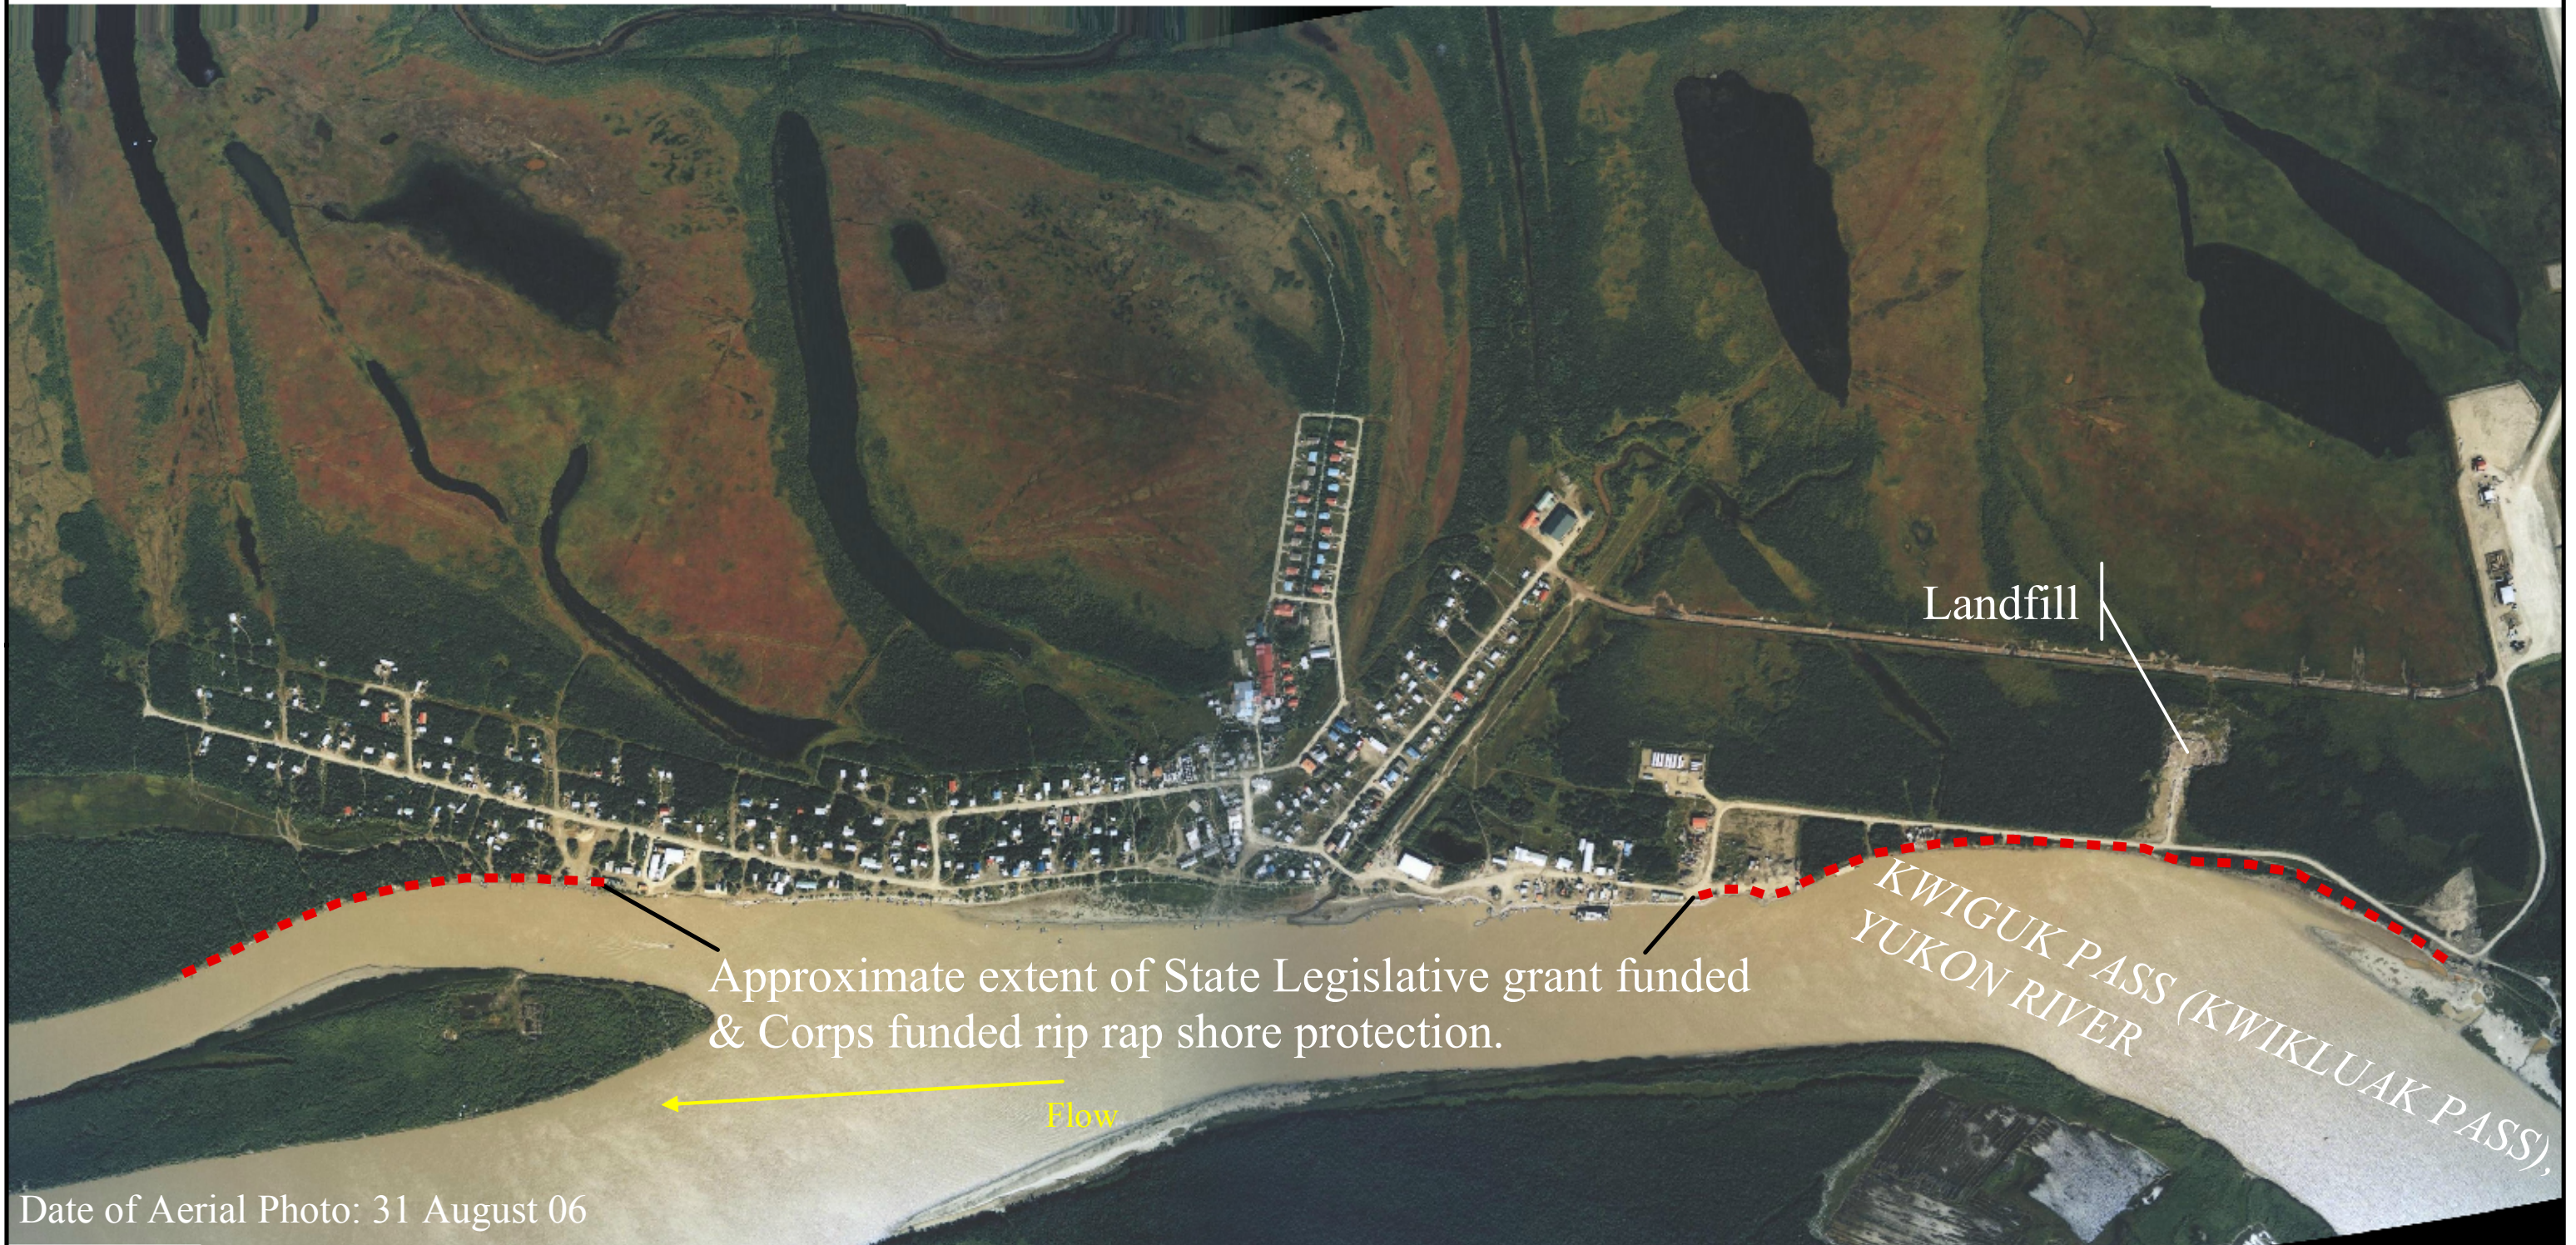
Alaska Baseline Erosion
Emmonak, Alaska

--- Linear Extent of Erosion
