## **ALASKA BASELINE EROSION ASSESSMENT**

### **Erosion Information Paper - Evansville, Alaska**

Current as of December 14, 2007

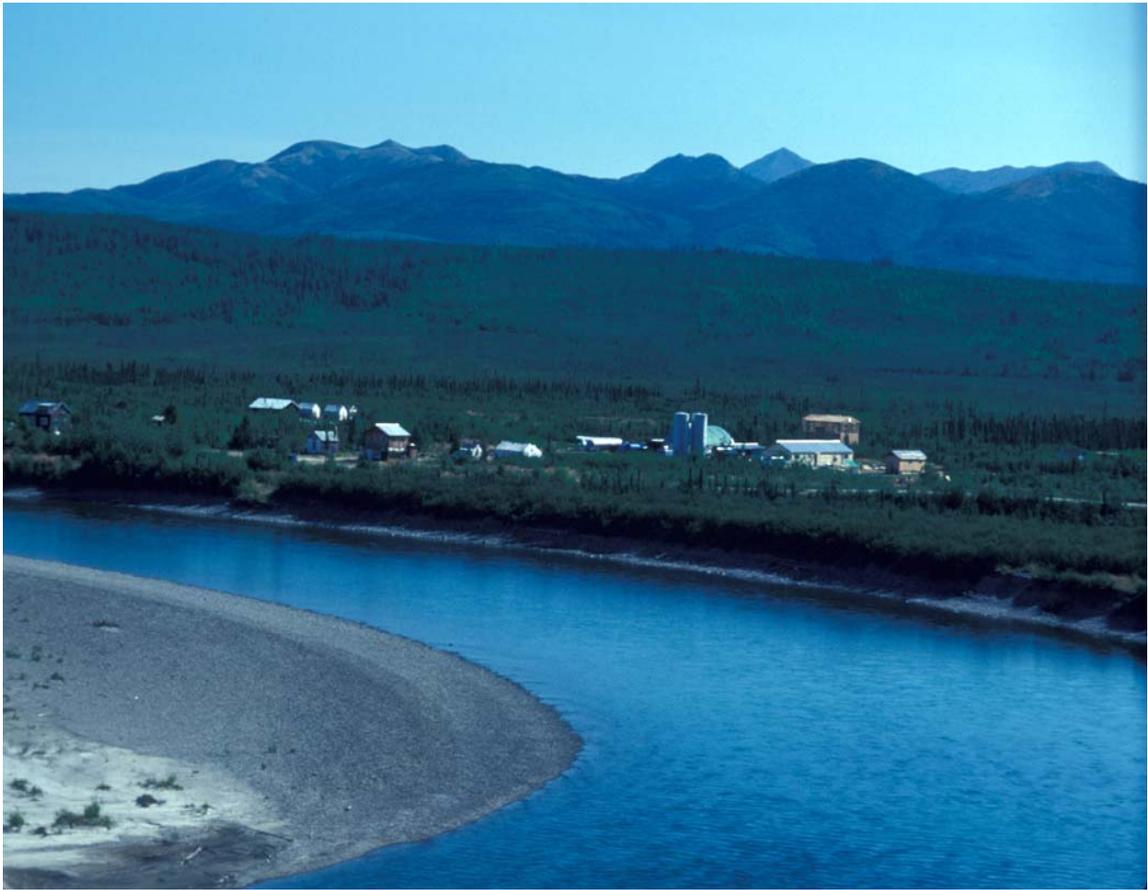
The Evansville community survey reports seasonal riverbank erosion associated with the Koyukuk River. The riverbank was estimated in the survey to be between 15 and 20 feet high along most of this area. Natural river flow, heavy rains, flooding, ice jams, spring breakup, and melting permafrost contribute to erosion. An August 1994 major erosion event during heavy rains caused extensive flooding on the Koyukuk River. No measurement records were provided in the erosion survey, but the rate of ongoing river erosion in Evansville was estimated to be 10 feet per year.

**Photo 1: Koyukuk River erosion at Evansville. USFWS, 2003.**

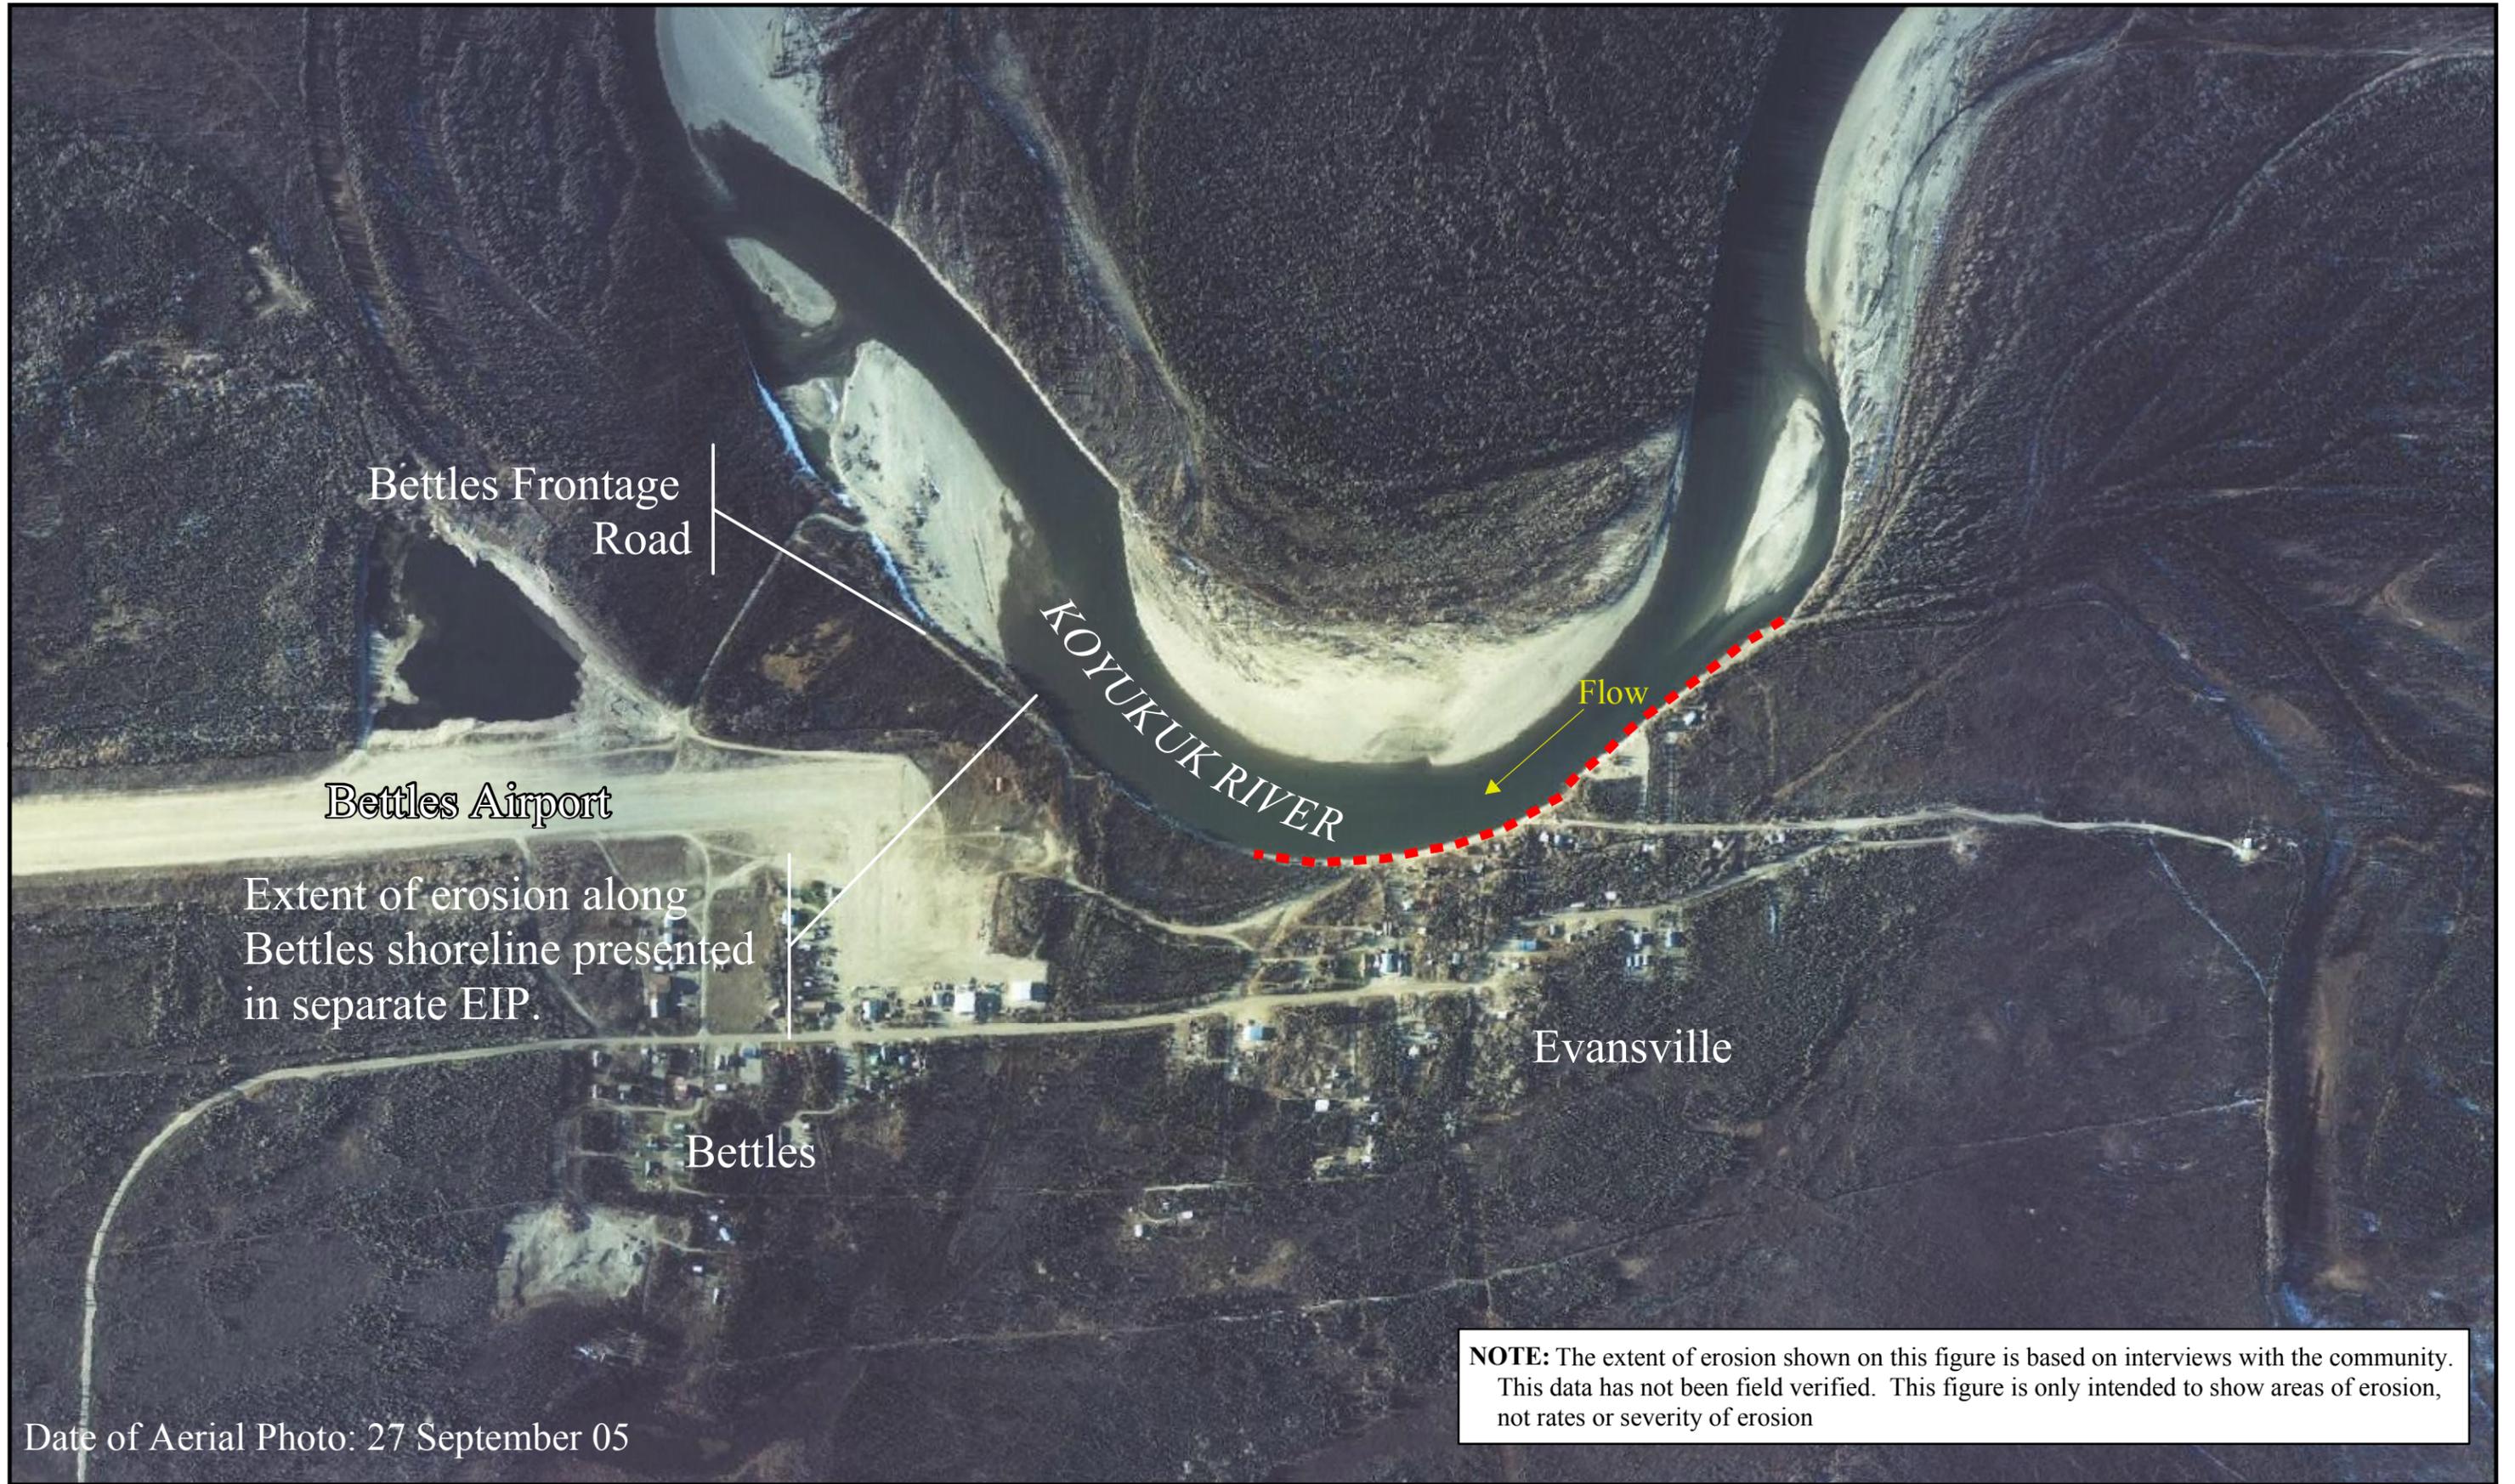
Alaska Baseline Erosion  
Evansville, Alaska

--- Linear Extent of Erosion
