U.S. Army Corps  
of Engineers  
Alaska District

## **ALASKA BASELINE EROSION ASSESSMENT**

# **Erosion Information Paper - Fairbanks, Alaska**

Current as of January 18, 2008

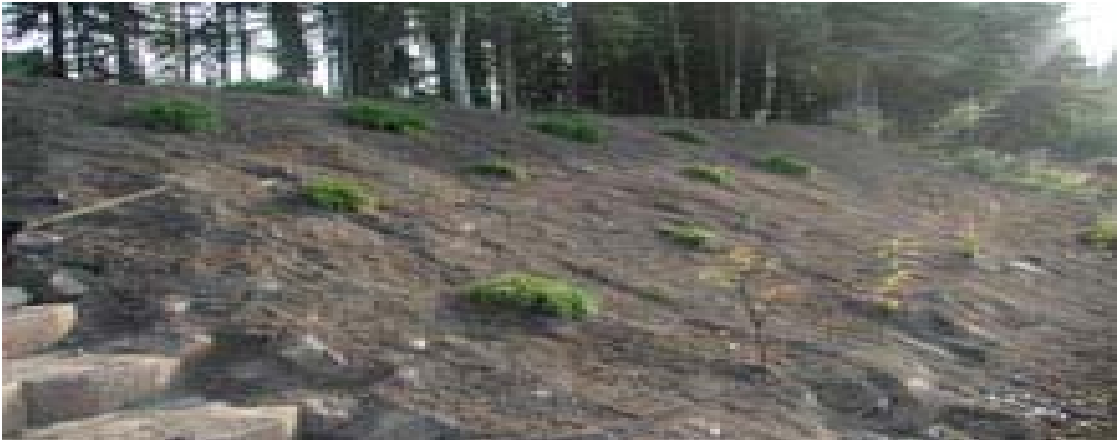
**Photo 1: Bio-engineered restoration of rapidly eroding bank of the Chena River at River Bend Estates included placing a log berm at the toe with willow-staked riprap upslope, and planting birch and juniper trees at the top of the bank. Photo courtesy of the USFWS, No photo date.**

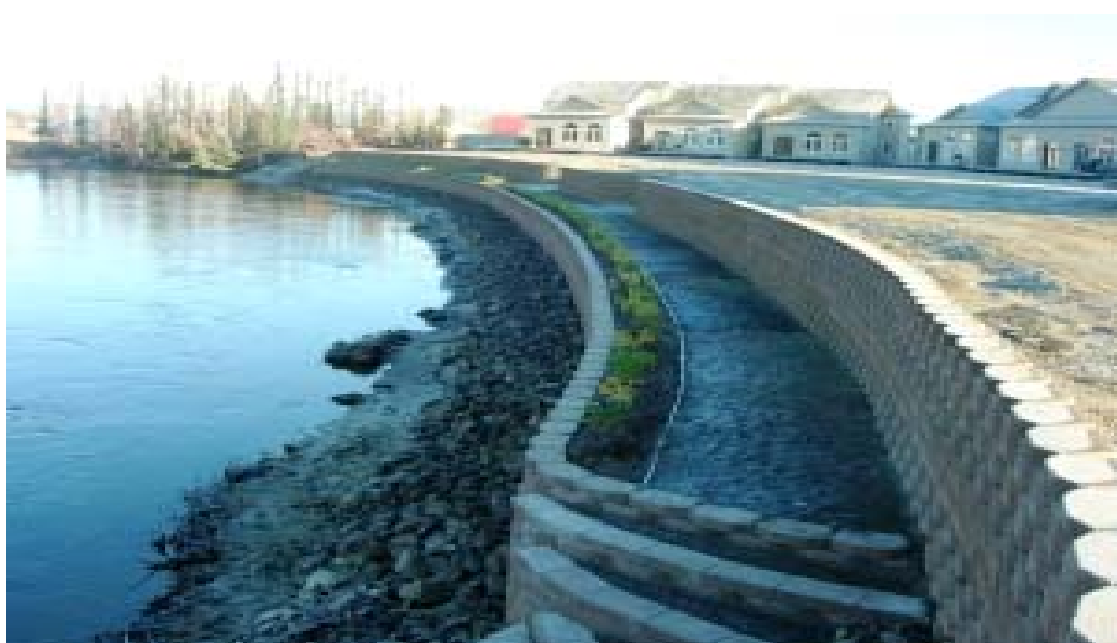
**Photo 2: Summit Consulting engineered a 400-foot double tiered retaining wall along the north side of the Chena River to prevent erosion at the Riverbend Condominiums site at Doyon Estates; Photo courtesy of Summit Consulting Services, Inc. 2005.**
