U.S. Army Corps
of Engineers
Alaska District

ALASKA BASELINE EROSION ASSESSMENT

Erosion Information Paper - Fort Yukon, Alaska

Current as of January 21, 2008

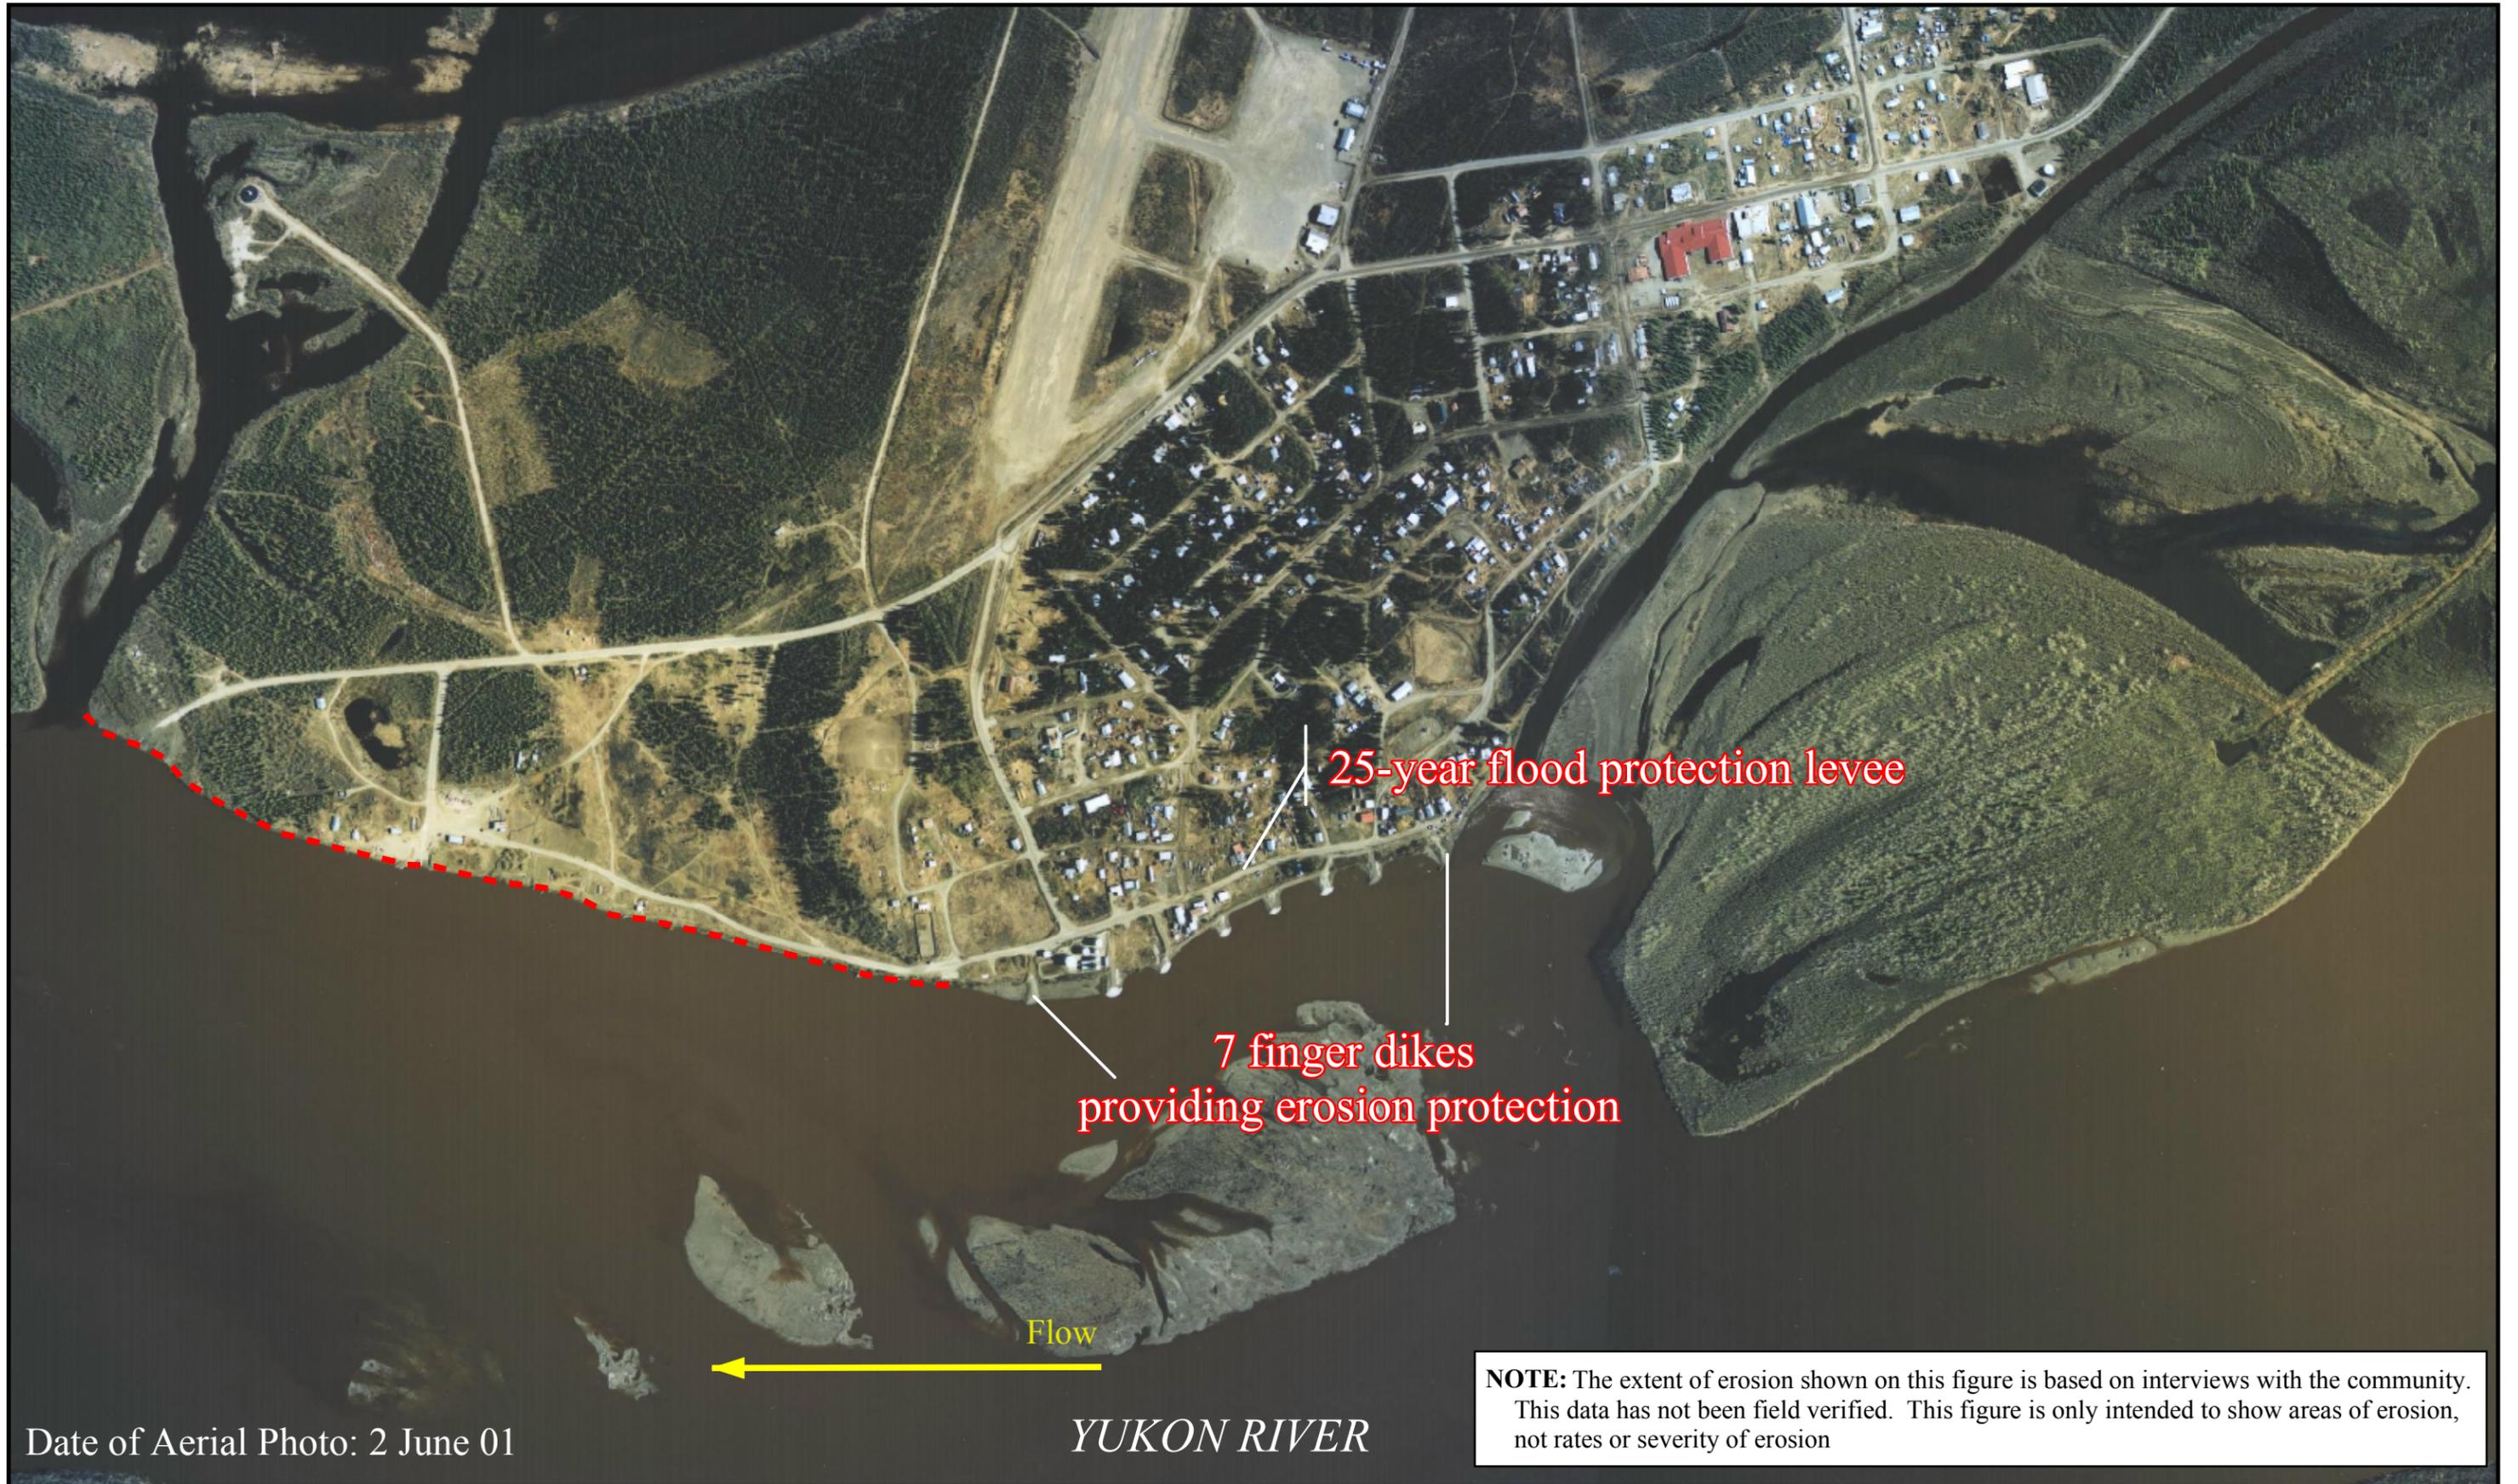
Alaska Baseline Erosion
Fort Yukon, Alaska

Bank erosion causes along the Yukon River are reported to be caused by natural river flow, water level changes, flooding, ice jams, spring break up, melting permafrost, boat traffic, pedestrian traffic, and vehicle traffic on the beach and bank all contribute to erosion. A large amount of gravel was removed from the Yukon River during construction of an Air Force site in 1955 which reportedly increased the flow velocity of the river and contributed to erosion. Several hundred feet have eroded along stretches of the river bank over the years, according to the *Fort Yukon Comprehensive Plan*. The riverbank is eroding at an estimated rate of 10 to 15 feet per year. The present erosion site is 1,200 to 1,500 feet horizontally and 15 feet vertically, extending from the Y-shaped slough downstream and beyond the barge landing to the finger dikes upstream.

Two residences are in danger of falling into the river, the city landing for boats is no longer usable due to erosion damage, and the barge landing is in danger of becoming unusable. Outbuildings, residential fuel tanks, food storage structures, drying racks, smoke houses, a main access road, utility poles, power lines, a sewage lagoon, sites of significant cultural and

archeological value, boardwalks, pathways, and a park area are all less than 100 feet from the active erosion area.

NOTE: The extent of erosion shown on this figure is based on interviews with the community. This data has not been field verified. This figure is only intended to show areas of erosion, not rates or severity of erosion
