U.S. Army Corps
of Engineers
Alaska District

ALASKA BASELINE EROSION ASSESSMENT

Erosion Information Paper - Gakona, Alaska

Current as of December 12, 2007

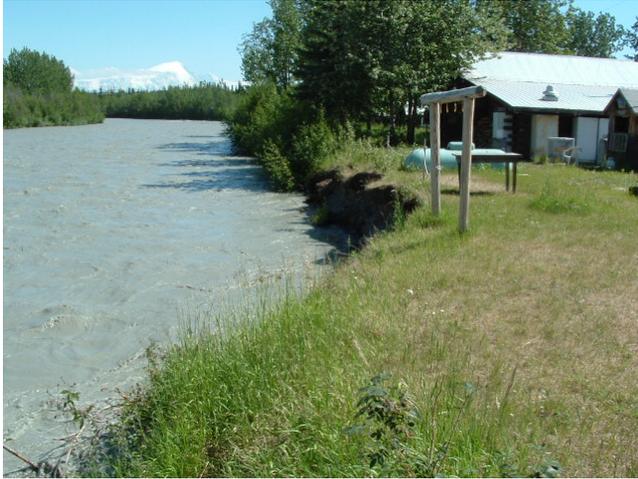
The community survey reports localized erosion associated with the Gakona River and slope erosion associated with roadwork by the Alaska Department of Transportation and Public Facilities (DOT&PF). A 450-foot section of the riverbank adjacent to the Gakona Lodge has significantly eroded, caused primarily by natural river flows and exacerbated by spring ice-jams. Two properties upstream of the lodge are reported to have erosion problems, but distance to the eroding bank was not reported. A 1985 Corps *Trip Report*, states that 2 to 4 feet of bank had eroded as of that year. The current lodge owner reports that during spring 2002, about 9 feet of bank was lost.

Photo 1: Erosion, looking east adjacent to the Gakona Lodge, July 2004.

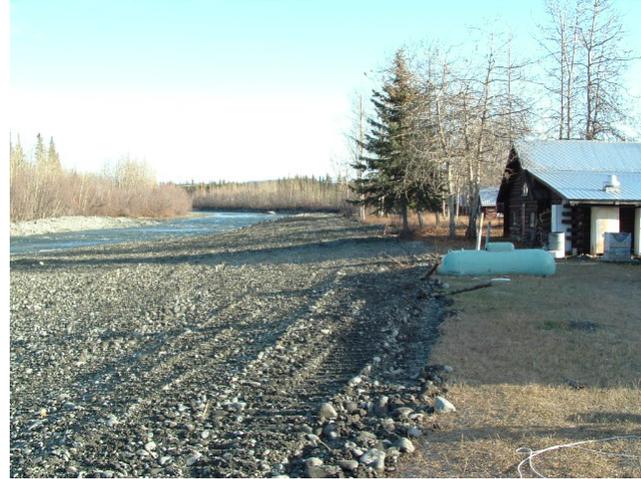
Photo 2: After erosion protection has been installed, looking east adjacent to Gakona Lodge, October 2004.

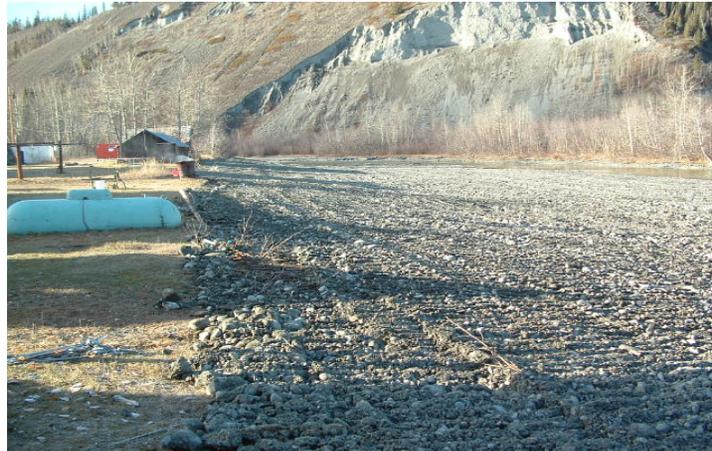
Photo 3: After erosion protection has been installed, looking west adjacent to Gakona Lodge, October 2004.

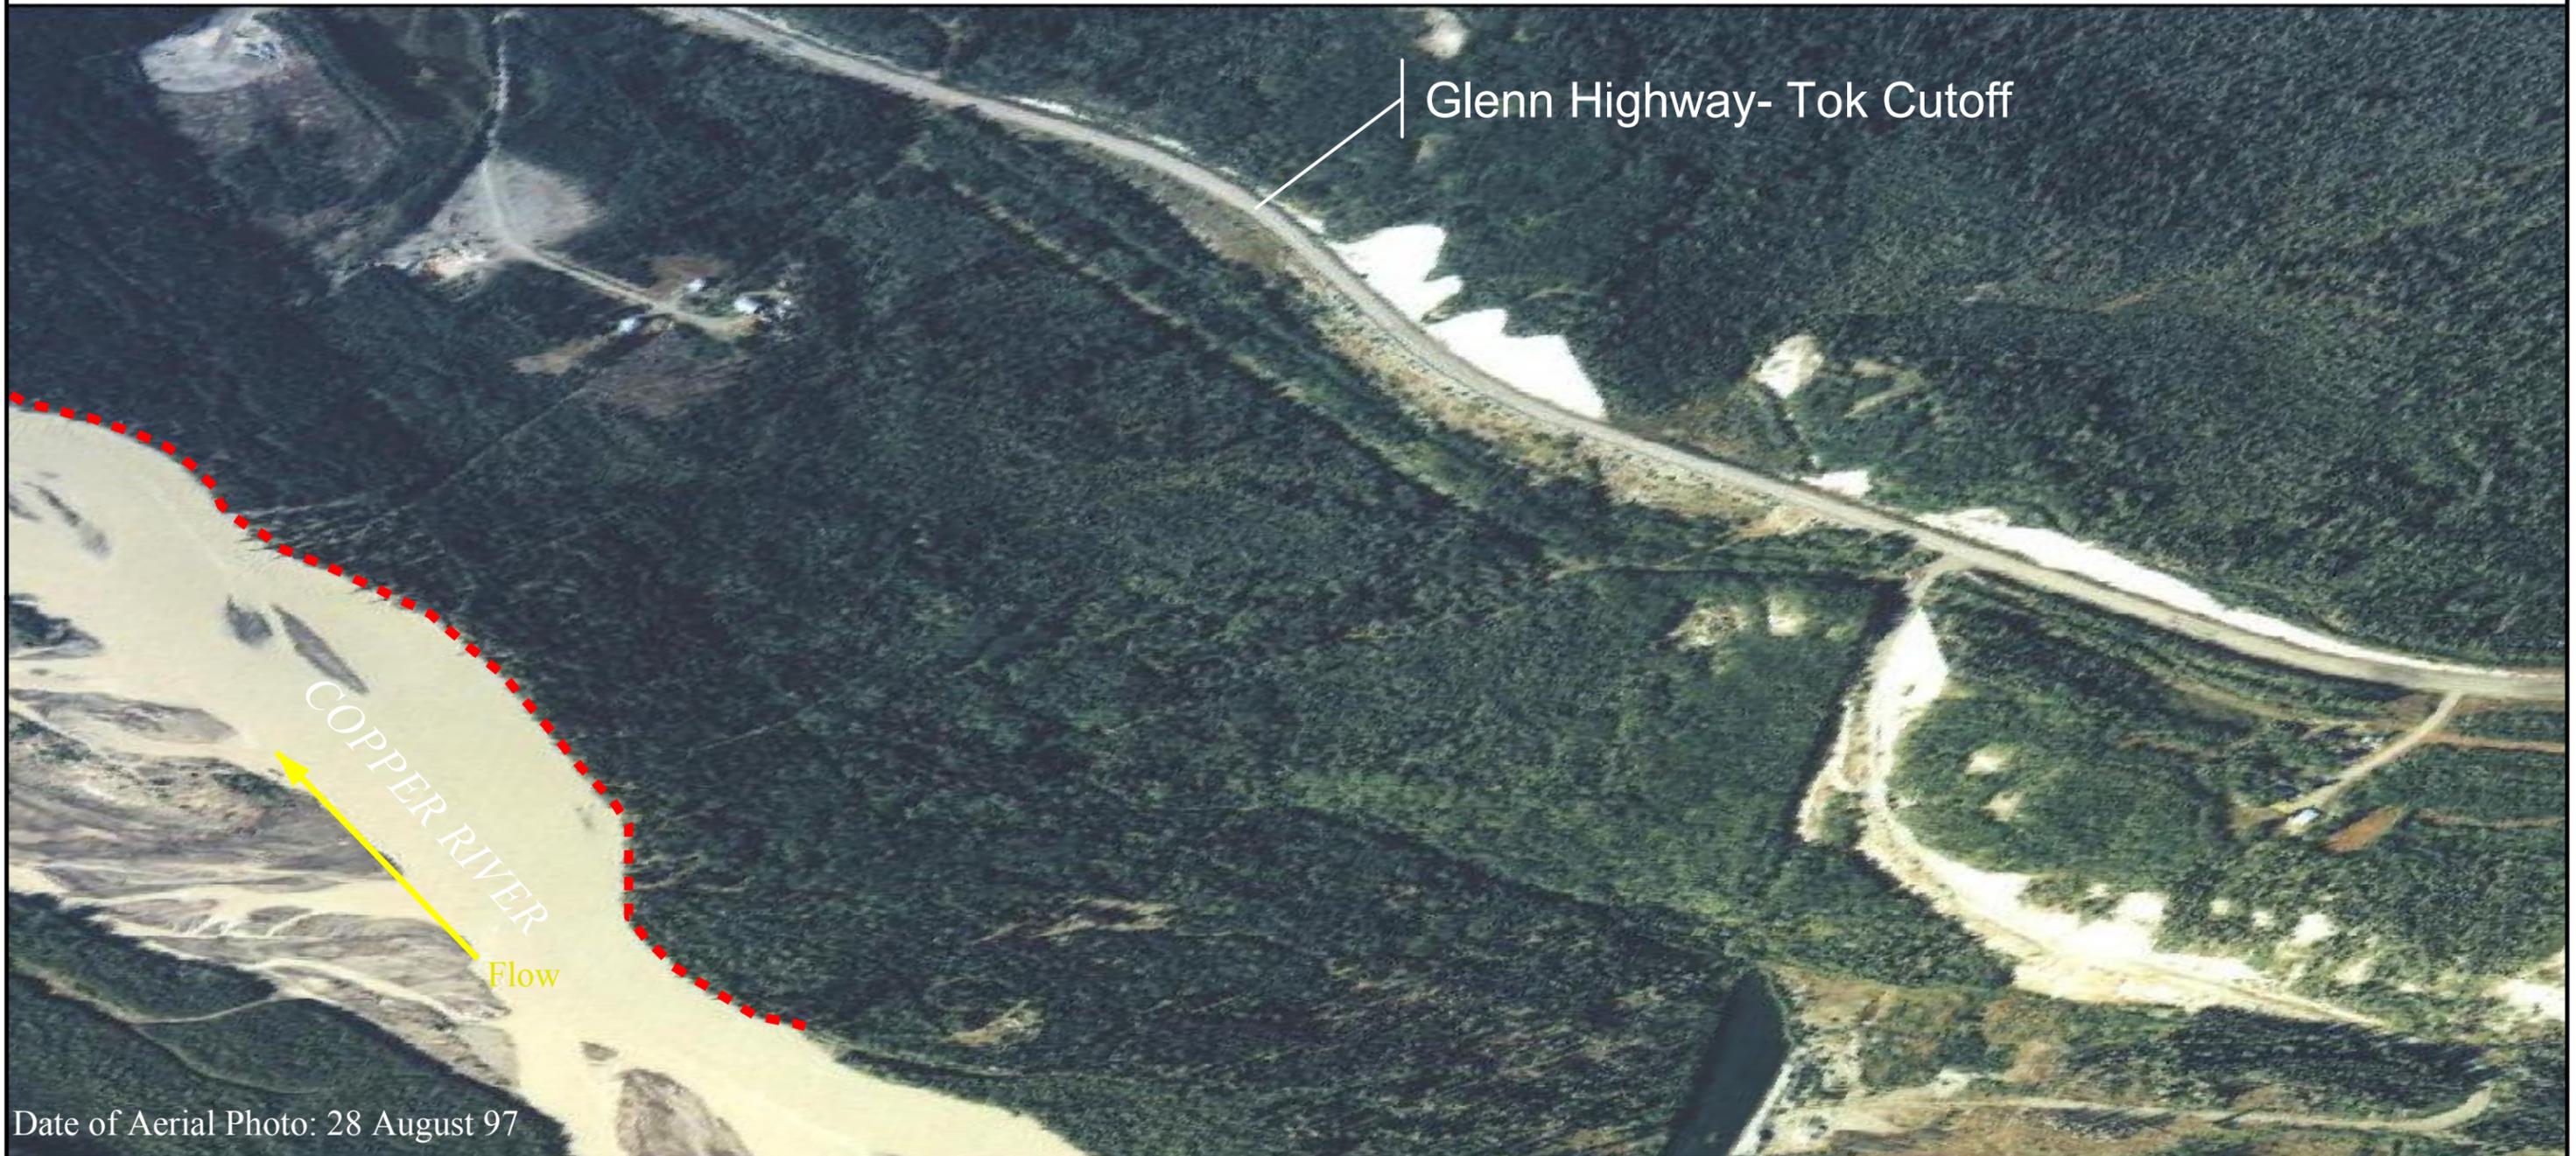
Alaska Baseline Erosion
Gakona, Alaska

--- Linear Extent of Erosion
