U.S. Army Corps  
of Engineers  
Alaska District

## **ALASKA BASELINE EROSION ASSESSMENT**

### **Erosion Information Paper - Galena, Alaska**

Current as of December 5, 2007

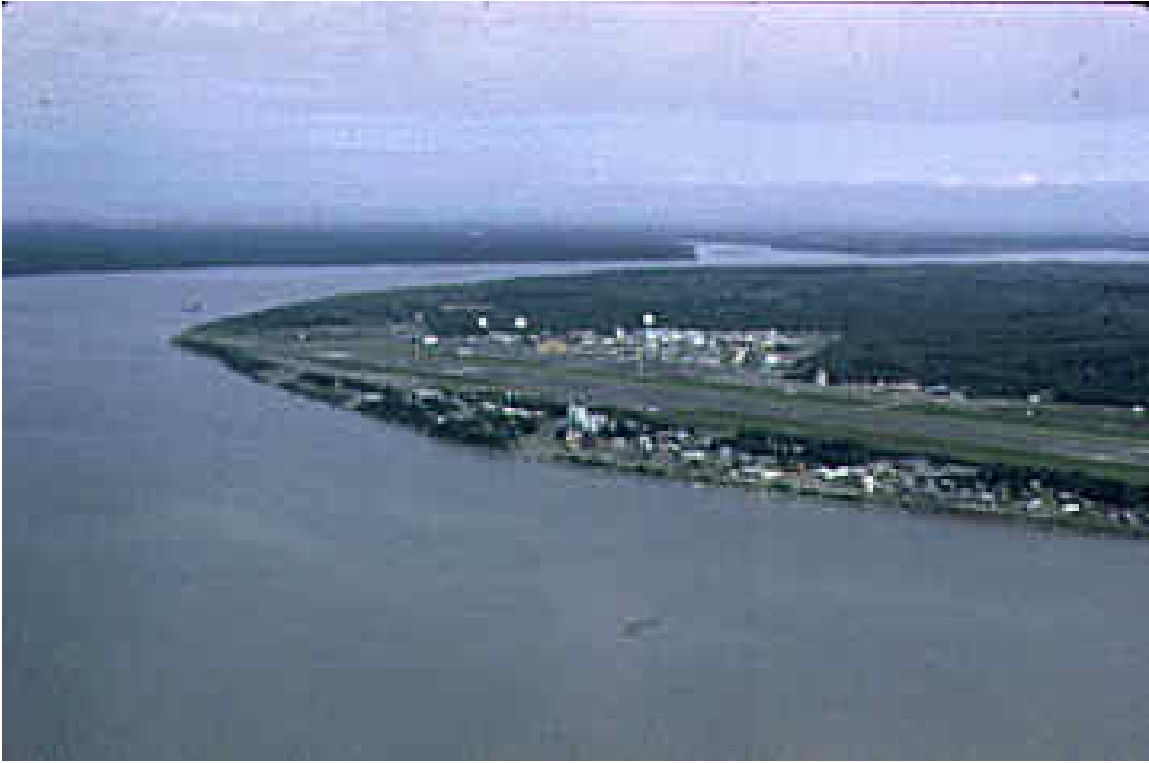
**Photo 1: Old Town Galena fronting the Yukon River is backed by the Galena airport. Photo is courtesy of the Division of Community and Regional Affairs, Community Photo Library © 1996.**

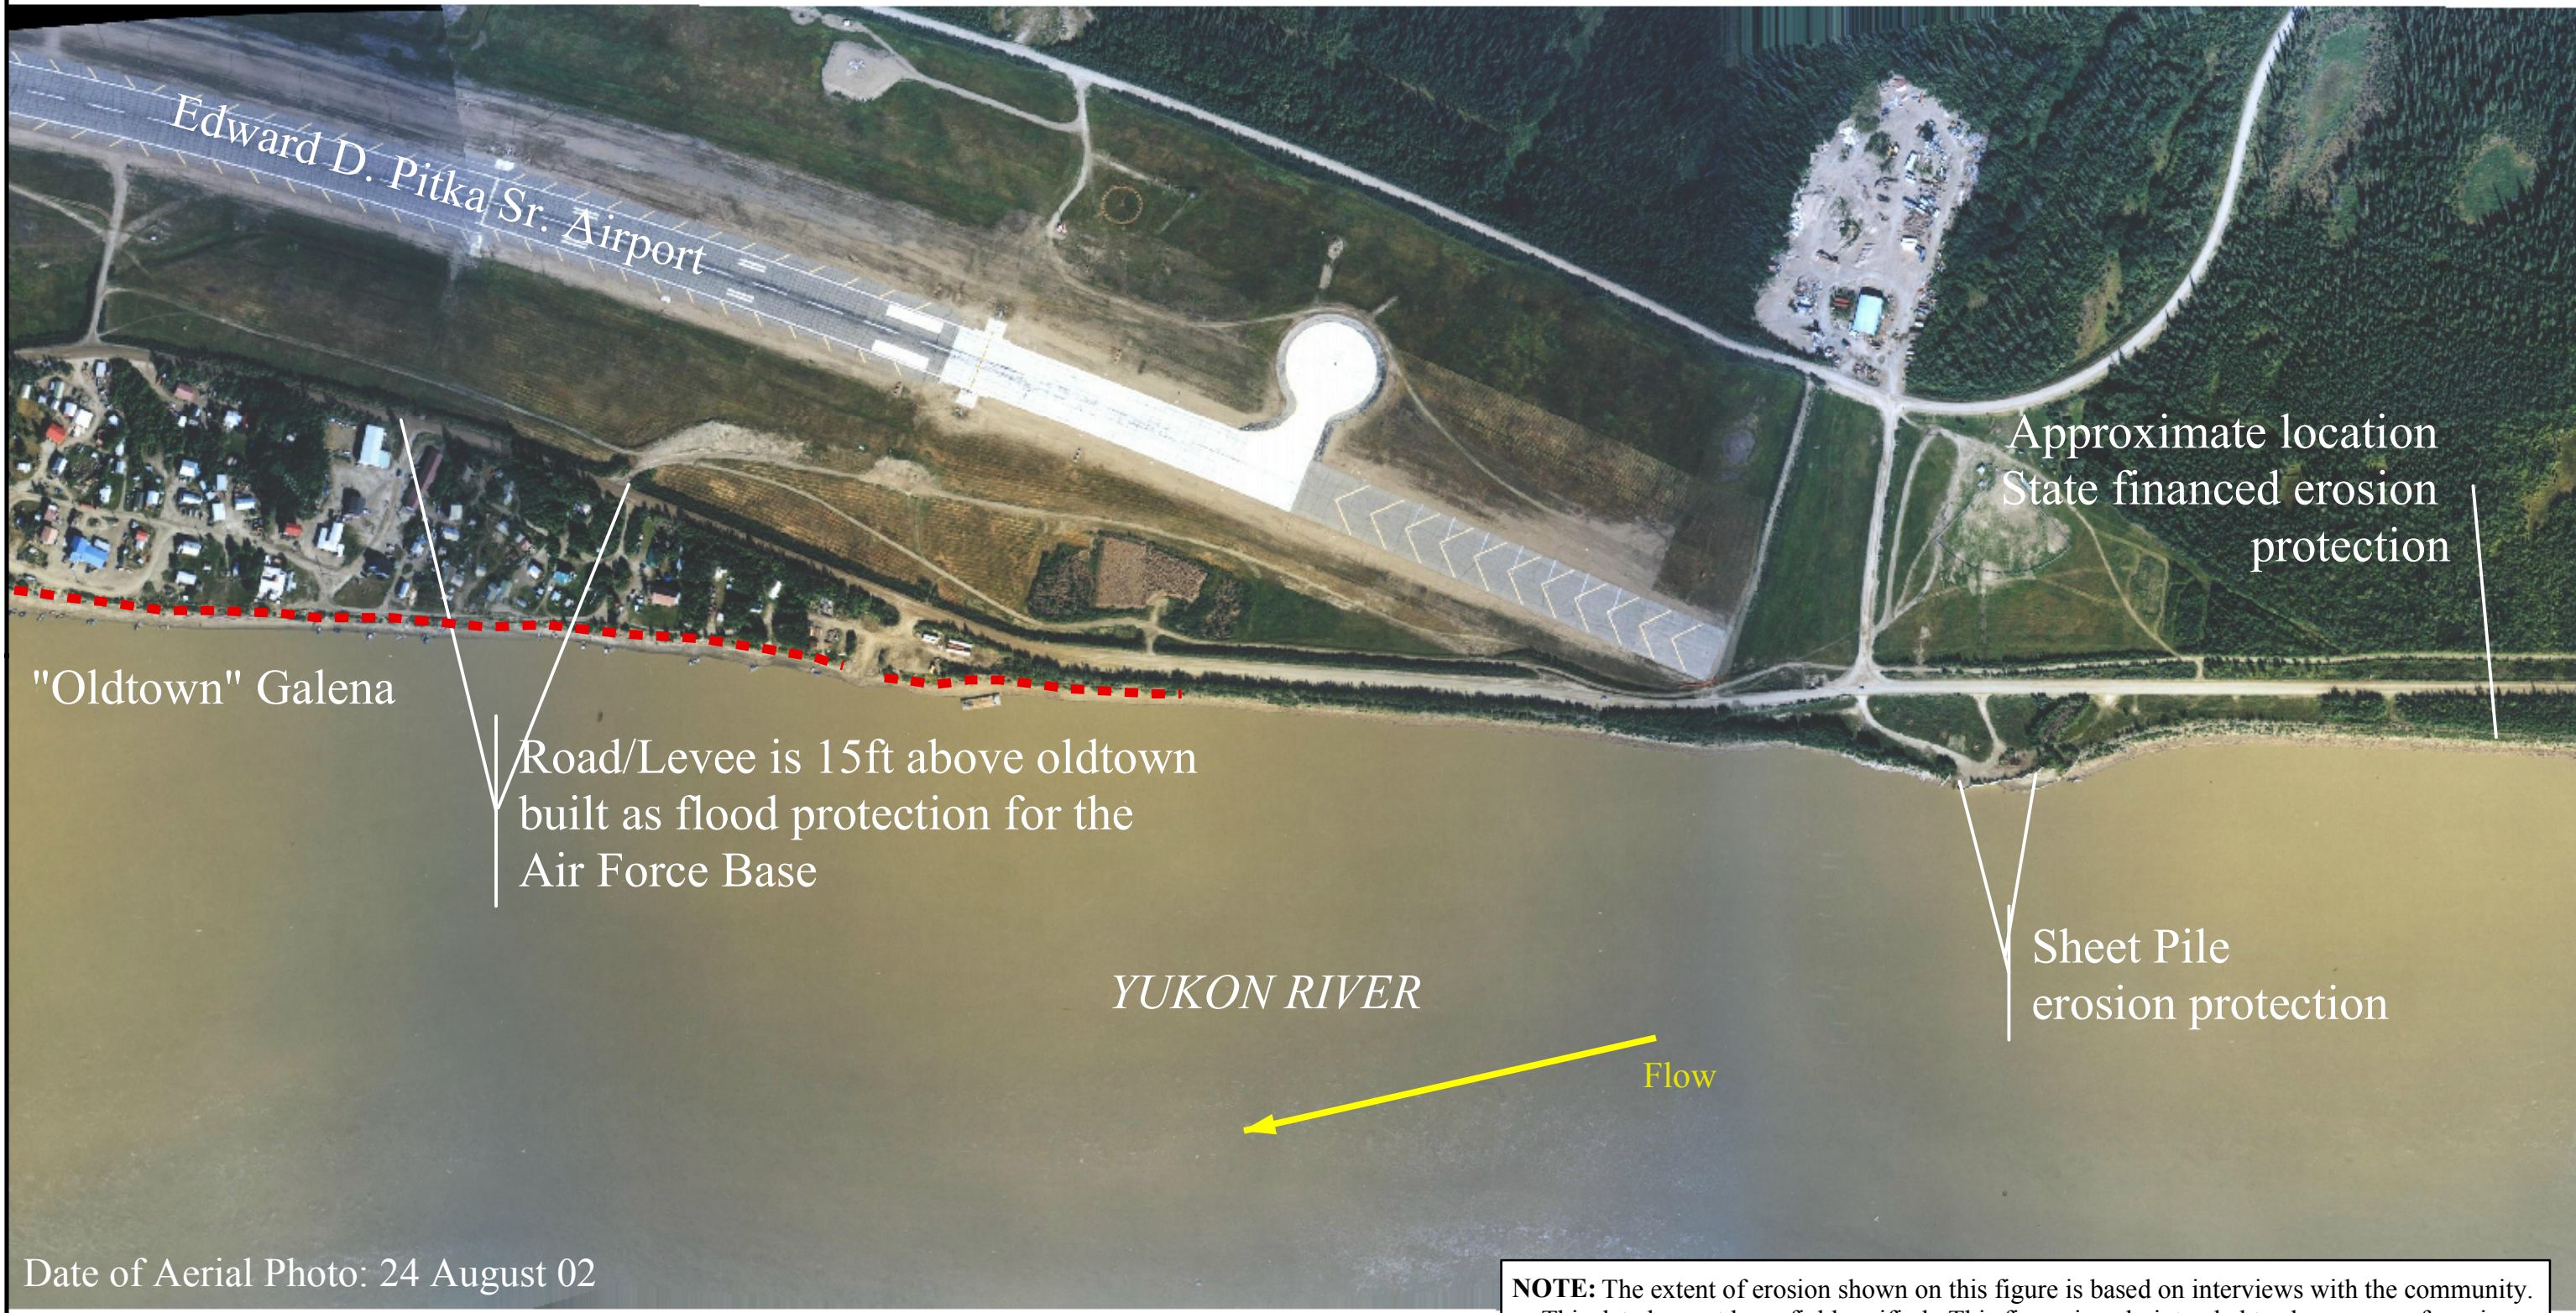
Date of Aerial Photo: 24 August 02

**NOTE:** The extent of erosion shown on this figure is based on interviews with the community. This data has not been field verified. This figure is only intended to show areas of erosion, not rates or severity of erosion

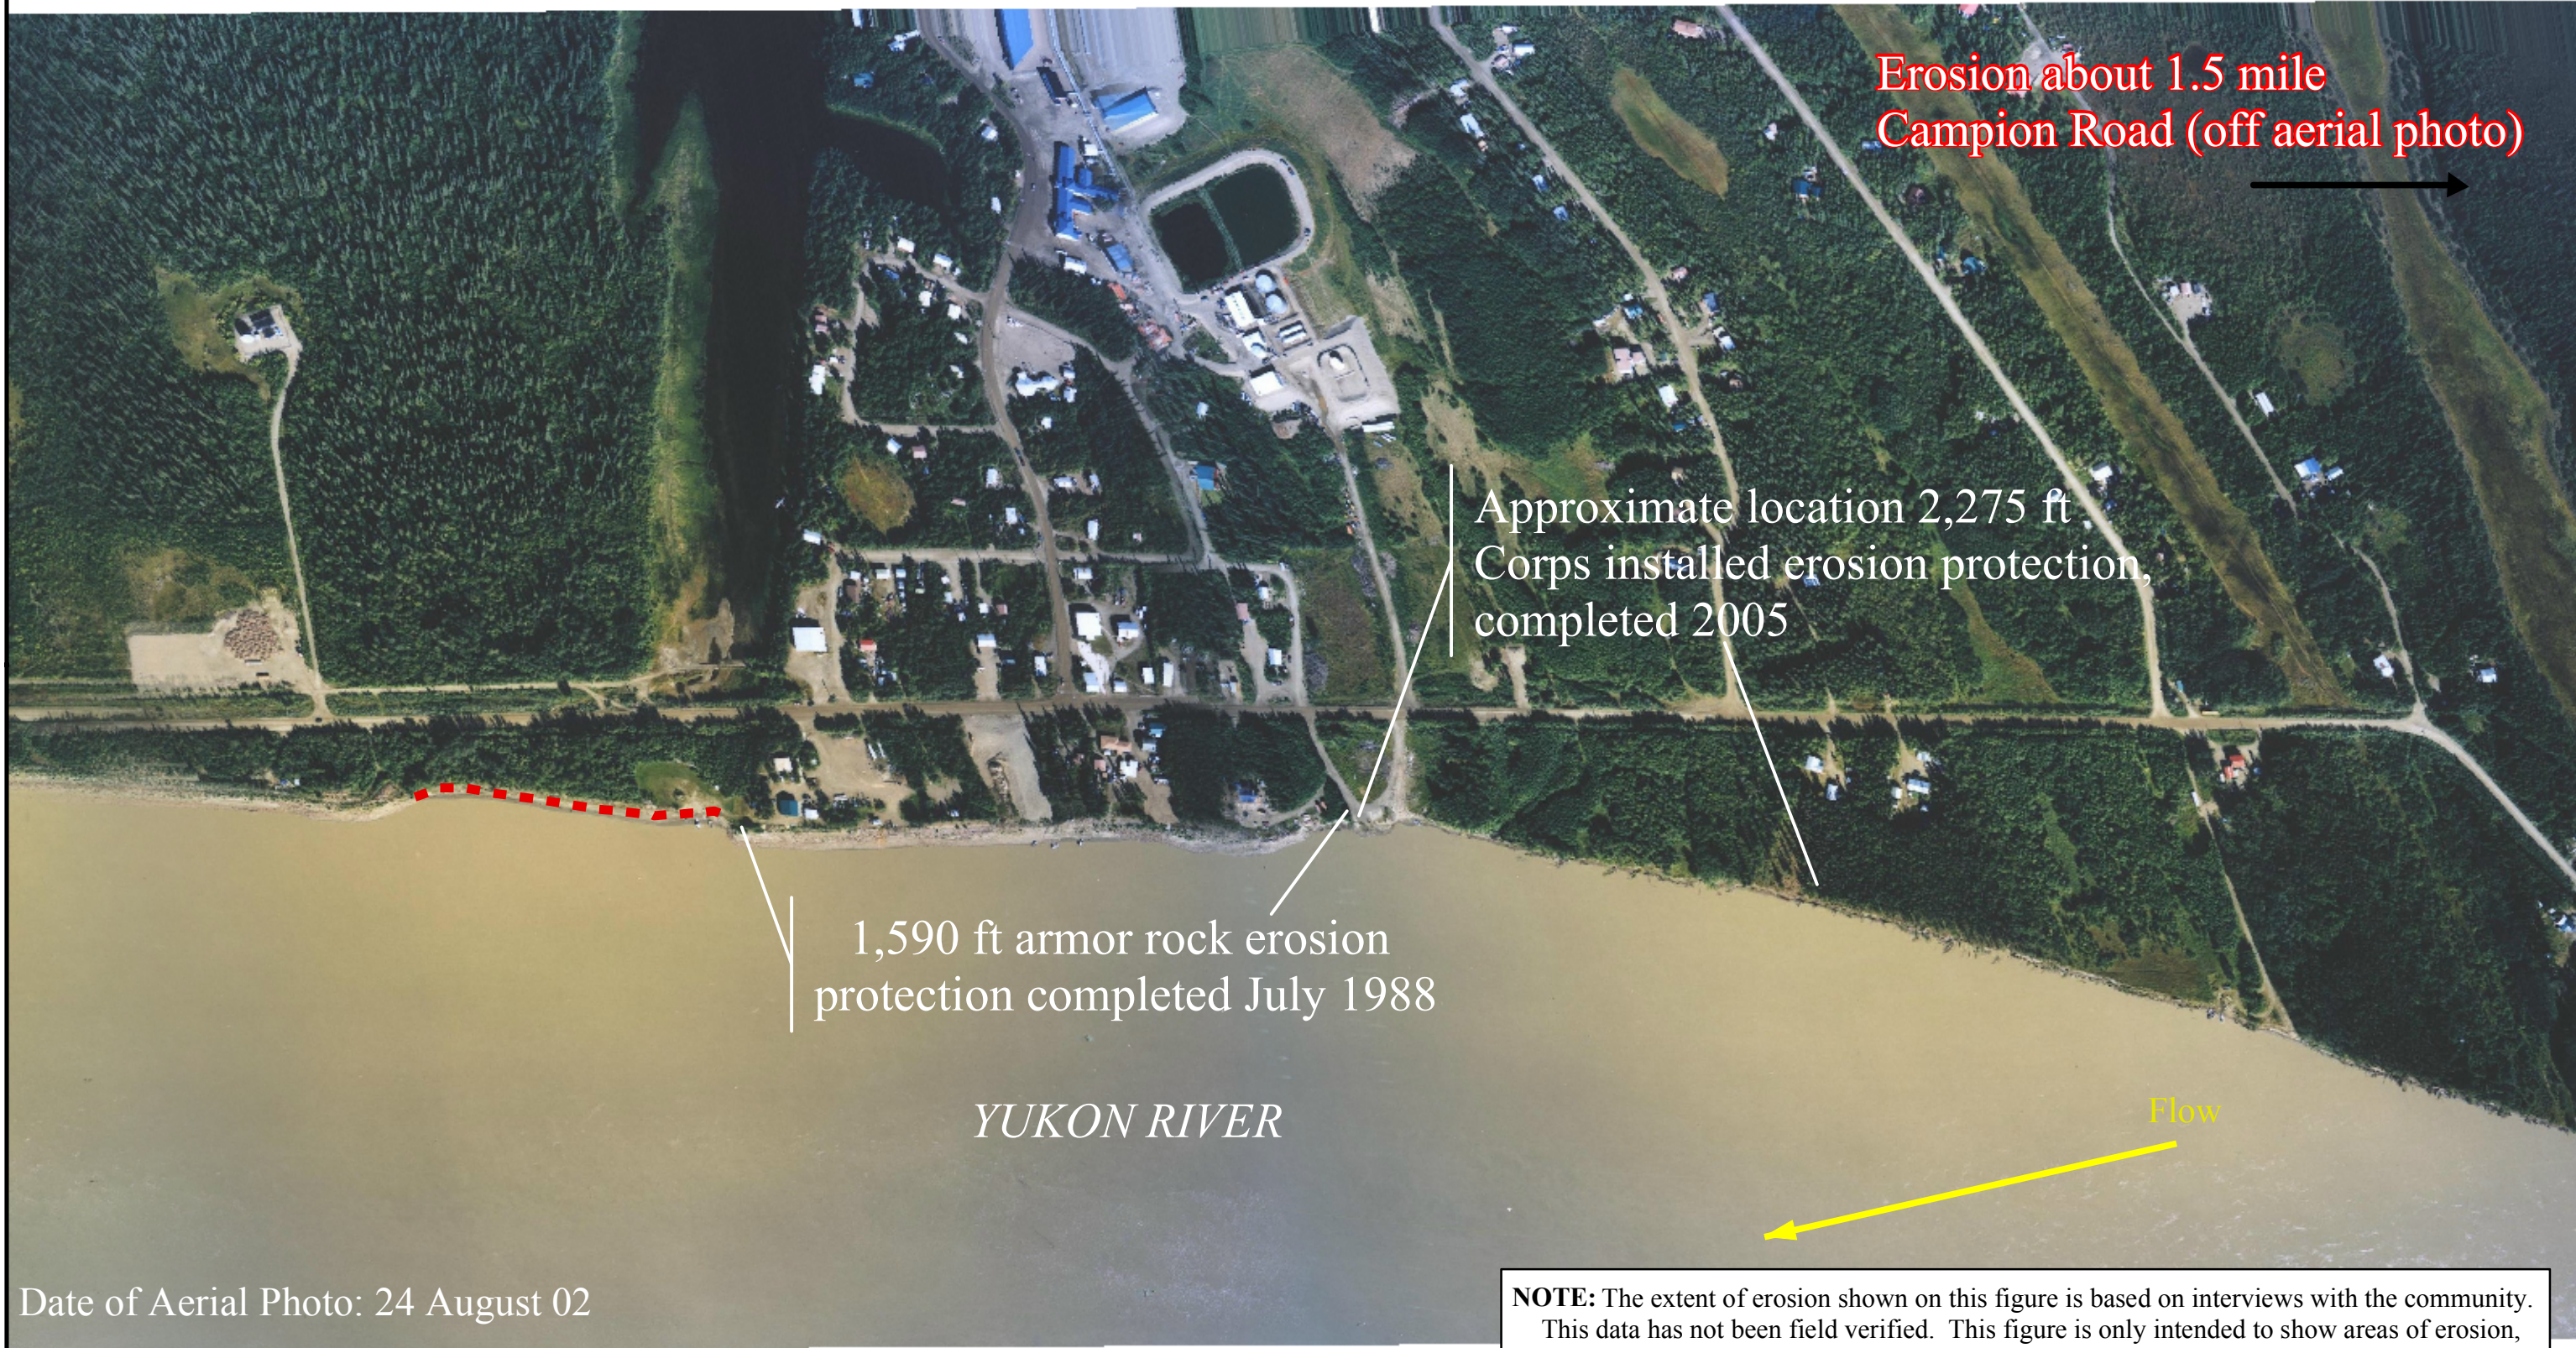
Date of Aerial Photo: 24 August 02

**NOTE:** The extent of erosion shown on this figure is based on interviews with the community. This data has not been field verified. This figure is only intended to show areas of erosion, not rates or severity of erosion
