ALASKA BASELINE EROSION ASSESSMENT

Erosion Information Paper – Girdwood, Alaska

Current as of October 12, 2007

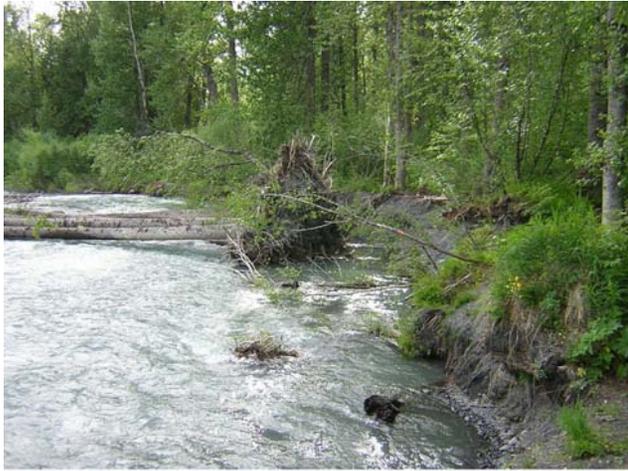
Photo 1: Glacier Creek log jam, date of photo not available.

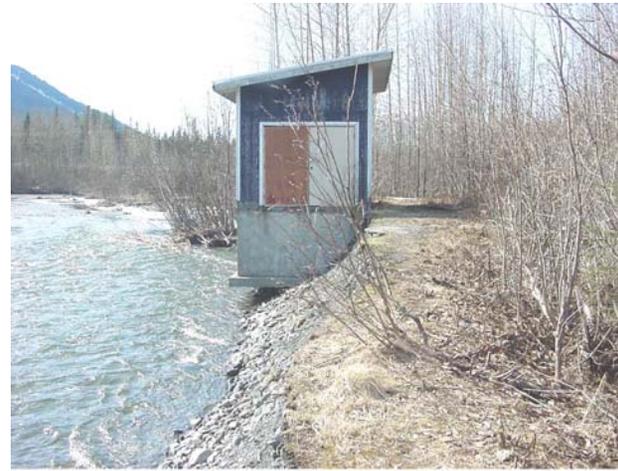
The erosion along California Creek upstream from the railroad bridge has been periodically repaired and maintained by the Alaska Railroad. The Girdwood airstrip is on the south side of Glacier Creek. The airstrip is maintained by Alaska Department of Transportation and Public Facilities and has been armored with rip rap to protect against erosion. The Girdwood Elementary School and a condominium housing project are near the creek. On the north side of Glacier Creek has eroded within 130 feet of the access road that leads to the Girdwood Elementary School. The creek has also eroded within 35 feet of the condominium housing project downstream from the elementary school. A municipal well building was undercut by Glacier Creek erosion and was relocated away from the creek. Costs for the measures were not provided.

Photo 2: Well head building site relocated, April 2000

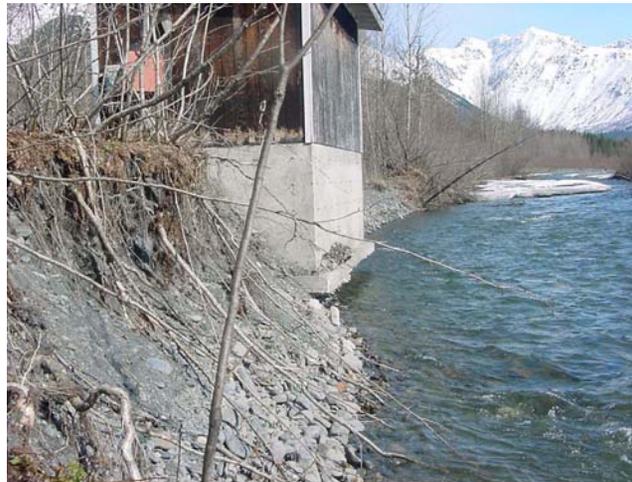
Photo 3: Well head building site relocated, April 2005.

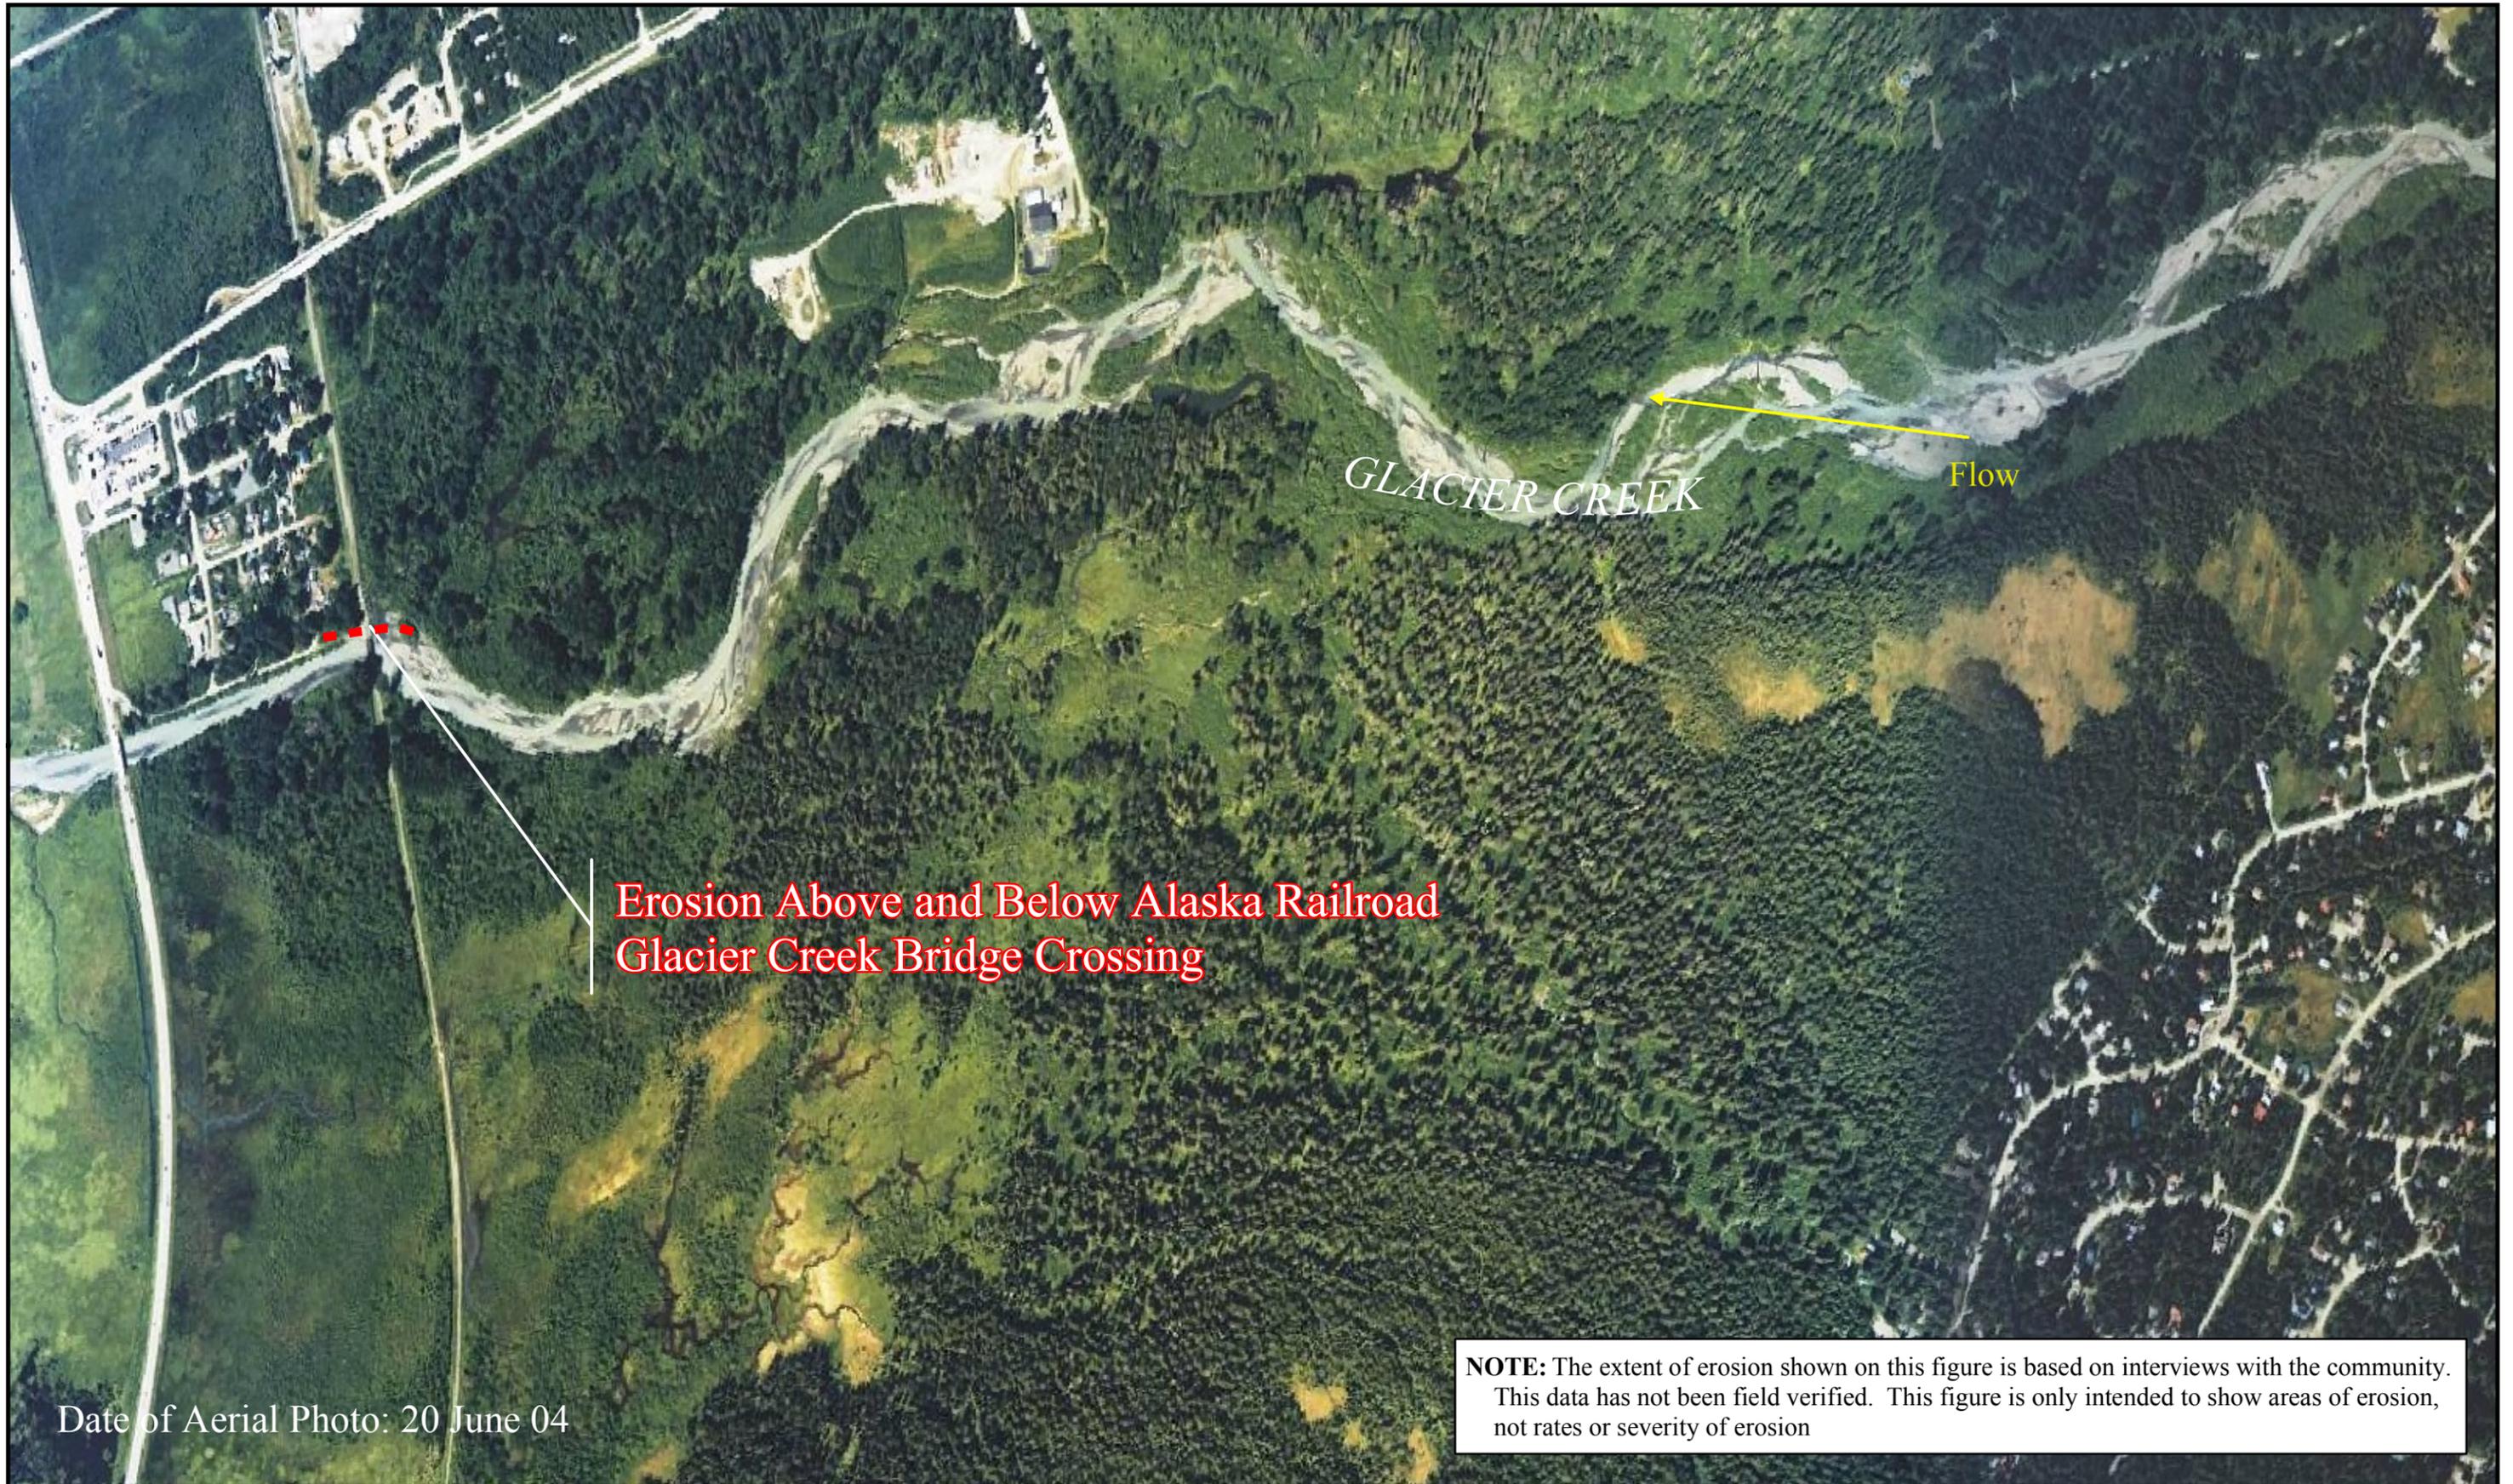
--- Linear Extent of Erosion
Part 1

Two additional erosion areas are along Glacier Creek. One area is downstream of the Alyeska Highway Bridge. The other area is upstream of the Alyeska Highway Bridge. The creek has been eroding mainly on the north side, but no information on erosion rates was available.

Erosion Above and Below Alaska Railroad
Glacier Creek Bridge Crossing
