U.S. Army Corps
of Engineers
Alaska District

ALASKA BASELINE EROSION ASSESSMENT

Erosion Information Paper - Golovin, Alaska

Current as of November 8, 2007

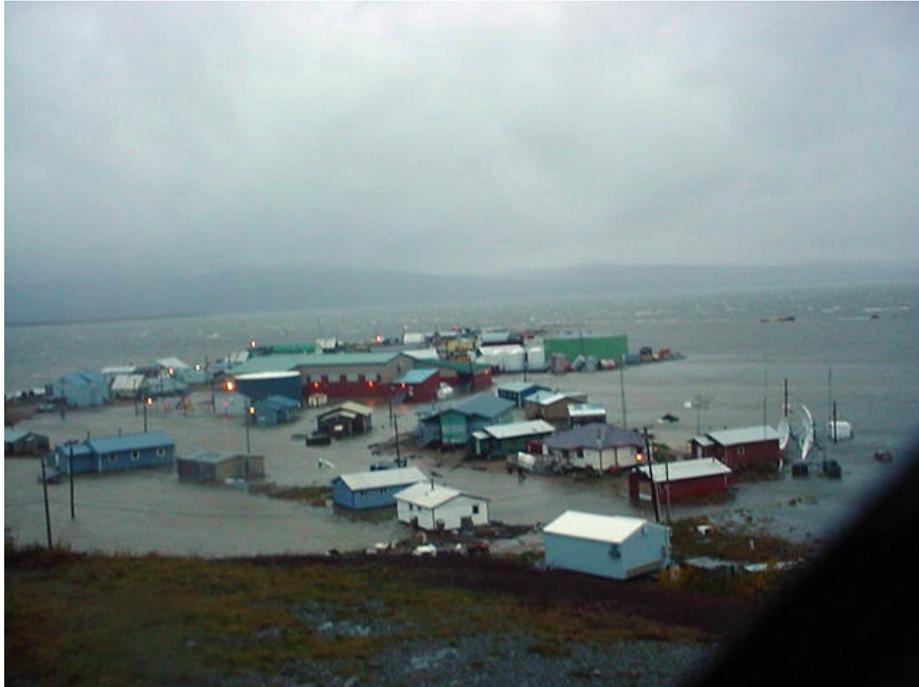
Photo 1: Most of the Golovin coastline is subject to erosion which increases during Bering Sea storms; this is Golovin during the September 23, 2005 Bering Sea storm.

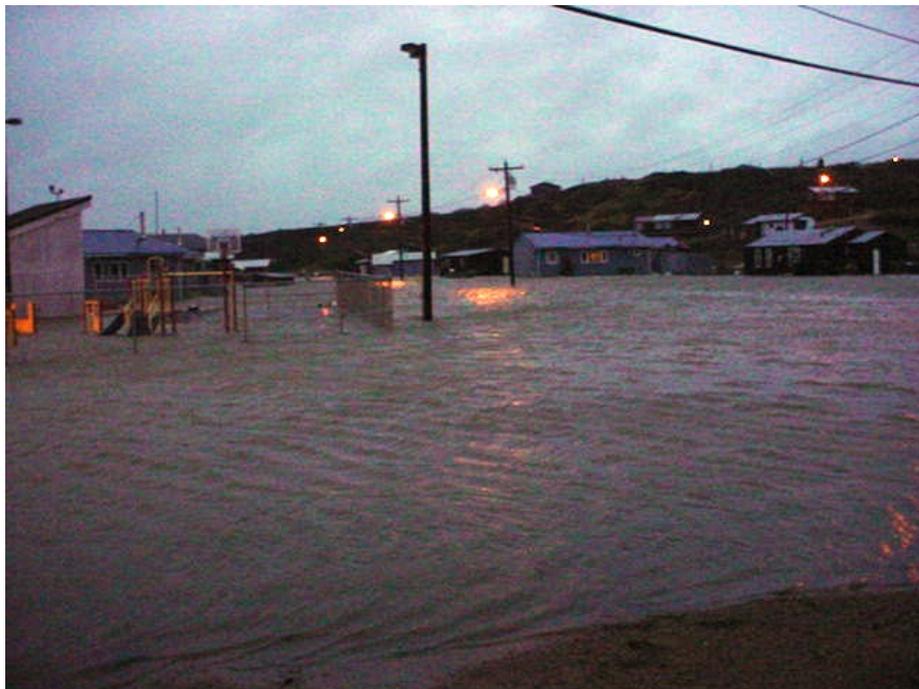
Photo 2: Golovin from Amuktoolik & Punguk St. corner toward Baldy Hill, September 2003.

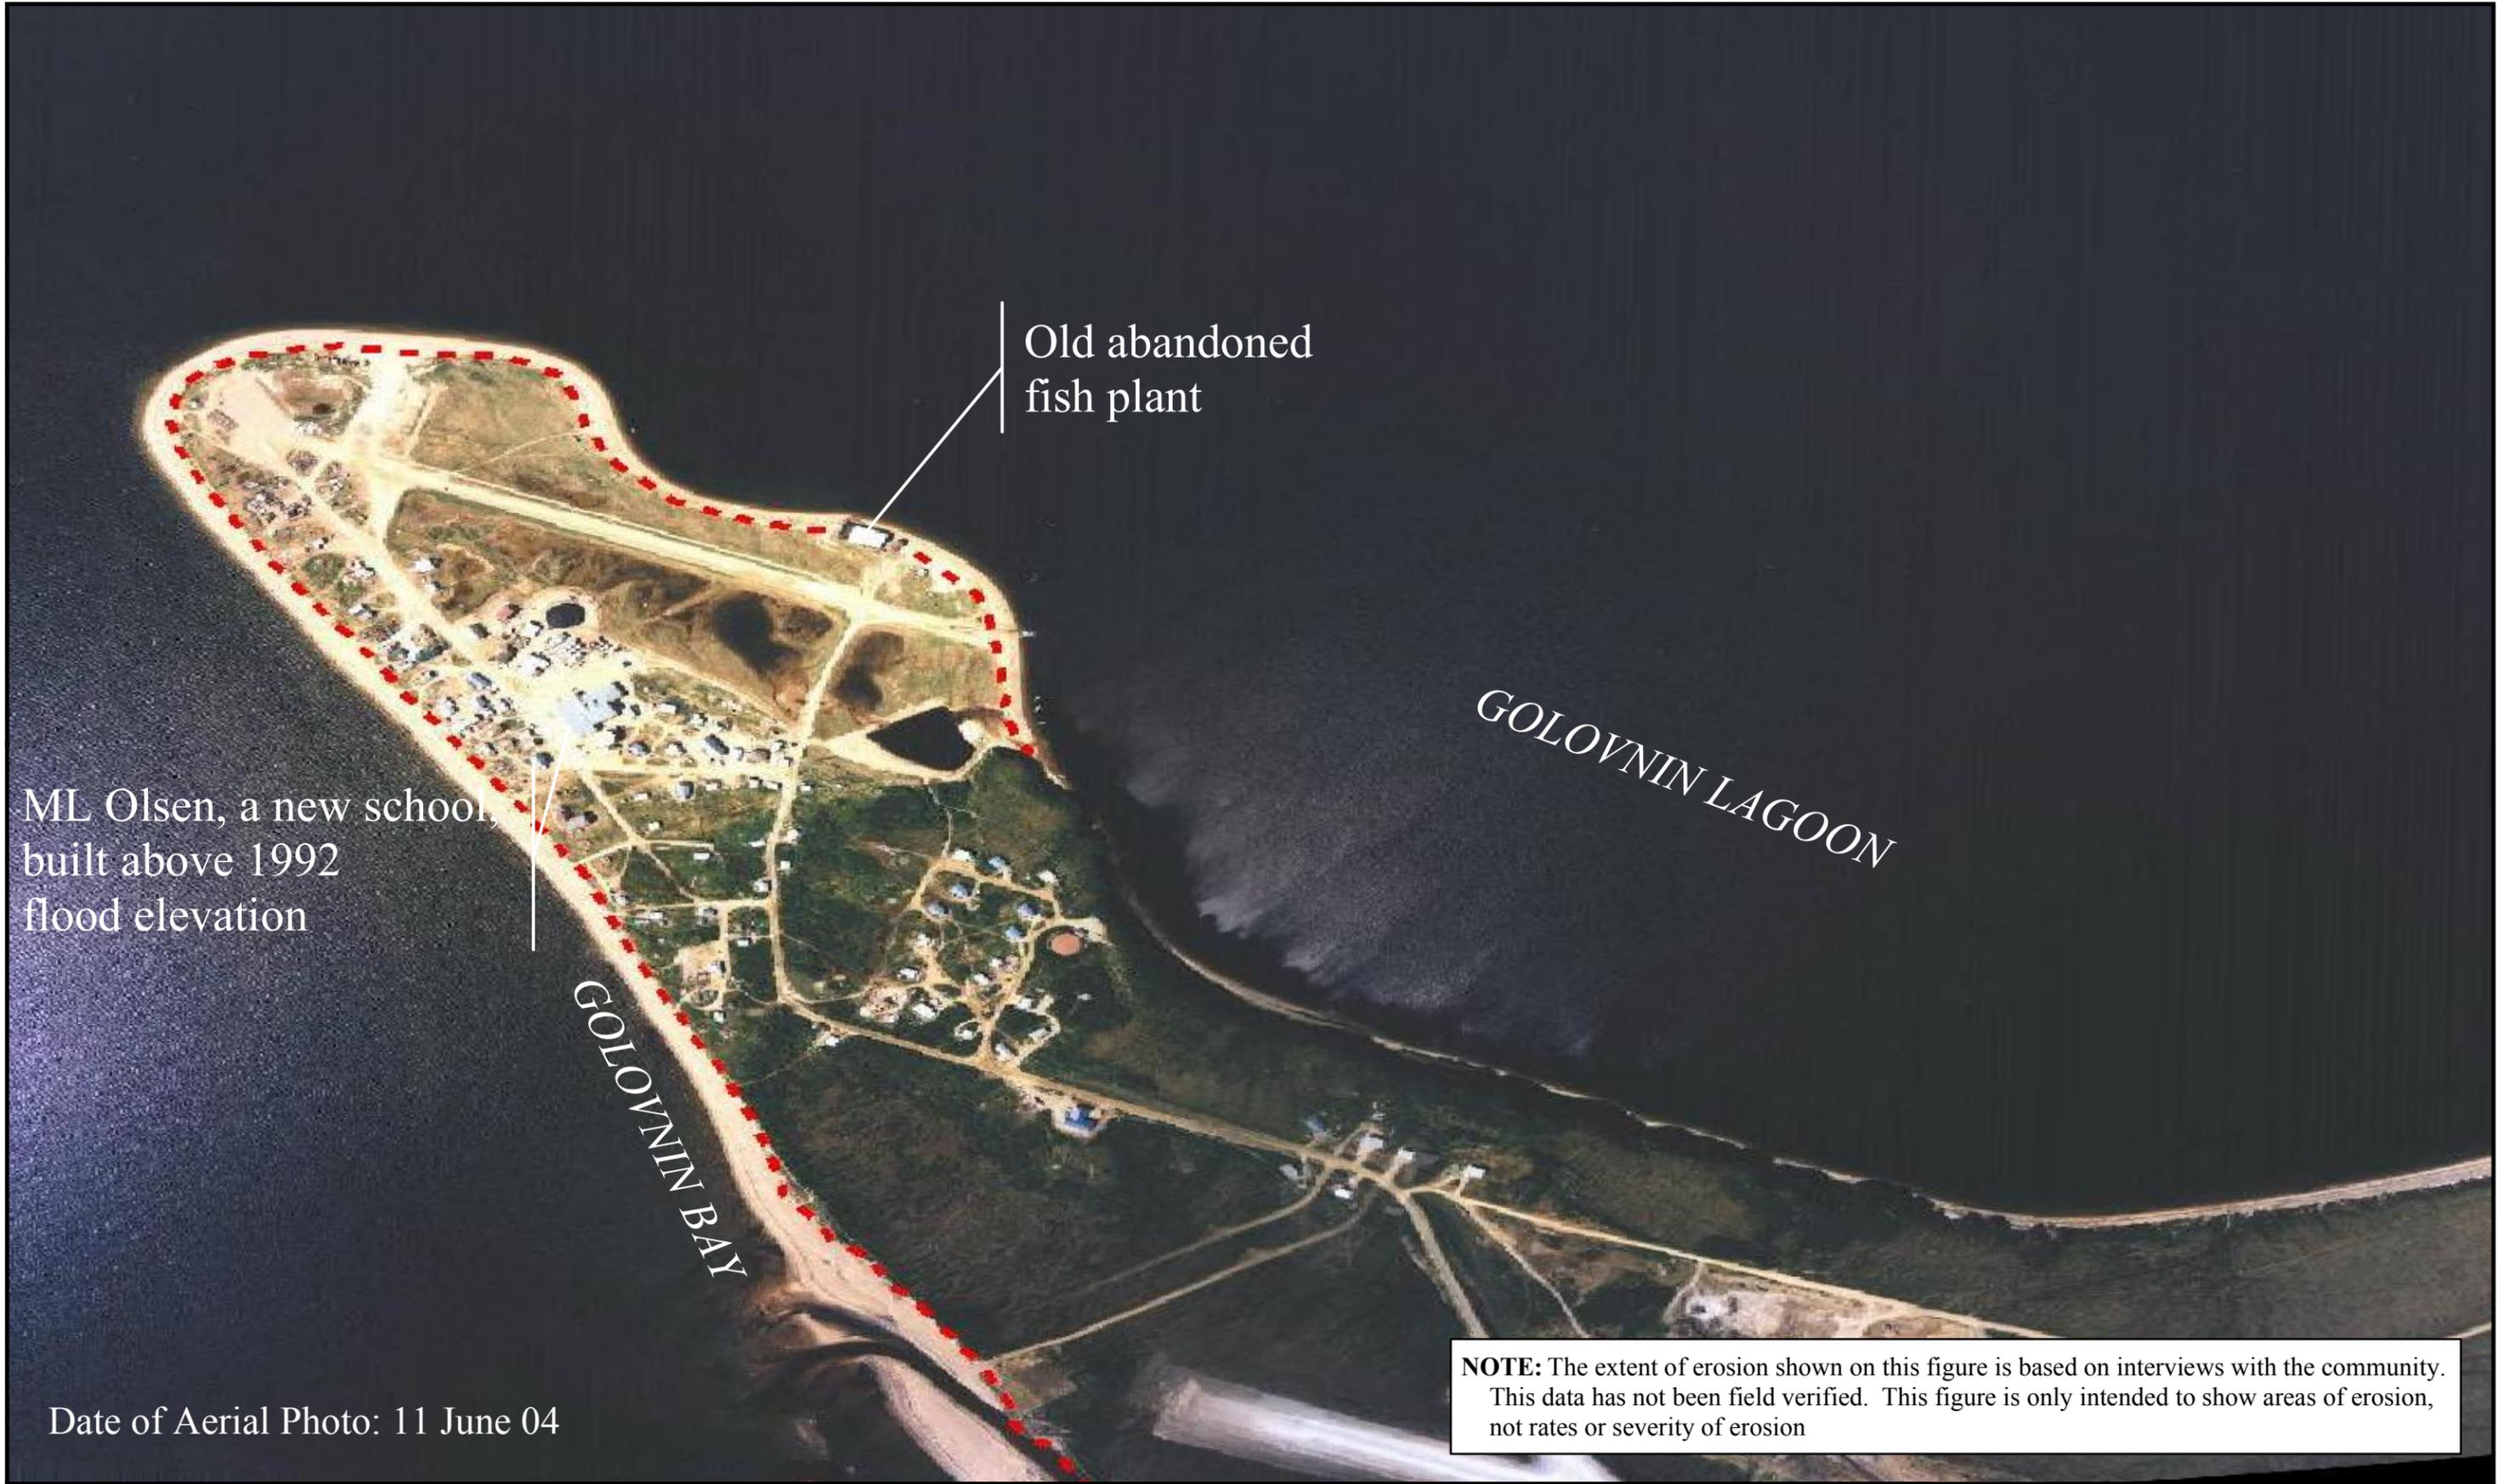
Alaska Baseline Erosion
Golovin, Alaska

- - - - Linear Extent of Erosion
