**U.S. Army Corps  
of Engineers**  
Alaska District

## ***ALASKA BASELINE EROSION ASSESSMENT***

### **Erosion Information Paper - Gulkana, Alaska**

Current as of January 15, 2008

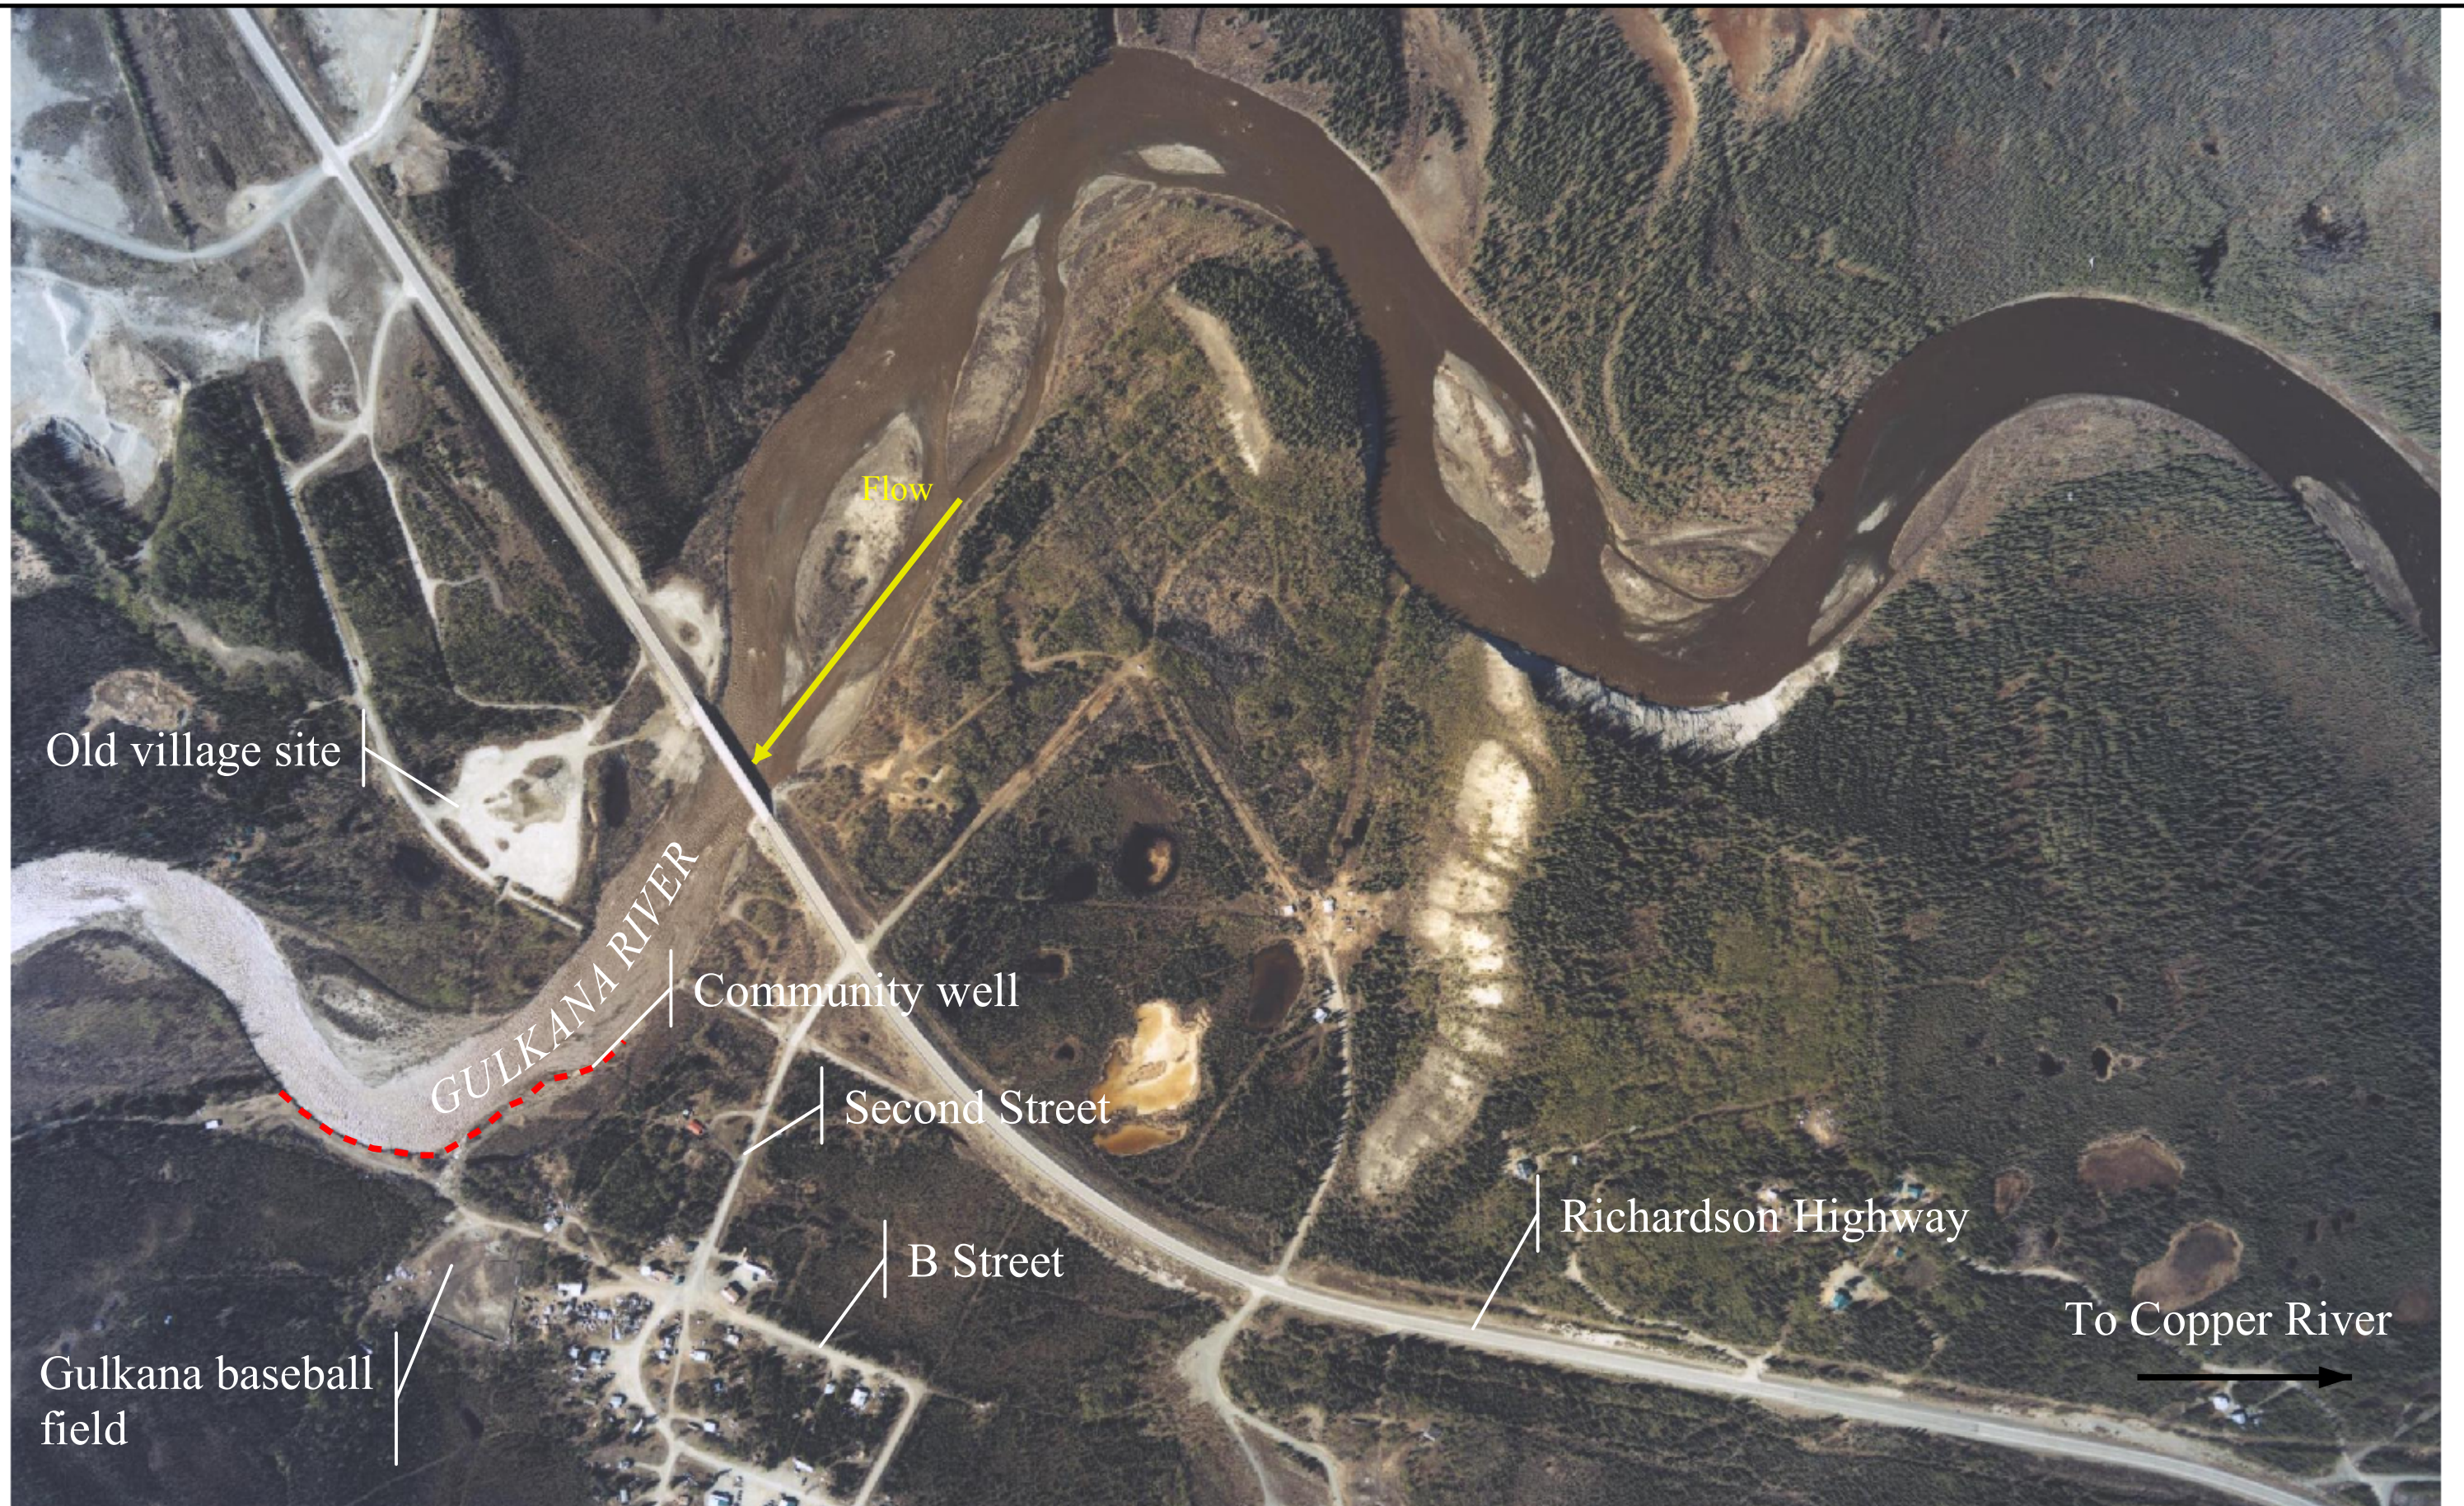
Gulkana River is on the south side of the community about 150 feet from the center of the developed area with areas of active erosion along the bank. River flows, spring break up, and ice scouring of the river banks all contribute to erosion. The actively eroding area is estimated to be 150 to 200 linear feet with an average erosion rate of about 1 to 2 feet a year. Approximately 15 feet of river bank eroded away between 2005 and 2007. The council spent about \$2,000 on equipment to place large boulders in various locations to prevent ice from scouring the river banks and to protect the road to the culture camp. There is a 300-linear-foot erosion area along the Copper River bank about 1/4 mile east of the community.

Erosion threatens the access road to the culture camp where shade houses and storage sheds are less than 100 feet from the river. The water well for the community is approximately 15 feet from the river and no protective measures have been undertaken by either local or state intervention. Some fish wheels on the Copper River are placed in shallow water that can lead to some of them getting stuck in debris, destroyed, or lost.
