U.S. Army Corps  
of Engineers  
Alaska District

## **ALASKA BASELINE EROSION ASSESSMENT**

### **Erosion Information Paper - Gustavus, Alaska**

Current as of October 30, 2007

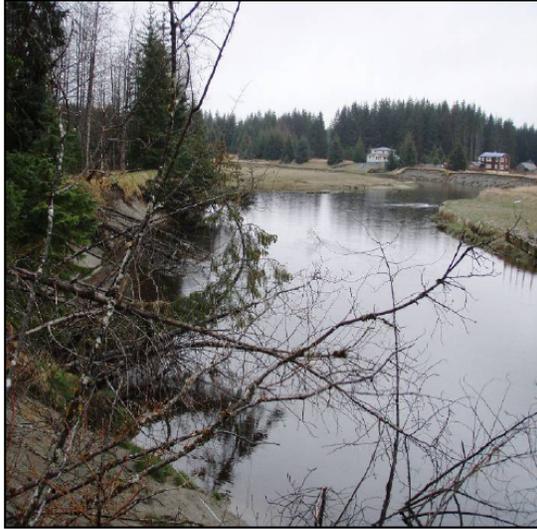
The roadway into the city hall was approximately 15 feet from the river three years ago and is now a mere 4 feet from the river bank. The city hall itself is not in immediate danger nor is the park; the roadway to the city hall is in danger but not immediate. The City Council was told by Department of Natural Resource officials that it would be cheaper to move the road than to try to abate the erosion.

Figure 1: Looking upstream at Town Hall Site

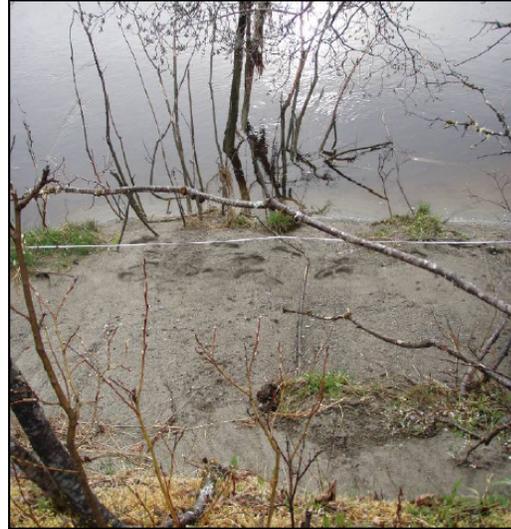
The river erosion processes are exacerbated by the tidal flow up the river which on large tides may reach more than a mile north of the mouth of the Salmon River. There is an amplification of erosion during high river flow during fall heavy rains and spring thaws. The river is eroding at cut bank meanders as much as 6 feet per year but that would be a maximum amount. The erosion problems are taking place in four locations, three of which involve land the City of Gustavus owns or soon will own. One is the meander near the city hall parking lot and city park immediately north of the Salmon River Bridge and the roadway into city hall; one is slightly upstream from the city hall in an area used as a ball diamond and the third is approximately ¼ mile north of the bridge. The fourth location is approximately 250 yards south of the Salmon River Bridge. This fourth location is now owned by the city, a gift from a previous owner who had installed sheet pile into the land to prevent the eventual erosion of his property. The erosion at the sheet pile location is rather severe and is presently etching away at the base of the now exposed sheet pile. This pile should be pulled but immediately below it is a residential house which may eventually be taken by the river. It is a dilemma for the city which would like to have the pile pulled but only with assurances by an engineer/hydrologist that the pulling of the pile will not exacerbate the erosion toward that residence.

Figure 2: Sand 'piping' from tidally charged riverbank

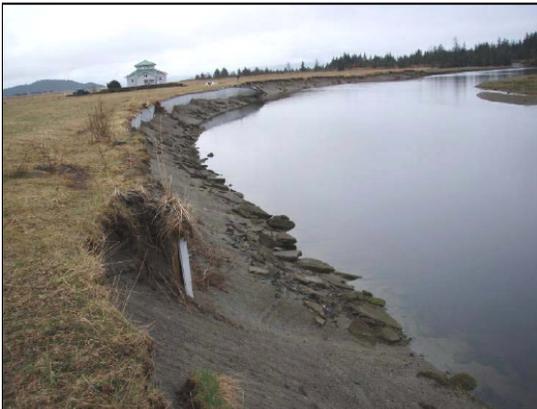
Figure 3: Upstream end scour of sheet pile

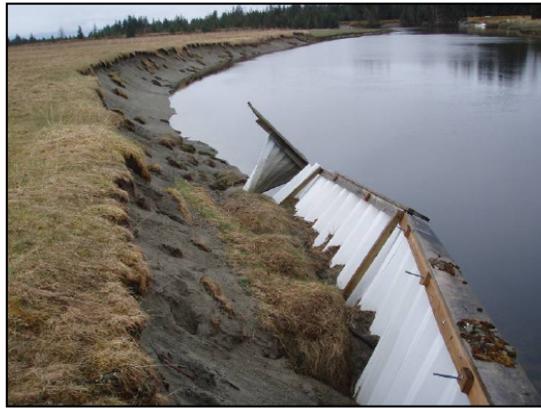
Figure 4: Downstream end failure of sheet pile
