ALASKA BASELINE EROSION ASSESSMENT

Erosion Information Paper – Haines, Alaska

Current as of October 16, 2007

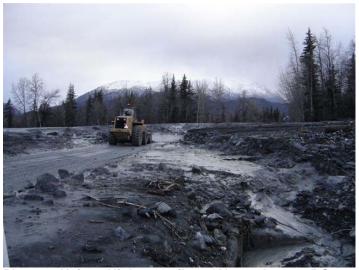
Photo 1: Haines Highway mile 23, November 2005 Storm.

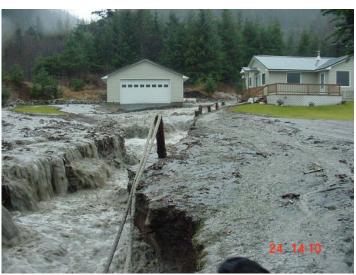
Photo 2: Lutak Highway mile 9; Belaski residence, Nov. 2005 Storm.

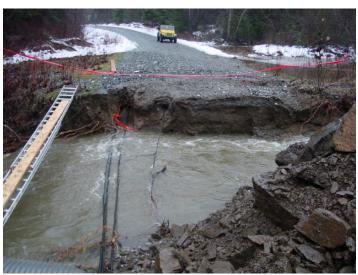
Photo 4: River Drive mile 2; Mosquito Lake Road, November 2005 Storm.

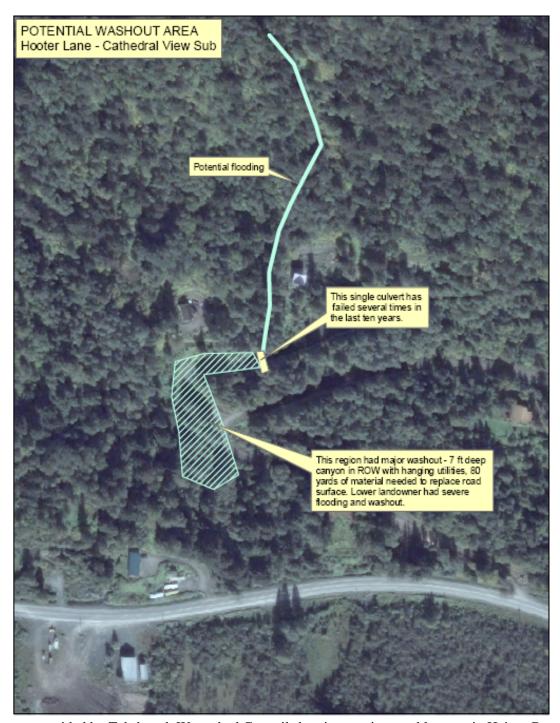
Diagram provided by Takshanuk Watershed Council showing erosion trouble spots in Haines Borough.

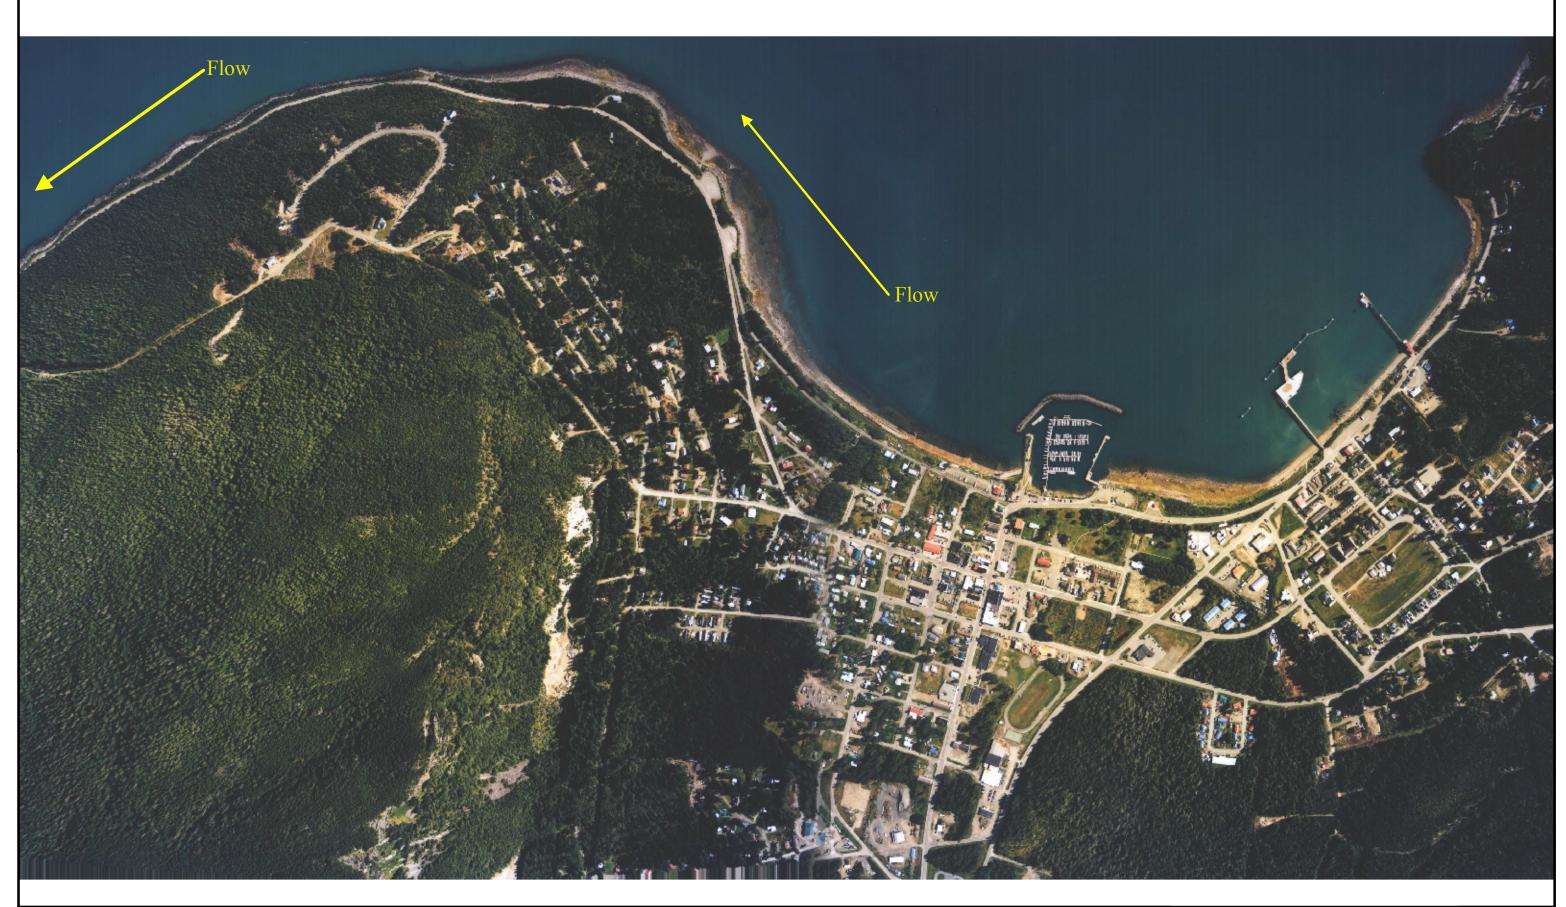
Extent of Erosion
