U.S. Army Corps  
of Engineers  
Alaska District

## **ALASKA BASELINE EROSION ASSESSMENT**

### **Erosion Information Paper - Holy Cross, Alaska**

Current as of February 13, 2008

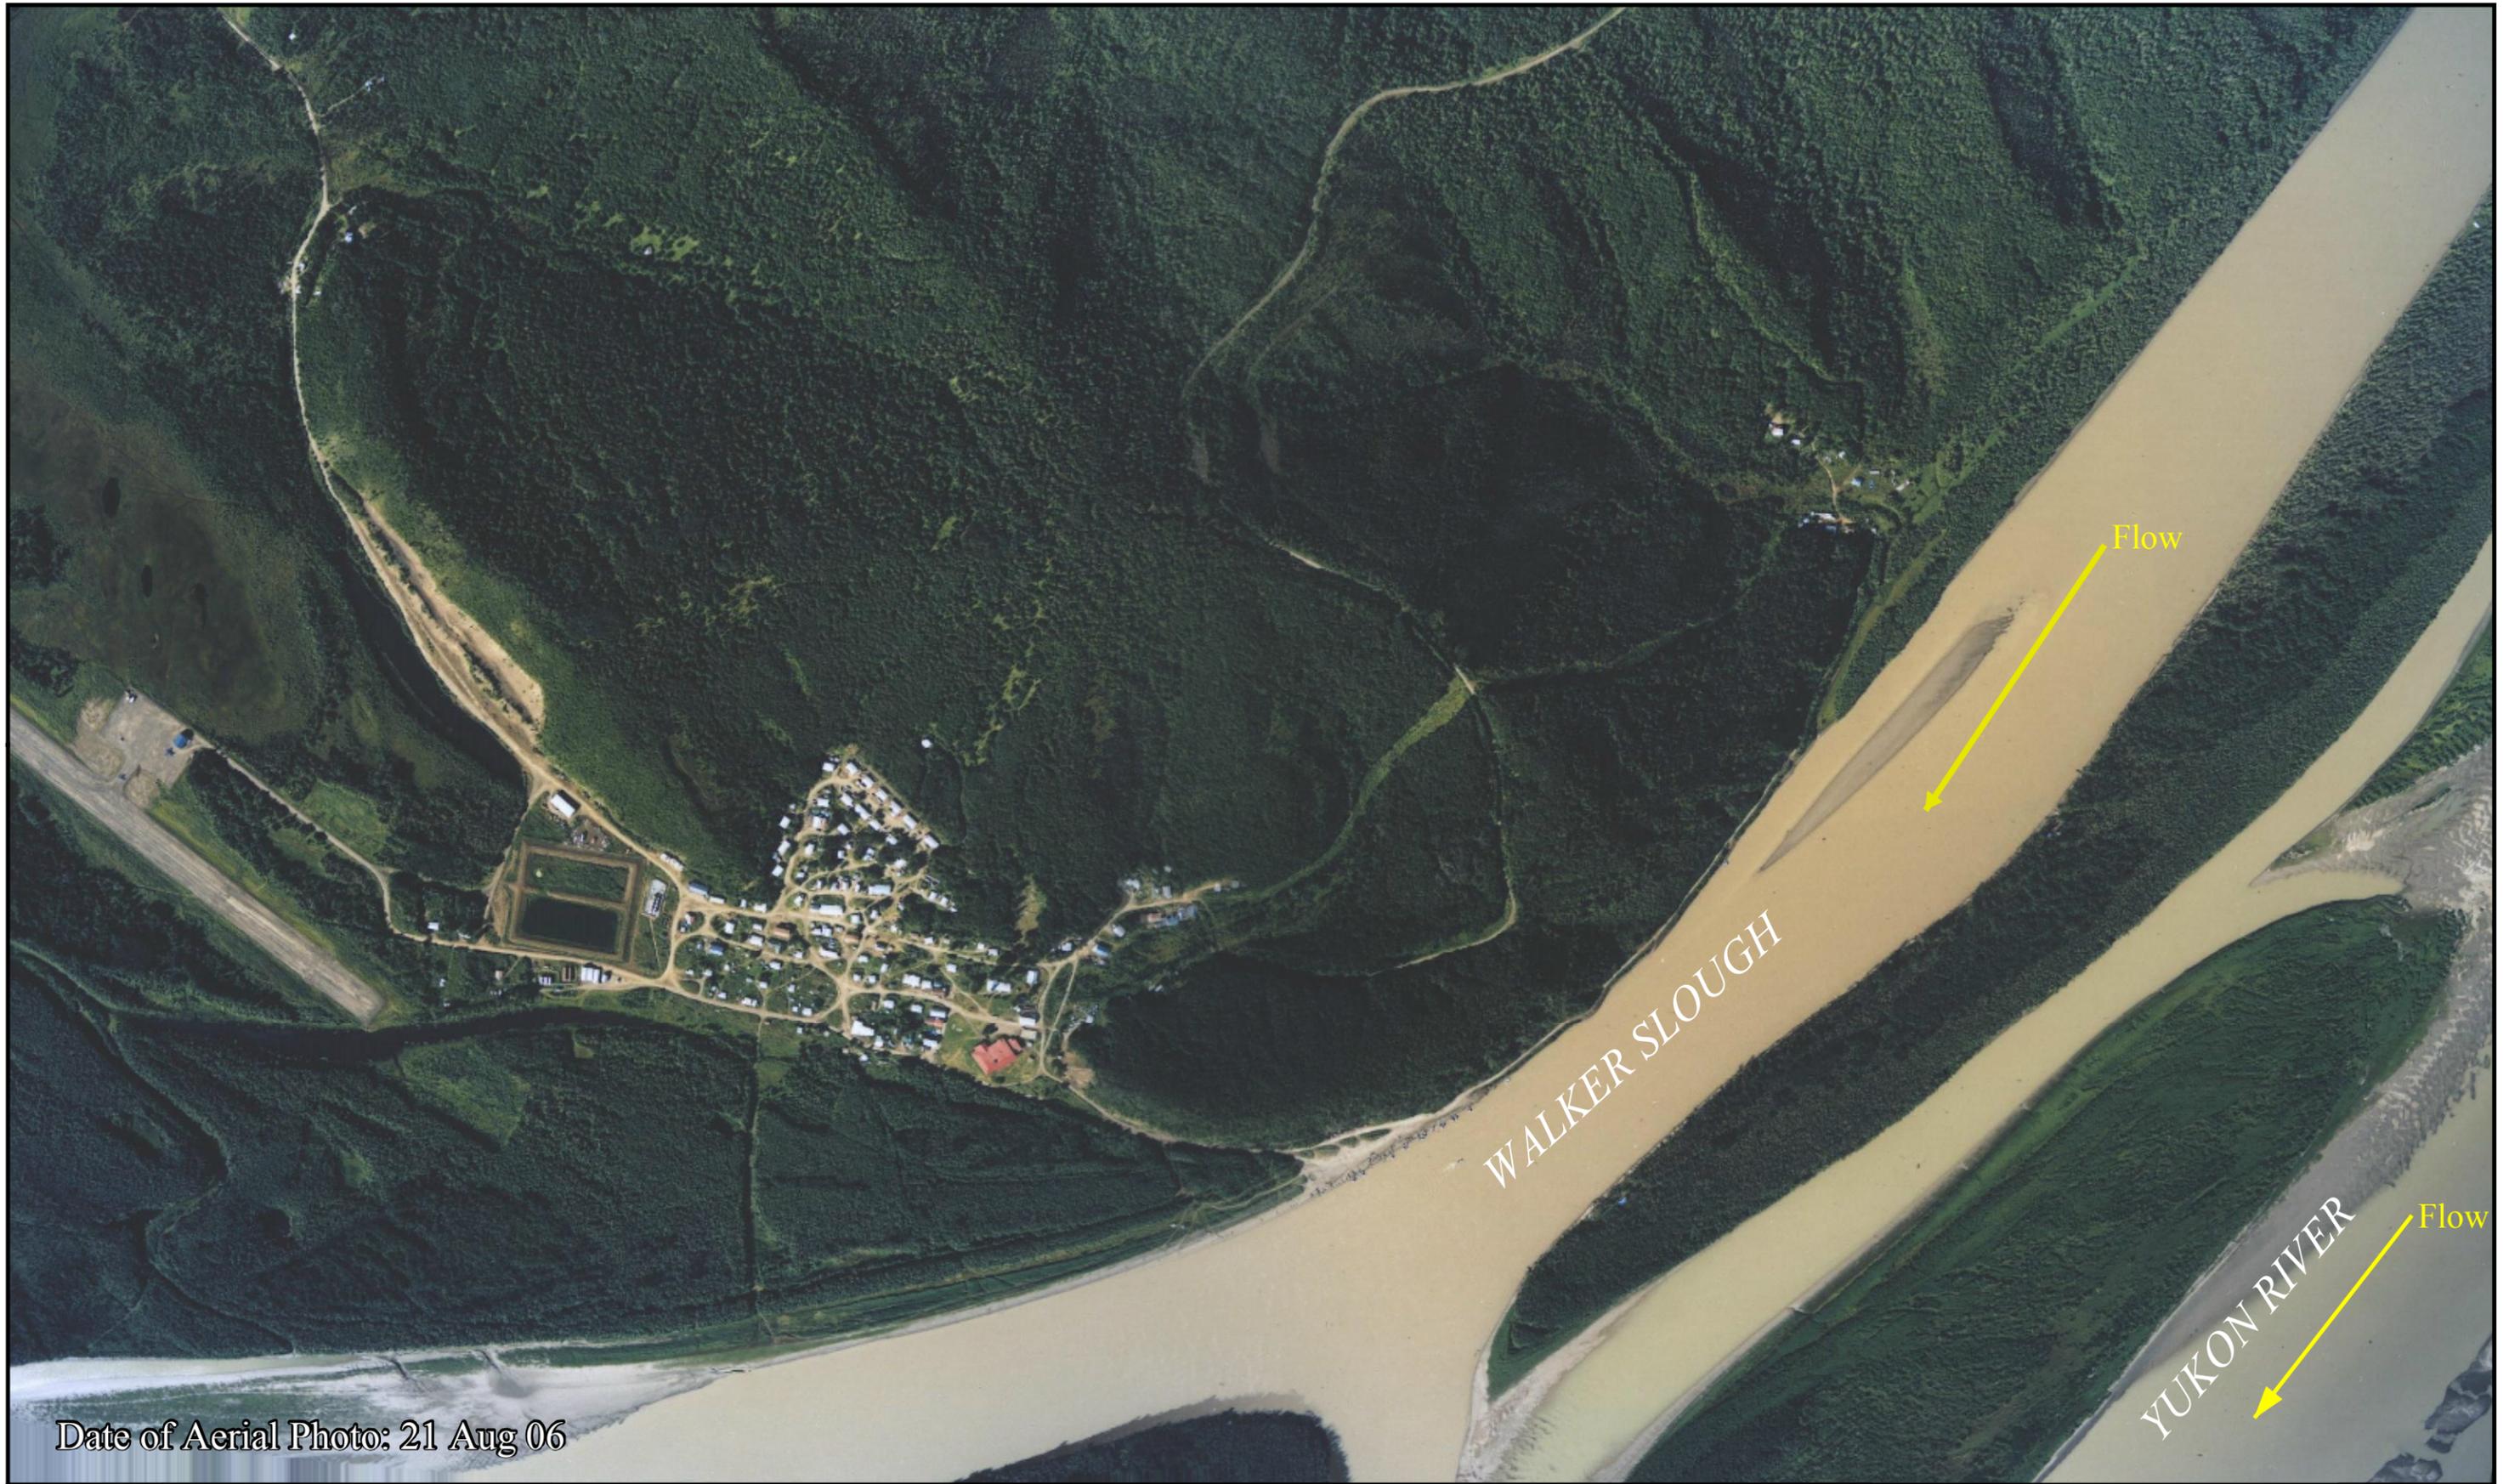
Alaska Baseline Erosion  
Holy Cross, Alaska

Holy Cross reported no erosion problems or issues. Ghost Creek Slough is slowly filling in. No erosion problems associated with the Yukon River have been reported.
