U.S. Army Corps
of Engineers
Alaska District

ALASKA BASELINE EROSION ASSESSMENT

Erosion Information Paper - Hughes, Alaska

Current as of April 23, 2008

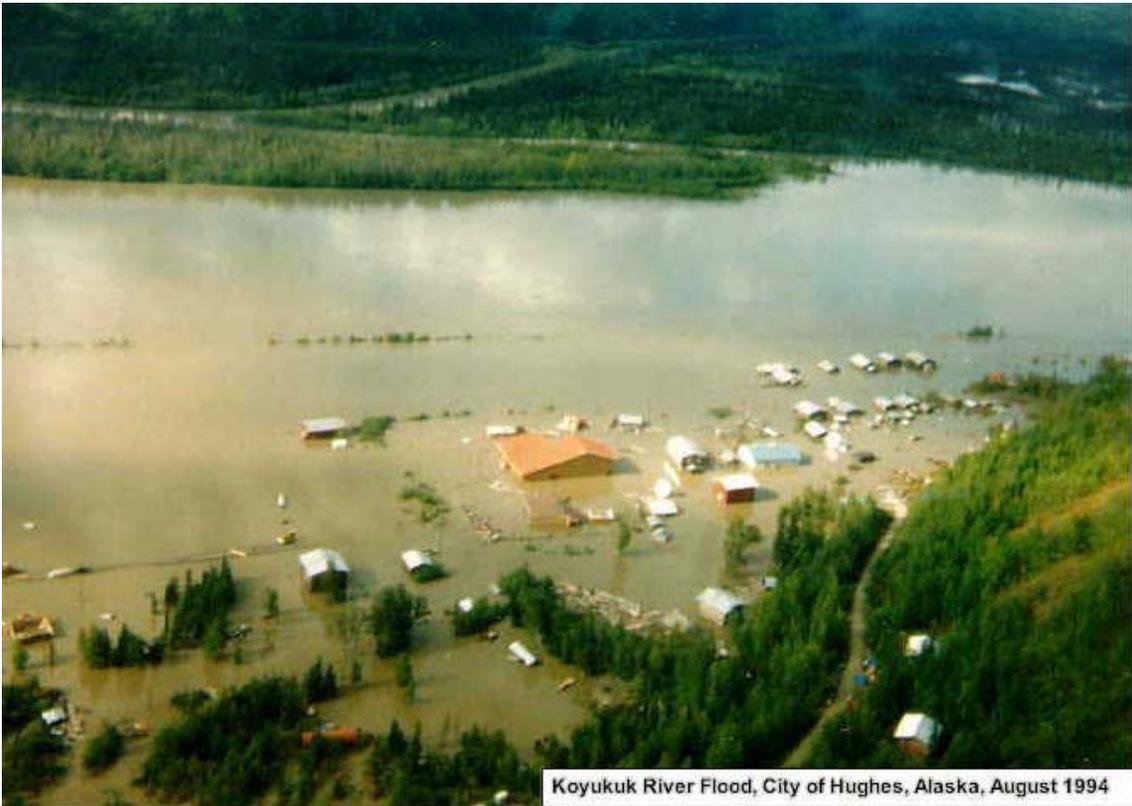
Photo 1: Hughes during the August 1994 flood; school is the red roofed building in the center of photo; photo courtesy of Division of Homeland Security and Emergency Management 1994.

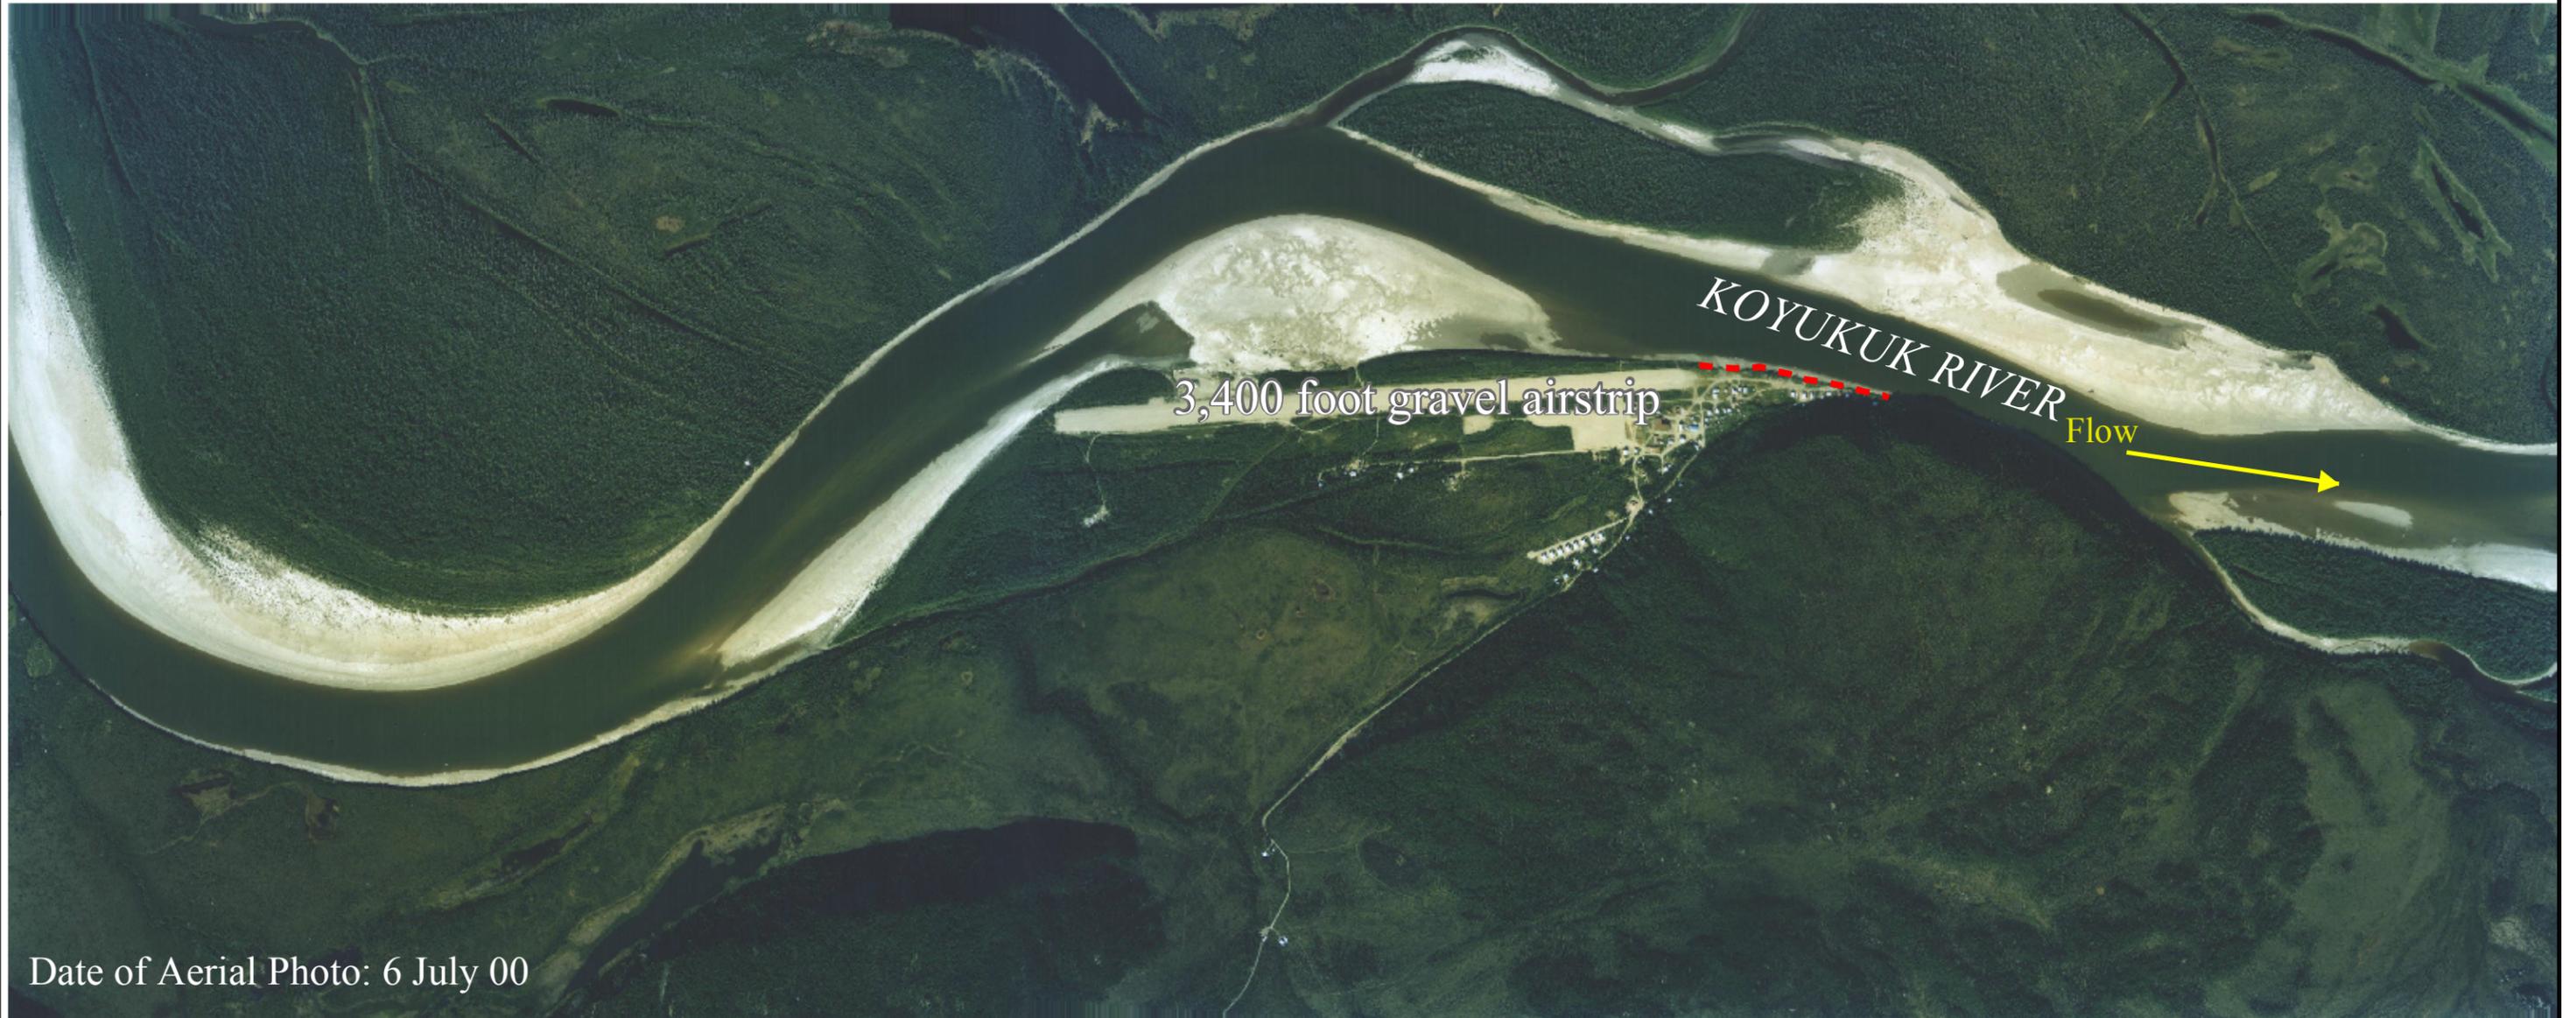
Alaska Baseline Erosion
Hughes, Alaska

The Koyukuk River bank is eroding at Hughes. Periodic fluctuations in river flows and levels, flooding, ice jams, spring break up, and melting permafrost are reported to contribute to erosion. The active erosion area is approximately 1,200 feet along the north end of the community in the residential area where the bank is approximately 10 feet high. Ongoing erosion is reported at about 5 feet per year, but no documentation or measurements were provided or available. The community of Hughes has a history of frequent flooding and associated erosion with floods reported in 1937, 1938, 1963, 1964, 1965, 1966, 1968, 1972, 1989, and 1994. The worst flood was caused by heavy rains during August 1994.
