U.S. Army Corps
of Engineers
Alaska District

ALASKA BASELINE EROSION ASSESSMENT

Erosion Information Paper - Huslia, Alaska

Current as of September 17, 2007

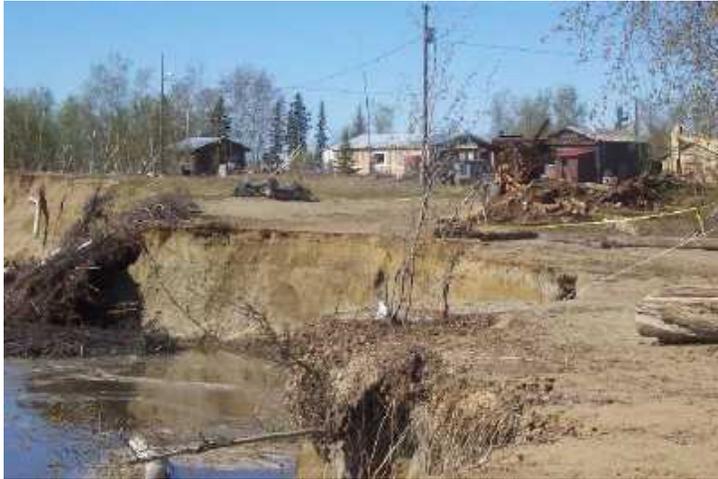
Photo 1: Koyukuk River erosion at Huslia, No date.

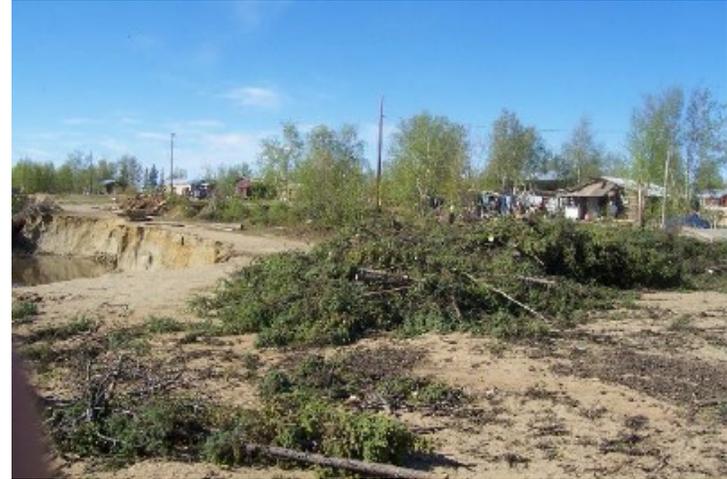
Photo 2: Huslia river bank, No date.

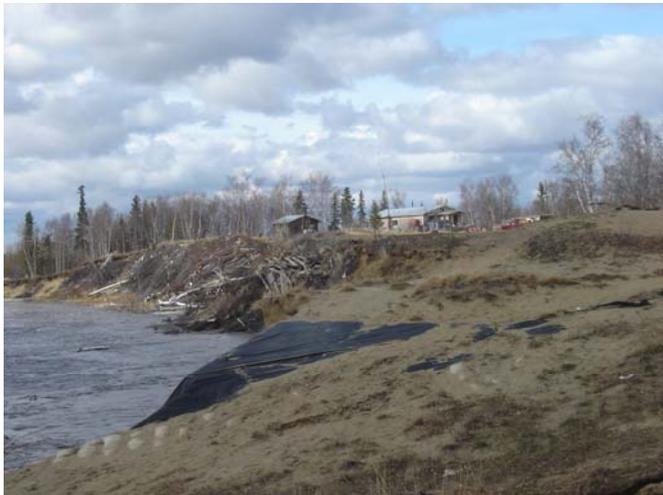
Photo 3: Koyukuk River erosion at Huslia, May 2008.

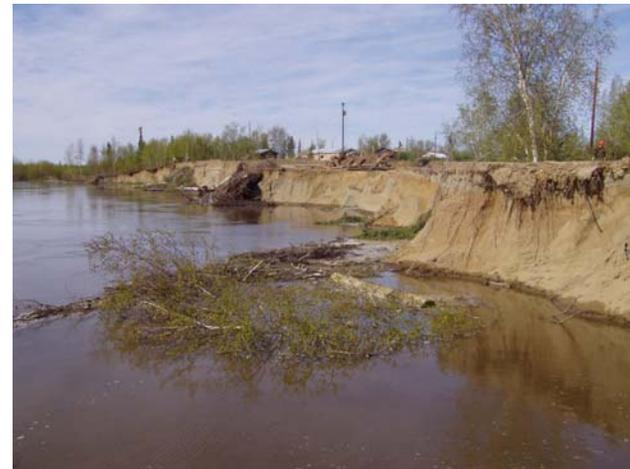
Photo 4: Koyukuk River high water and erosion, No date.

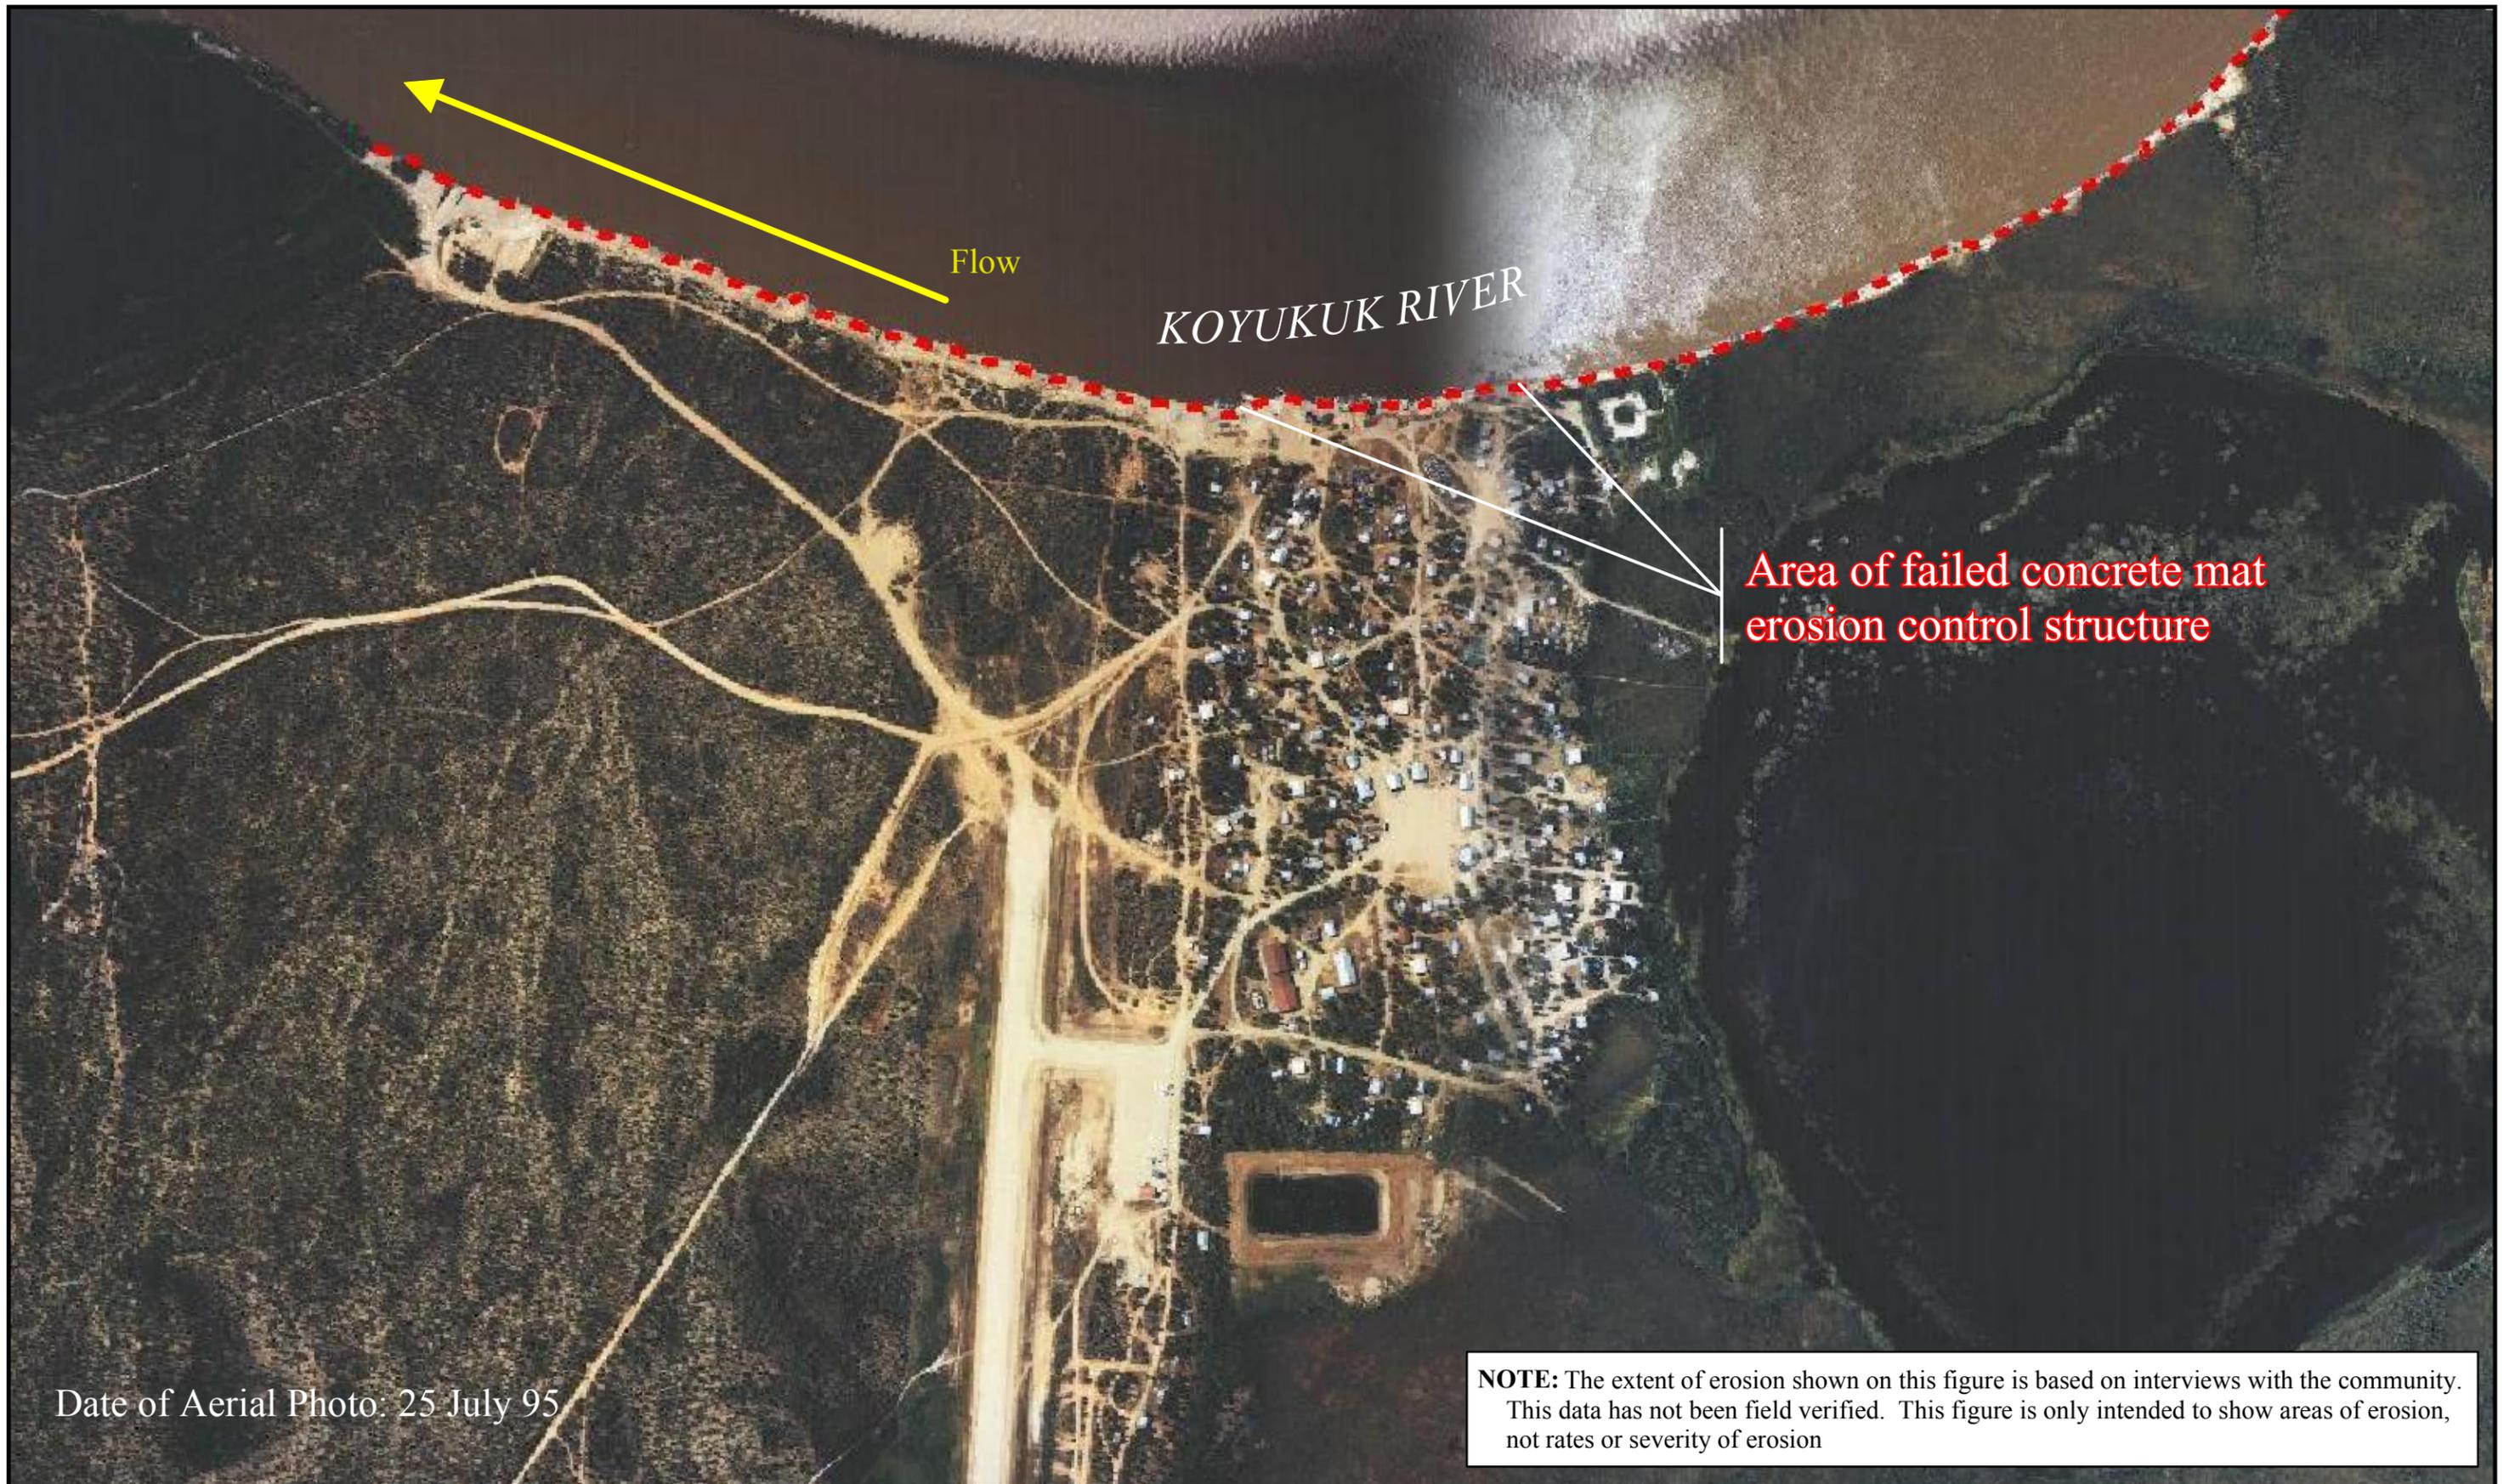
The most active erosion area is estimated to be 2,000 feet along the 70-foot-high riverbank. The community survey indicates the riverbank has been eroding at an estimated rate of 10 to 30 feet per year, but substantially greater rates have been reported during recent breakup flooding. The survey reported that the river eroded 2,000 feet of bank inland 60 feet in May of 2003, 100 feet in 2004, and 80 feet in 2005.

NOTE: The extent of erosion shown on this figure is based on interviews with the community. This data has not been field verified. This figure is only intended to show areas of erosion, not rates or severity of erosion
