ALASKA BASELINE EROSION ASSESSMENT

Erosion Information Paper - Hyder, Alaska

Current as of February 22, 2008

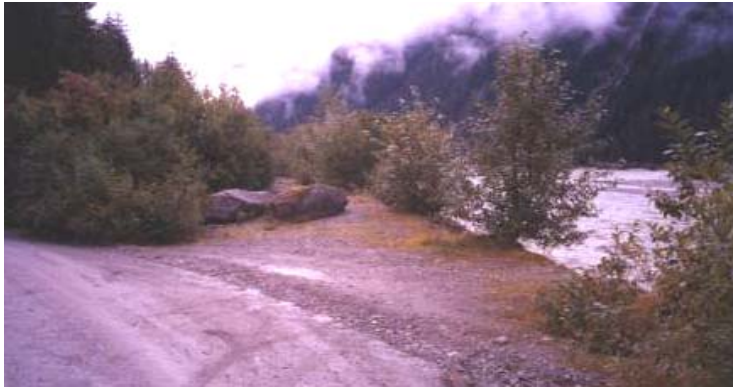
Photo 1: The dike crest at the upper end of the project, looking downstream.

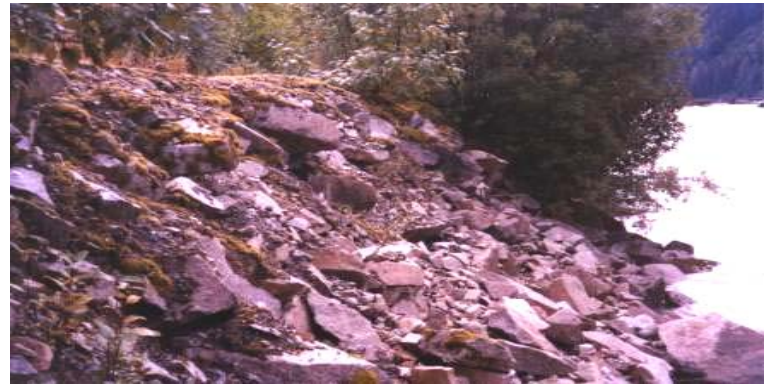
Photo 2: The dike side slope at the upstream end of the project. From the size of the material, it appears that the armor layer is totally gone. The side slope is approximately 1:1 rather than the constructed 2:1.

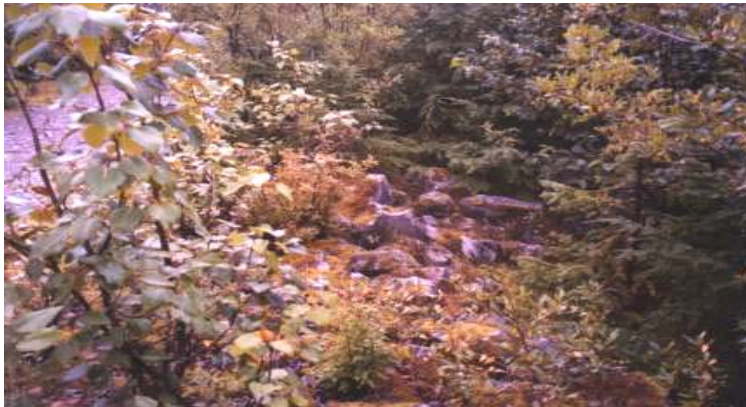
Photo 3: The river-side side slope of the dike near the downstream end of the project. This view shows the armor layer in place (at least the upper end of the layer). The dike top width here is 4-6 feet wider than most of the eroded upstream section of the project where the crest extends over the top face of the bedding and armor layers.

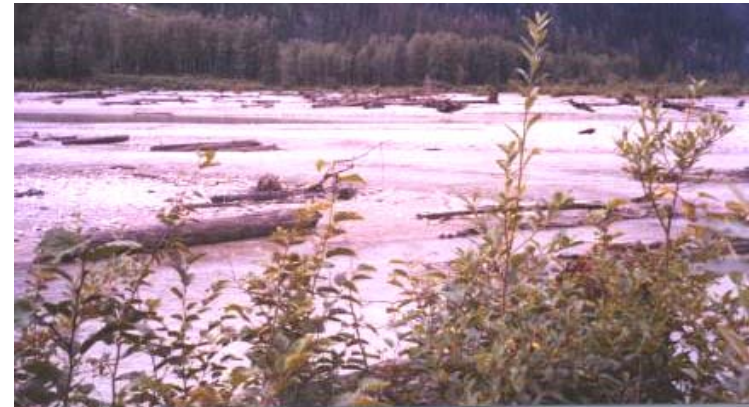
Photo 4: Debris in the river channel

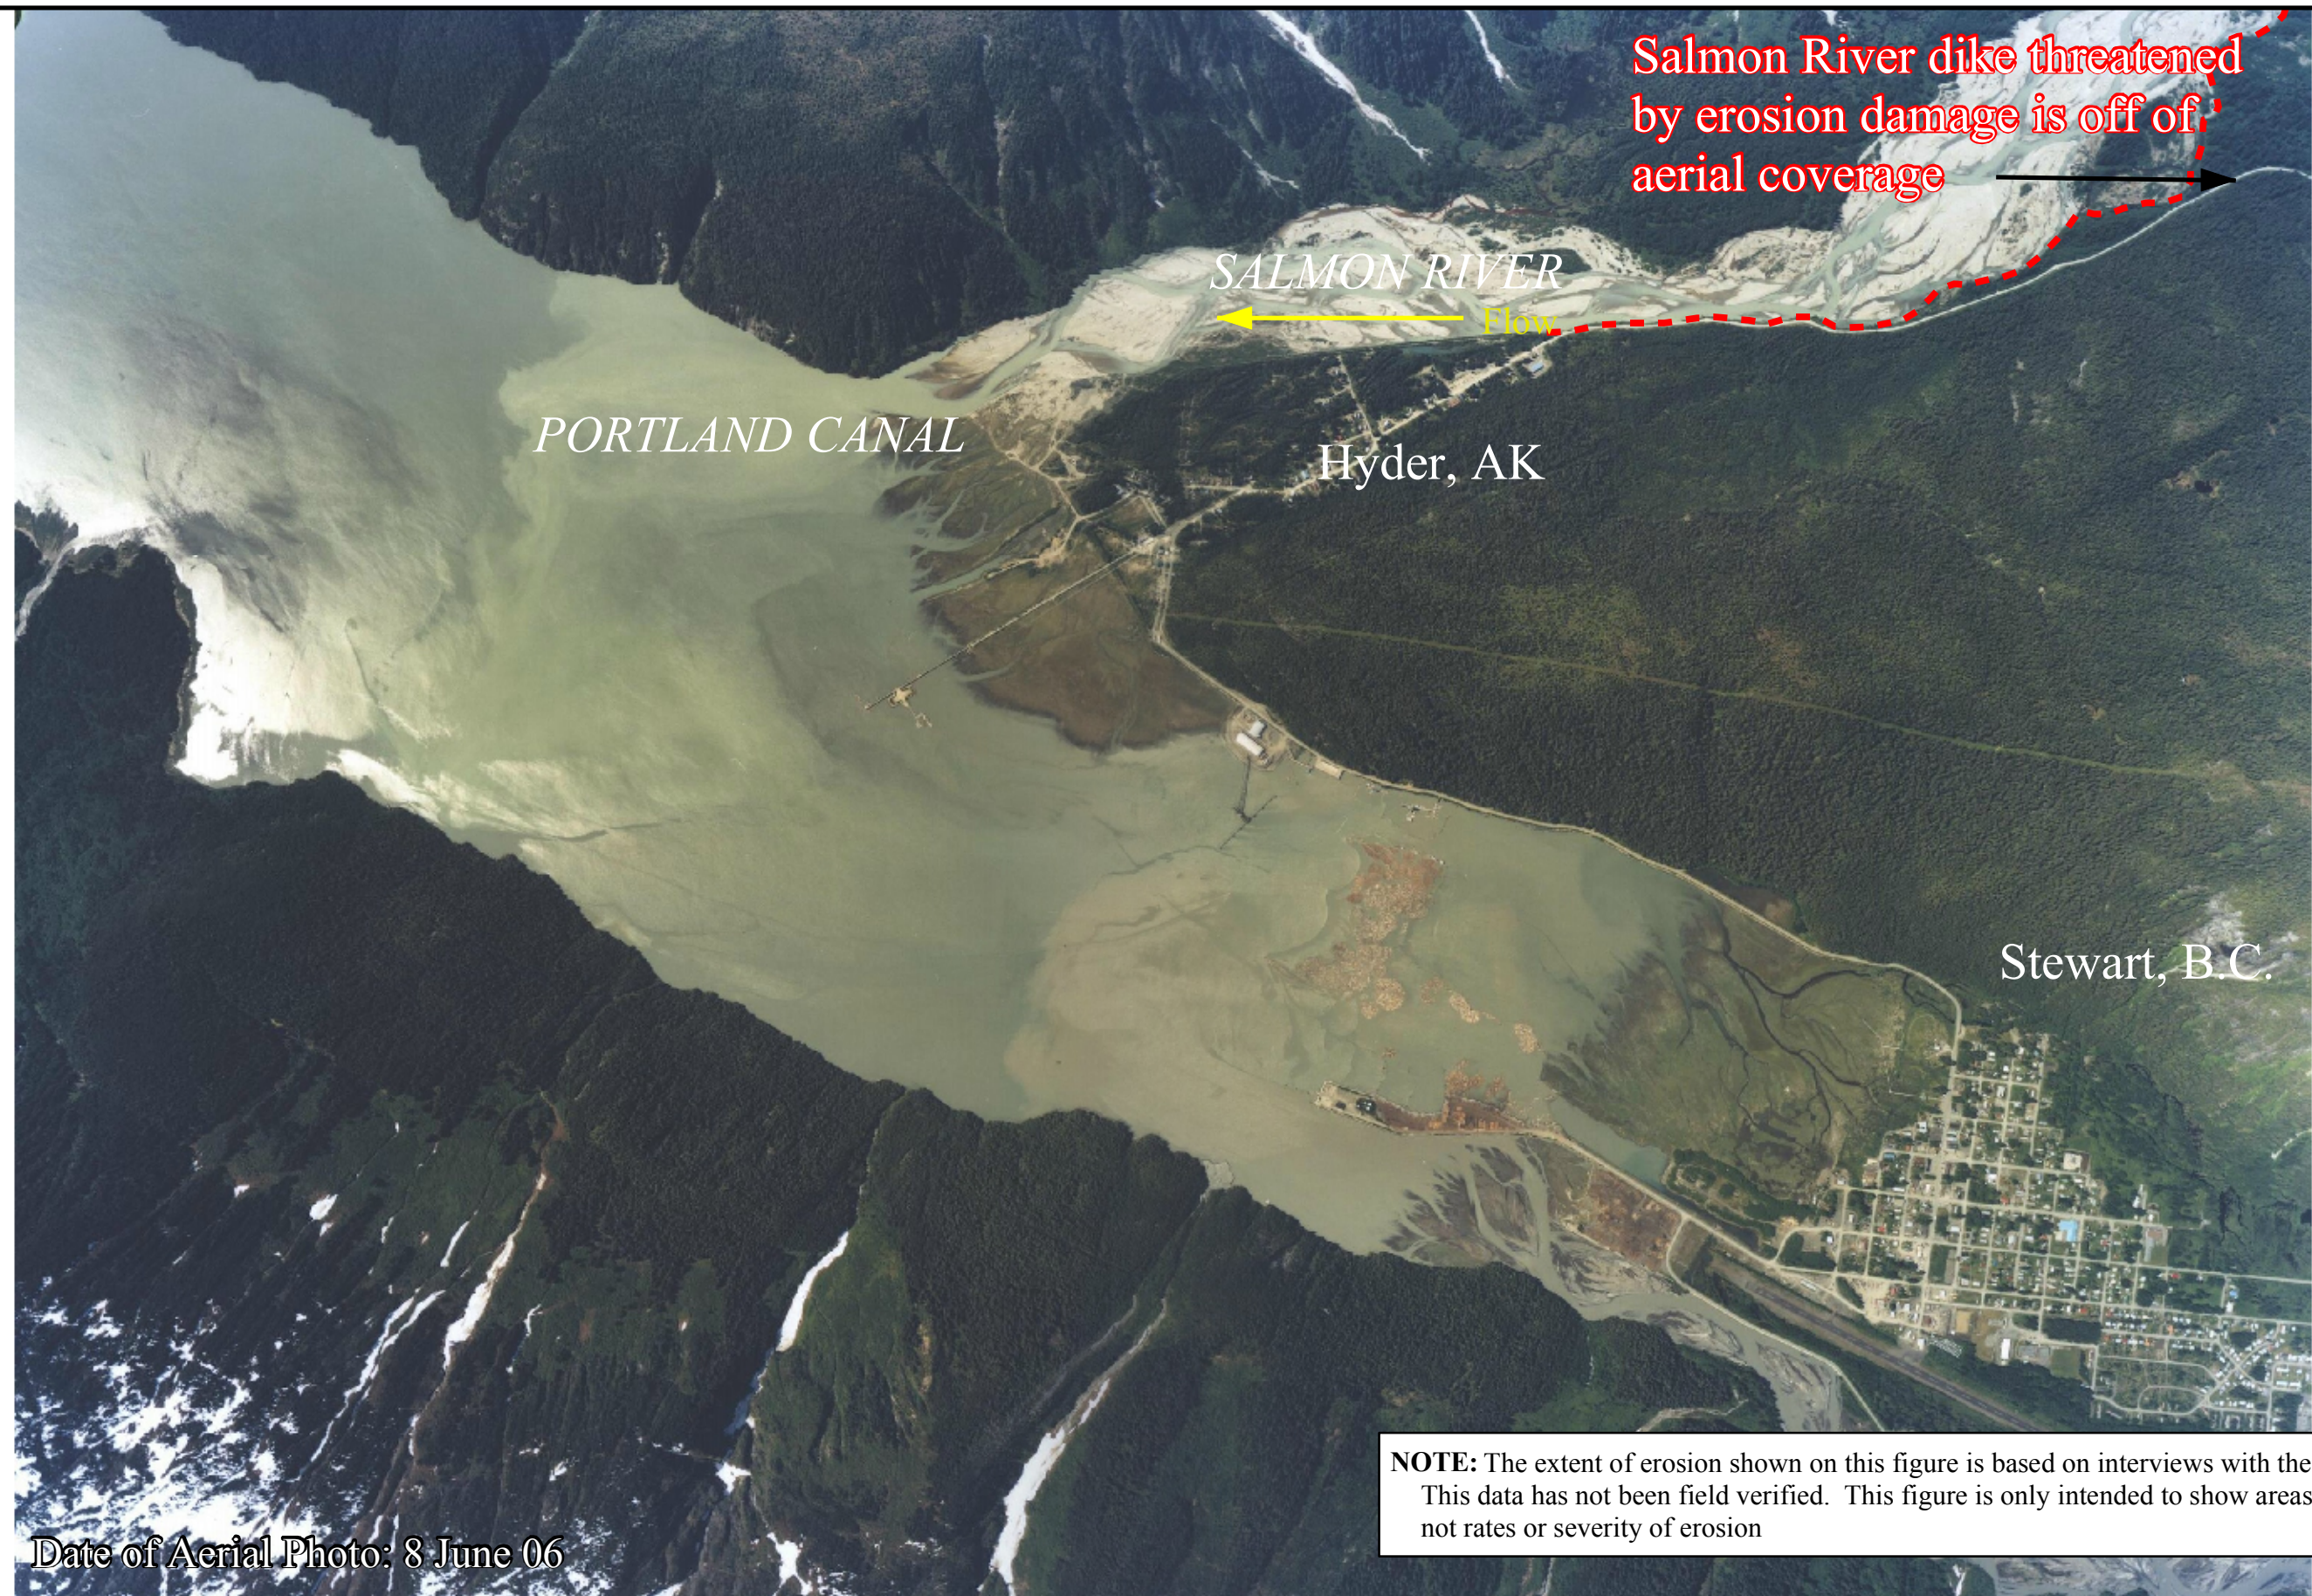
--- Linear Extent of Erosion

The existing erosion area begins north of the earth-and-rock dike constructed by the Corps in the 1930's and continues up the frontage/access road for approximately 8.5 miles. The eroding riverbank is 10 to 15 feet high along the road. The affected road is one of two roads providing access to the community. It is the only road with access to the gold mines north of the community, the wildlife observation area, and the glacier overlook. The observation area, glacier overlook, and mines are significant tourist attractions considered essential to the economic
