U.S. Army Corps
of Engineers
Alaska District

ALASKA BASELINE EROSION ASSESSMENT

Erosion Information Paper - Iliamna, Alaska

Current as of February 23, 2009

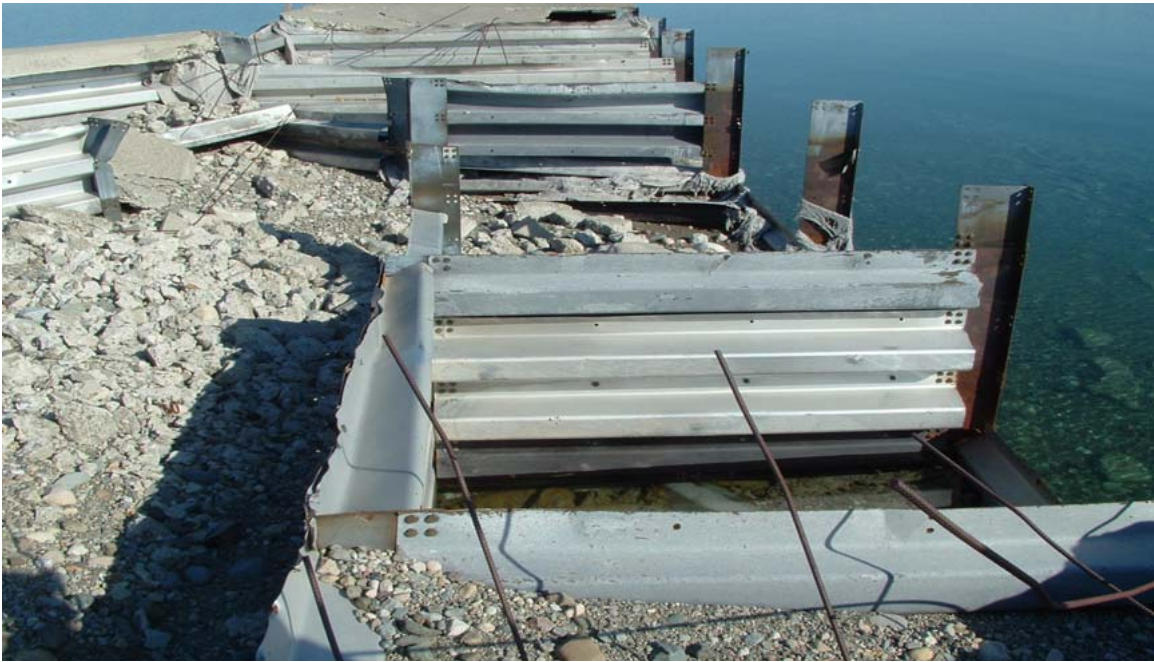
The shoreline may be eroding in the dock landing area as a result of wave action. Storm-driven waves in the fall reportedly approach 6 feet high at the dock.

A Corps 2005 *Site Visit Memorandum* states the only structure with erosion damage is the Iliamna dock. The dock is a bolted-sheet structure backfilled with pit-run cobble and gravel. Previously, the concrete and sheeting on both ends of the dock have been damaged by waves entering the bay from the east. In 1991, the gravel along the outer edge of the dock was capped with a reinforced concrete surface about 20 feet wide and 10 to 12 inches thick with 1½ inch wide wooden expansion joints. Fill for the damaged areas consisted of washed-out reclaimed material, ranging in size from gravel to boulders. Boats were severely damaged in past years with a few vessels damaged beyond practical repair (cost: \$40,000 each).

Photo 1: Storms causing waves on Iliamna Lake have caused extensive damage to both the dock and mooring vessels, photo courtesy of Alaska District Corps of Engineers, 2005.

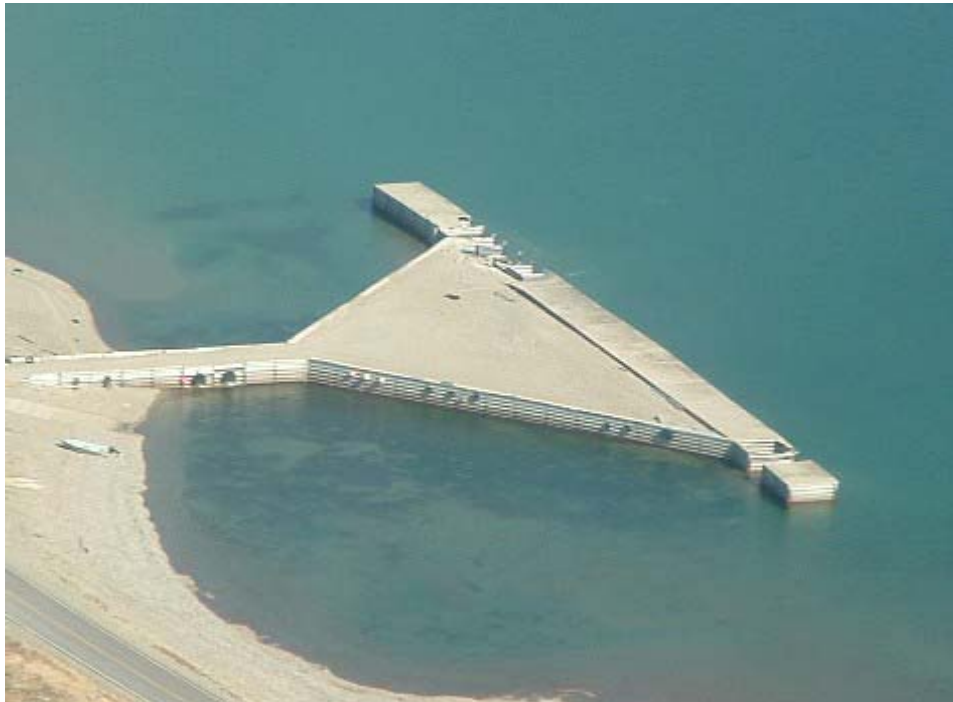
Photo 2: Aerial view of the Iliamna dock, photo courtesy of Alaska District Corps of Engineers, 2005.
