U.S. Army Corps
of Engineers
Alaska District

ALASKA BASELINE EROSION ASSESSMENT

Erosion Information Paper – Juneau-Douglas, Alaska

Current as of October 26, 2007

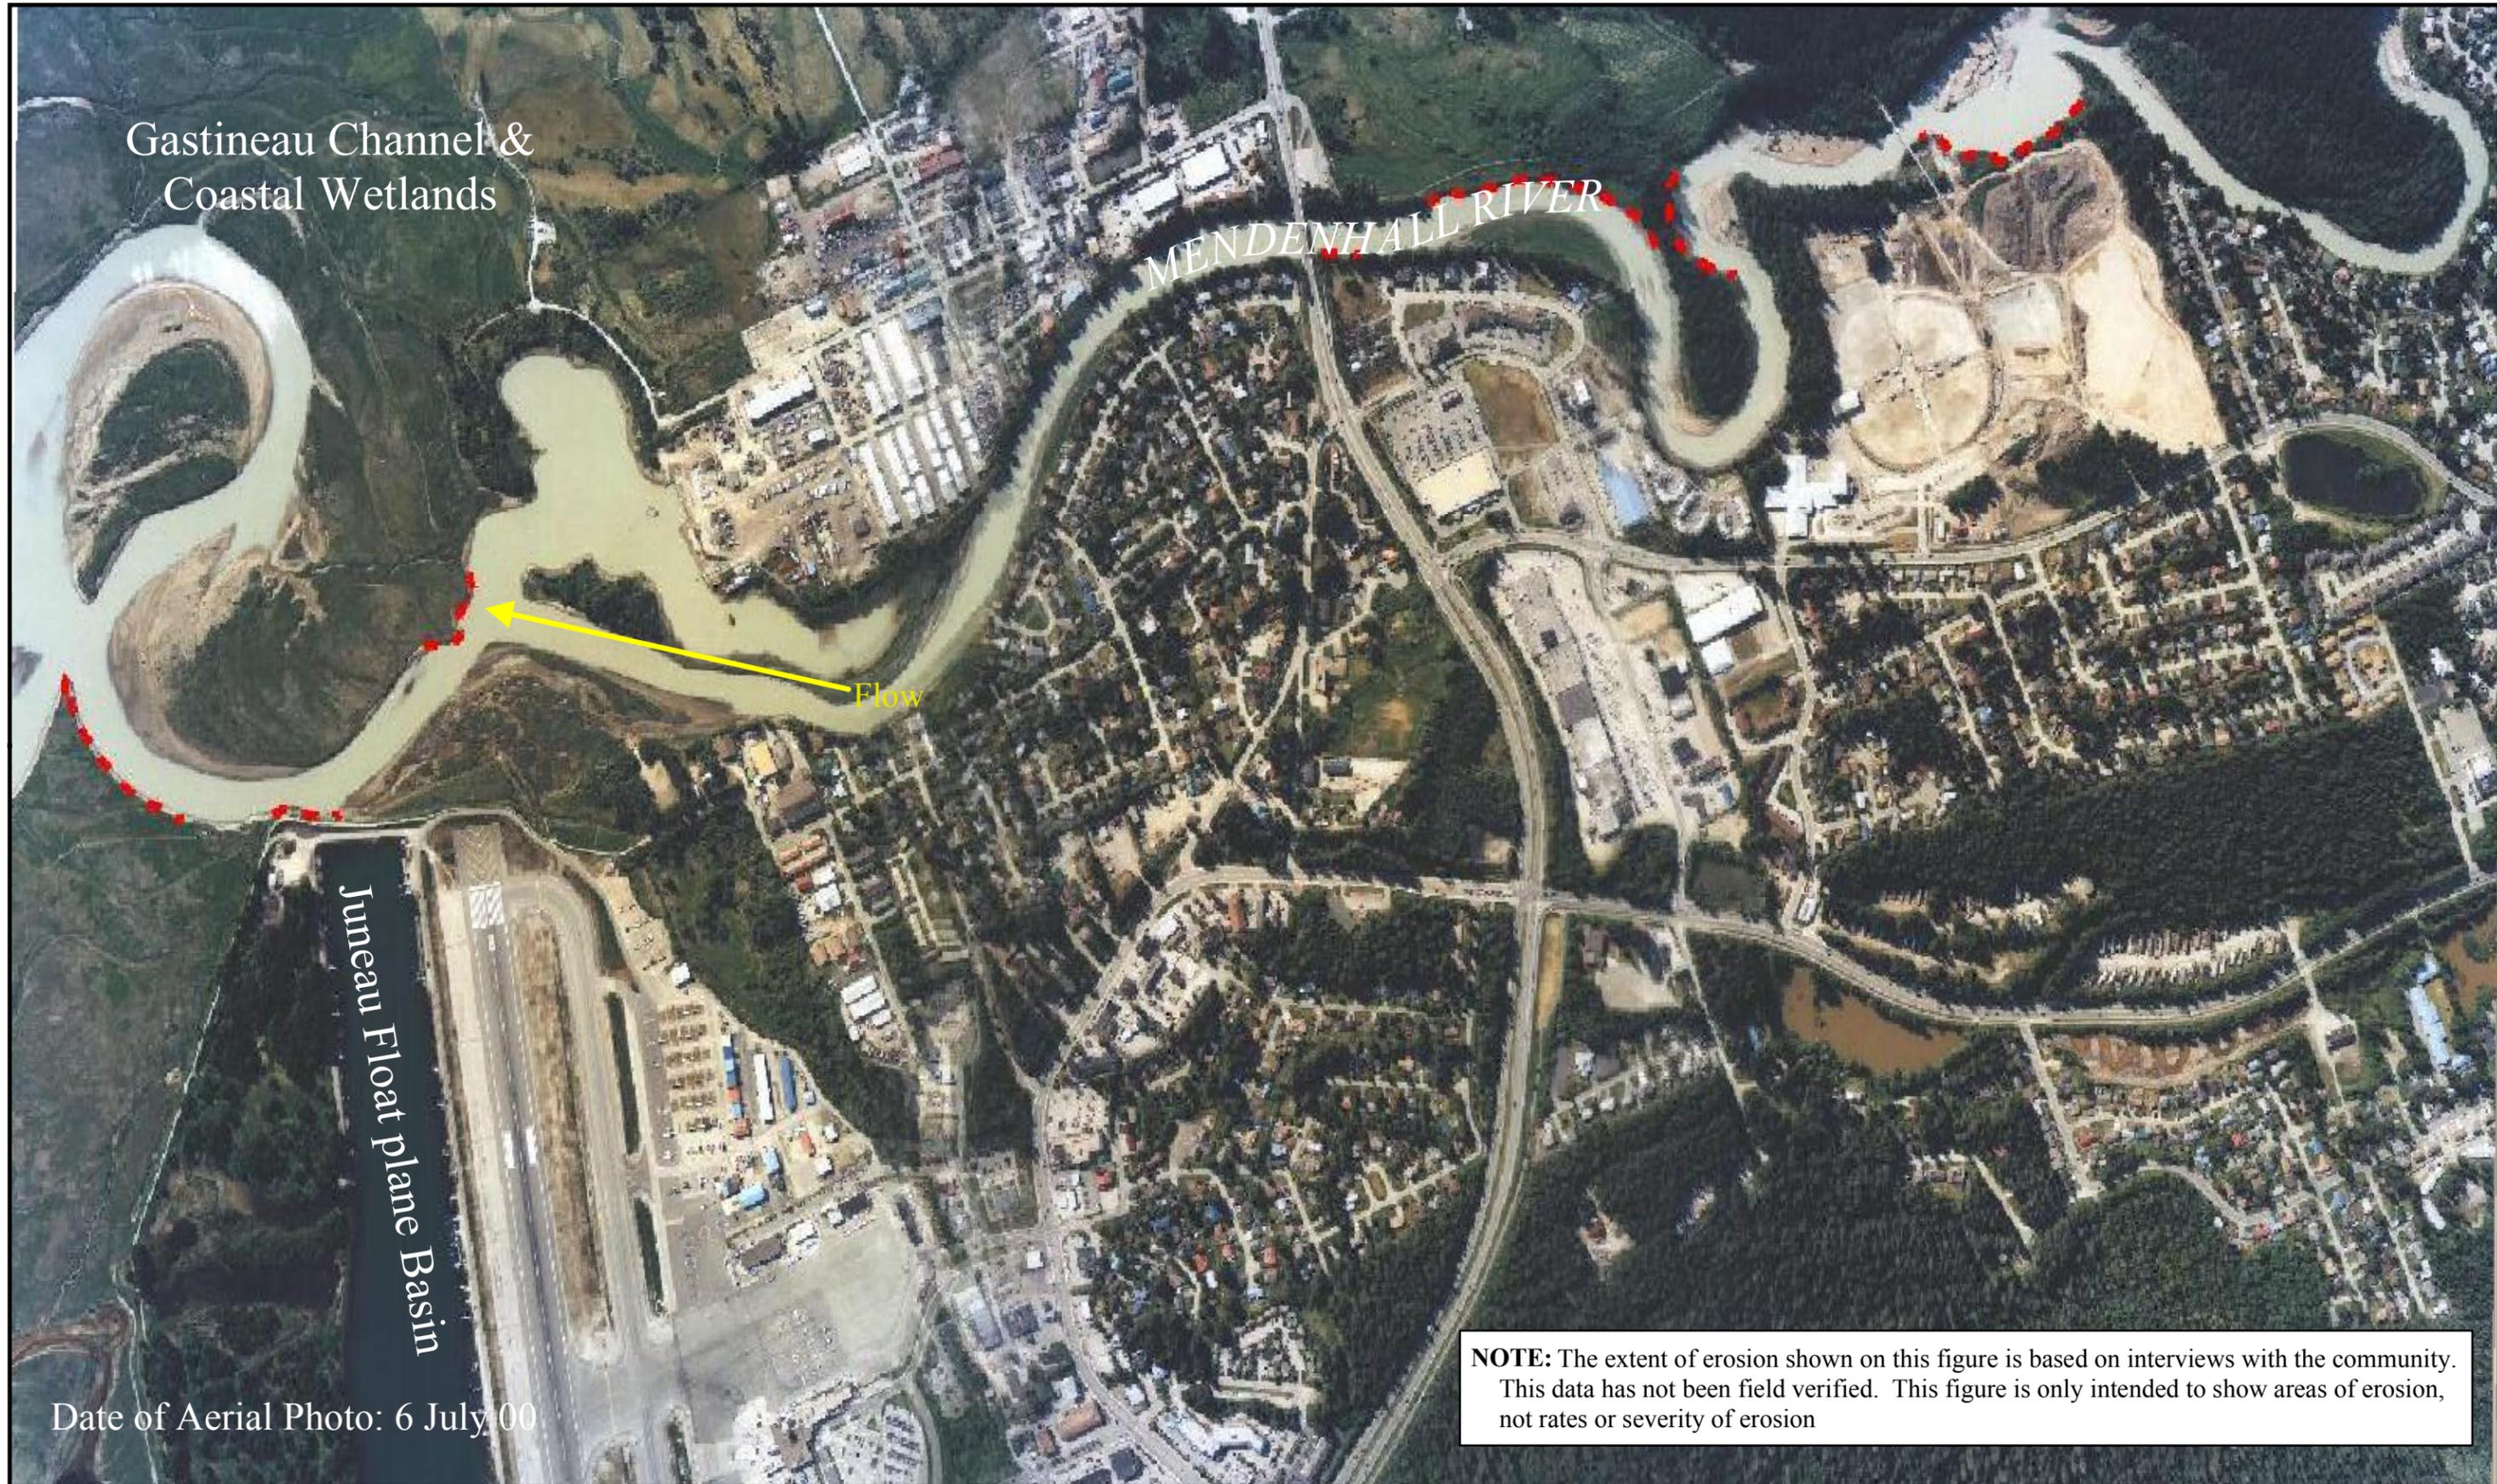
Alaska Baseline Erosion
Juneau, Alaska

Erosion along the Mendenhall River has primarily involved undeveloped land. The estimated erosion rate is 2 to 10 feet per year. The river is close to cutting through an oxbow on the river. There is erosion along the west end of the Juneau Airport and floatplane pond, and portions of the airport runway fill and floatplane pond dike have been lost.

No photos were provided by the community or other sources. The attached diagram shows the linear extent of erosion areas along the Mendenhall River. The Douglas-Juneau downtown waterfront area is also shown on the diagram.
