U.S. Army Corps
of Engineers
Alaska District

ALASKA BASELINE EROSION ASSESSMENT

Erosion Information Paper – King Cove, Alaska

Current as of November 6, 2007

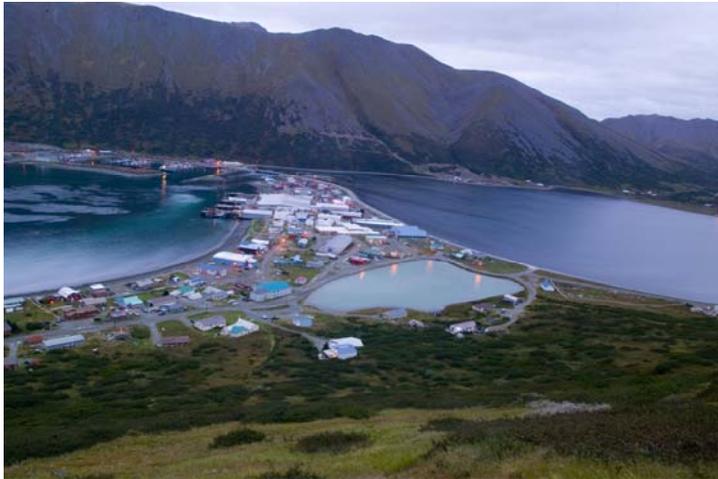
Photo 1: King Cove, October 2005.

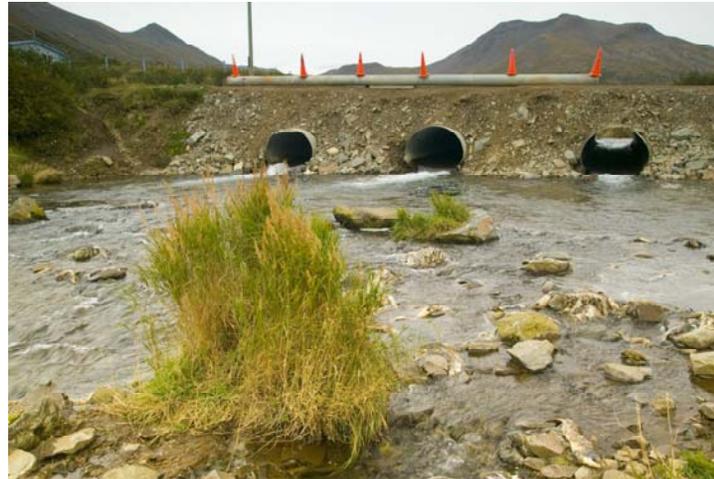
Photo 2: Ram's Creek culverts planned for replacement with open span bridge in 2008, October 2005.

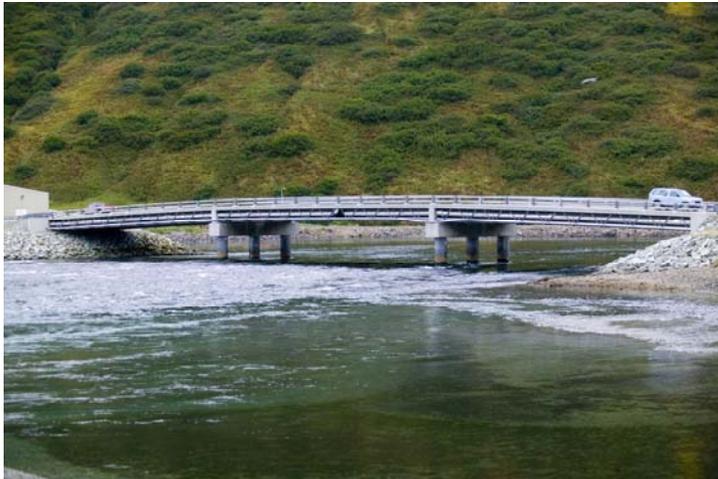
Photo 3: King Cove Bridge, October 2005.

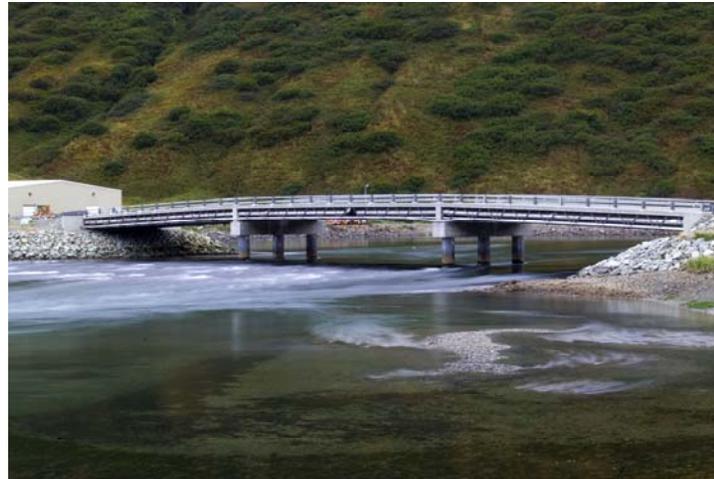
Photo 4: King Cove Bridge provides access across King Cove Lagoon inlet to the spit, October 2005.
