Community Erosion Assessment Kongiganak, Alaska 26 January 2009

1. Community: Kongiganak, Alaska

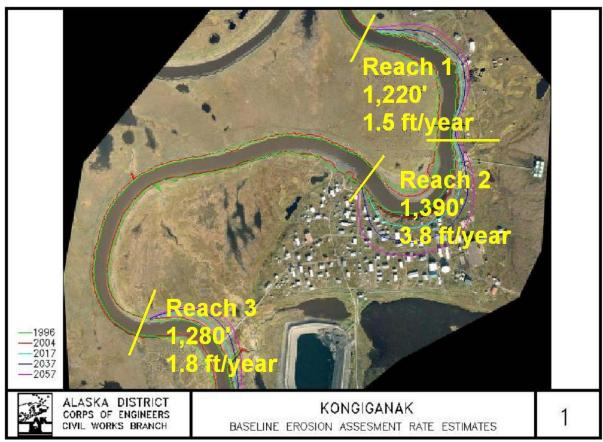
Figure 2. Kongiganak Erosion Map

For this study the area was divided into three reaches. Reach 1 is a 1,220-foot portion of riverbank that fronts the community and is eroding at a rate of 1.5 feet per year. Reach 2 is a 1,390-foot portion of riverbank directly upstream (and north) of Reach 2 and is eroding at a rate of 3.8 feet per year. Reach 3 is a 1,280-foot portion of riverbank west of town and is eroding at a rate of 1.8 feet per year.

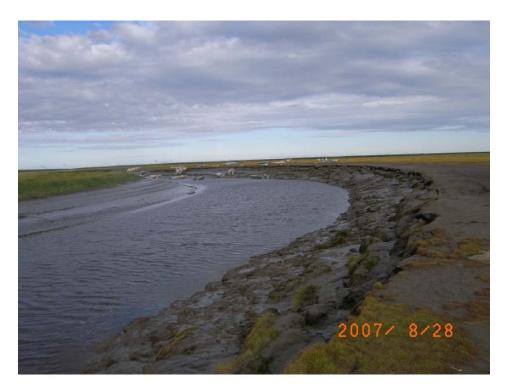
Kongiganak RIMG0243 Photo 1: Looking upstream from bank in Reach 3.

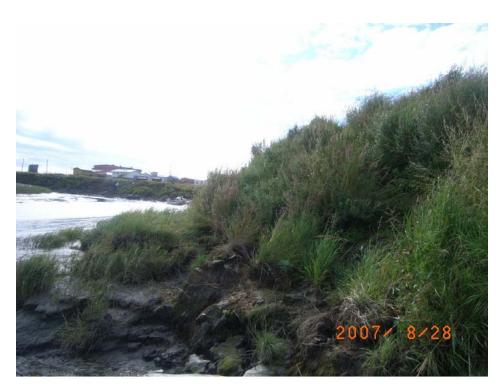
N 59° 57.654' W 162° 53.515' Kongiganak RIMG0259 Photo 2: Looking upstream from bank fronting main town site. Bank is 30+ feet high here.

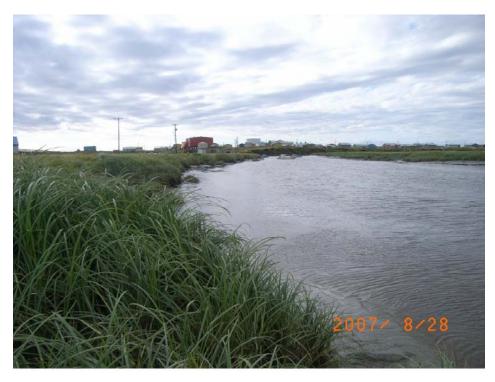
N 59° 57.793' W 162° 53.276' Kongiganak RIMG0286 Photo 3: Looking downstream from north end of town.
