U.S. Army Corps
of Engineers
Alaska District

ALASKA BASELINE EROSION ASSESSMENT

Erosion Information Paper - Kotzebue, Alaska

Current as of January 24, 2008

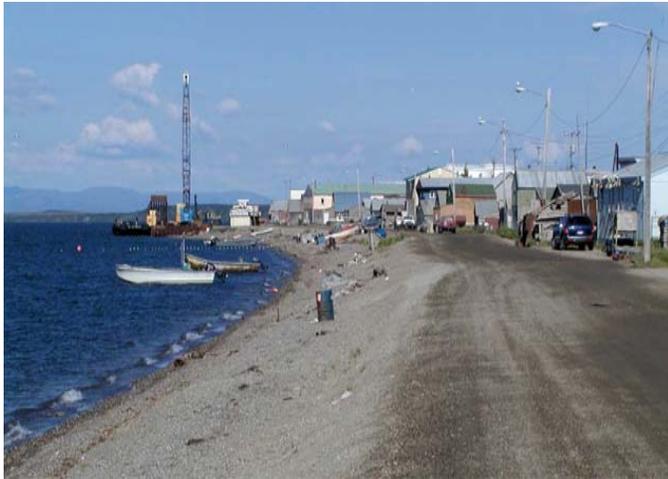
Photo 1: Shore Drive looking toward Crowley dock, 2007.

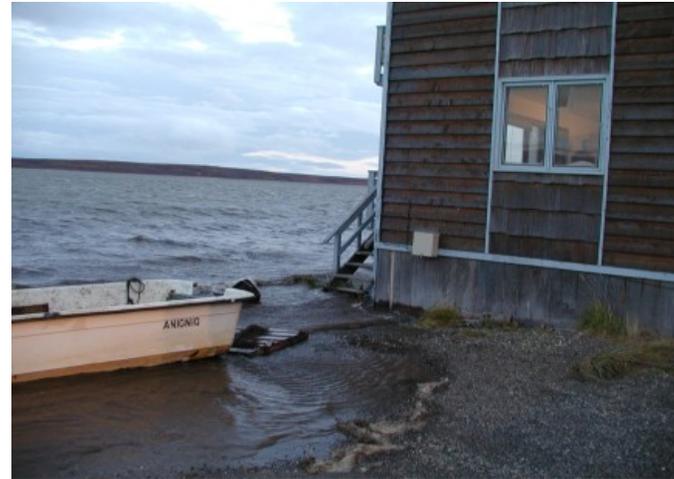
Photo 2: Kotzebue lagoon and Swan Lake merge as a large low pressure weather system over the Seward Peninsula and high tide raised water levels higher than usual on Sept. 23, 2005.

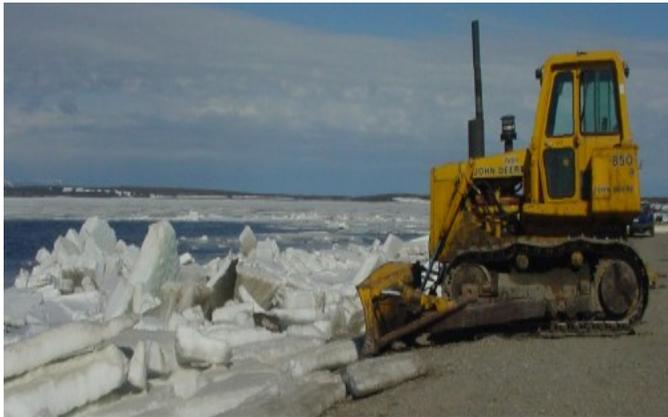
Photo 3: Dozing ice off of Shore Drive, May 2002.

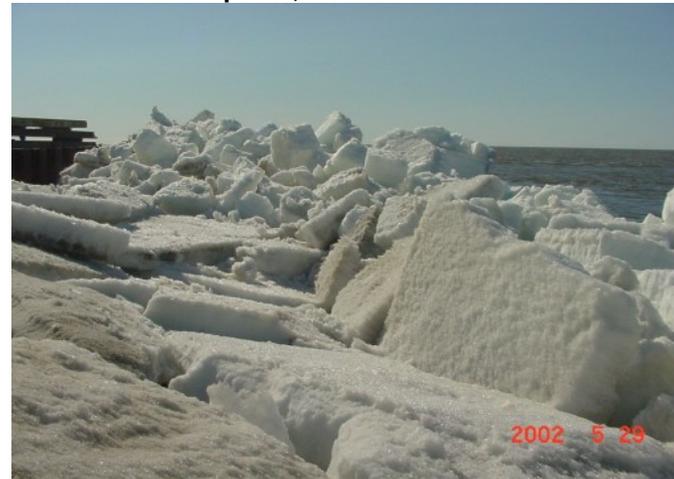
Photo 4: Ice piles up near Nullagvik Hotel, May 2002.

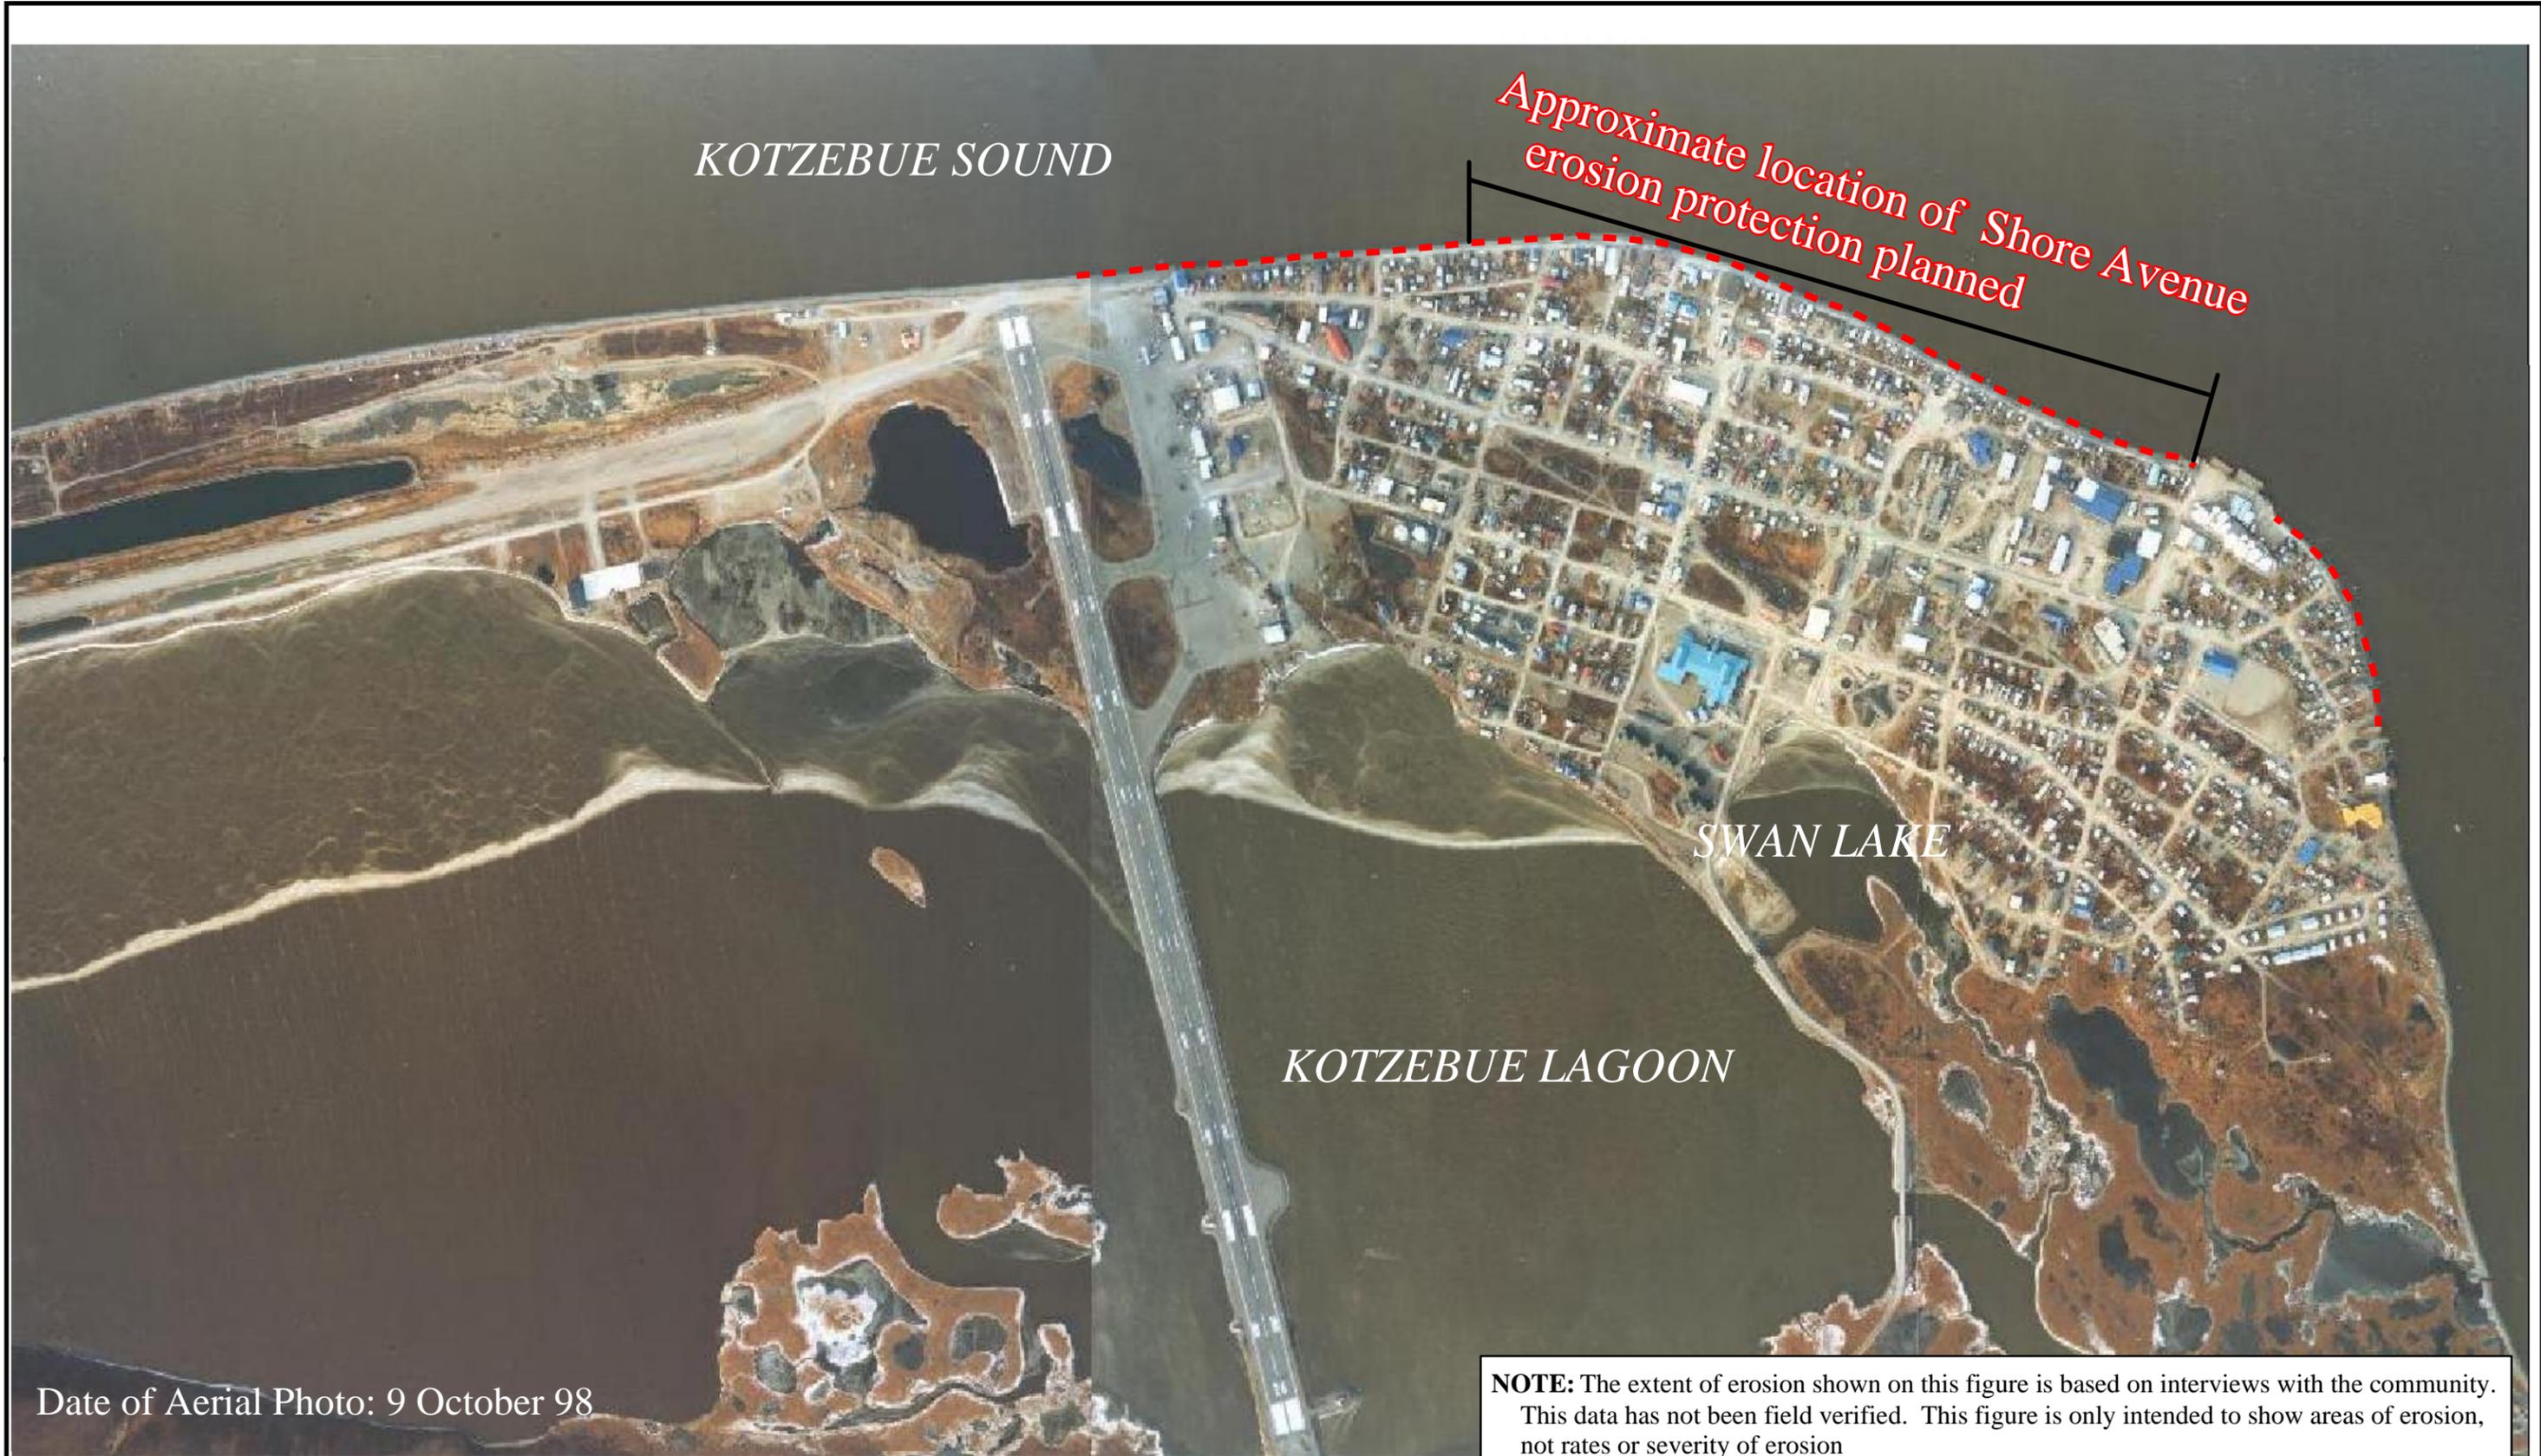
Alaska Baseline Erosion
Kotzebue, Alaska

Kotzebue is on a 3-mile-long spit ranging in width from 1,100 to 3,600 feet. Storm surges, storm-driven waves, and ice action contribute to periodic beach erosion. These contributors were also described in the 1984 *Task Force on Erosion Control Report*, prepared by the Alaska Department of Transportation and Public Facilities (DOT&PF). The bank along Shore Avenue, from Lake Street to Crowley Marine Dock, is being eroded. This area abuts Kotzebue Sound and is approximately 4,600 feet long and 4 to 10 feet high. The erosion rate is estimated to be 1 to 3 feet per year.

--- Linear Extent of Erosion
