U.S. Army Corps
of Engineers
Alaska District

ALASKA BASELINE EROSION ASSESSMENT

Erosion Information Paper - Koyuk, Alaska

Current as of November 6, 2007

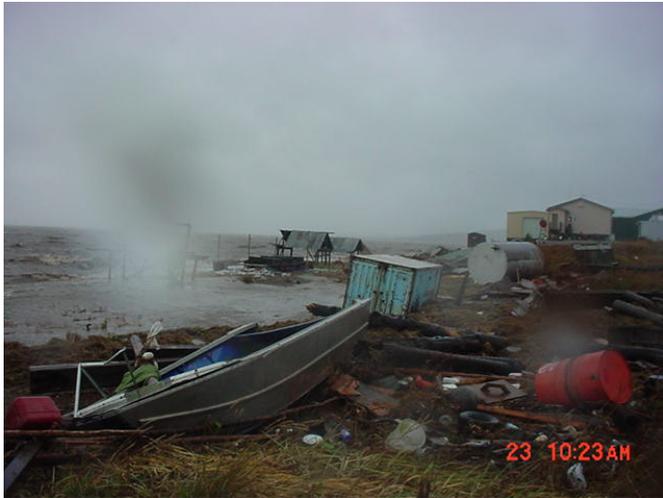
Photo 1: Koyuk coastline during fall storm, Sept. 2005

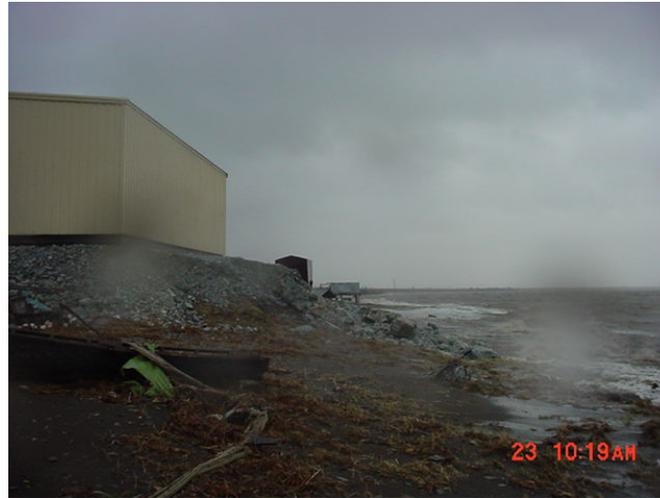
Photo 2: Koyuk storm surge, Sept. 2005.

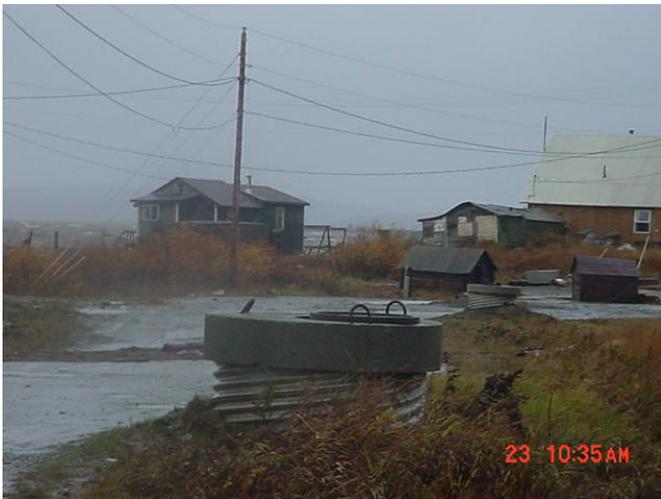
Photo 3: Wind driven waves causing flooding and erosion in Koyuk, Sept. 2005.

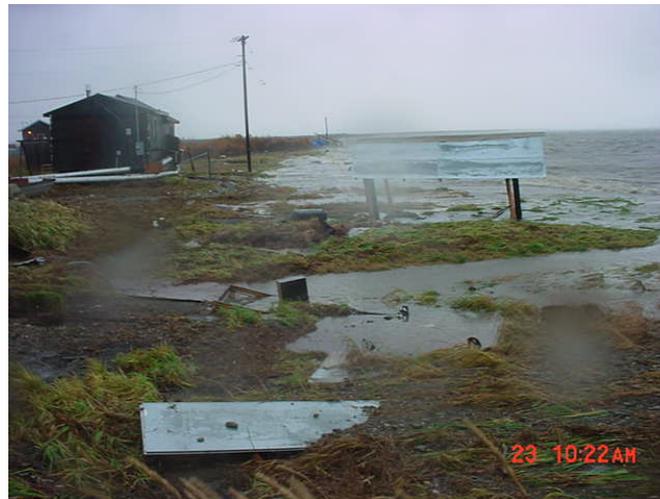
Photo 4: Koyuk shoreline structures during fall storm, Sept. 2005.

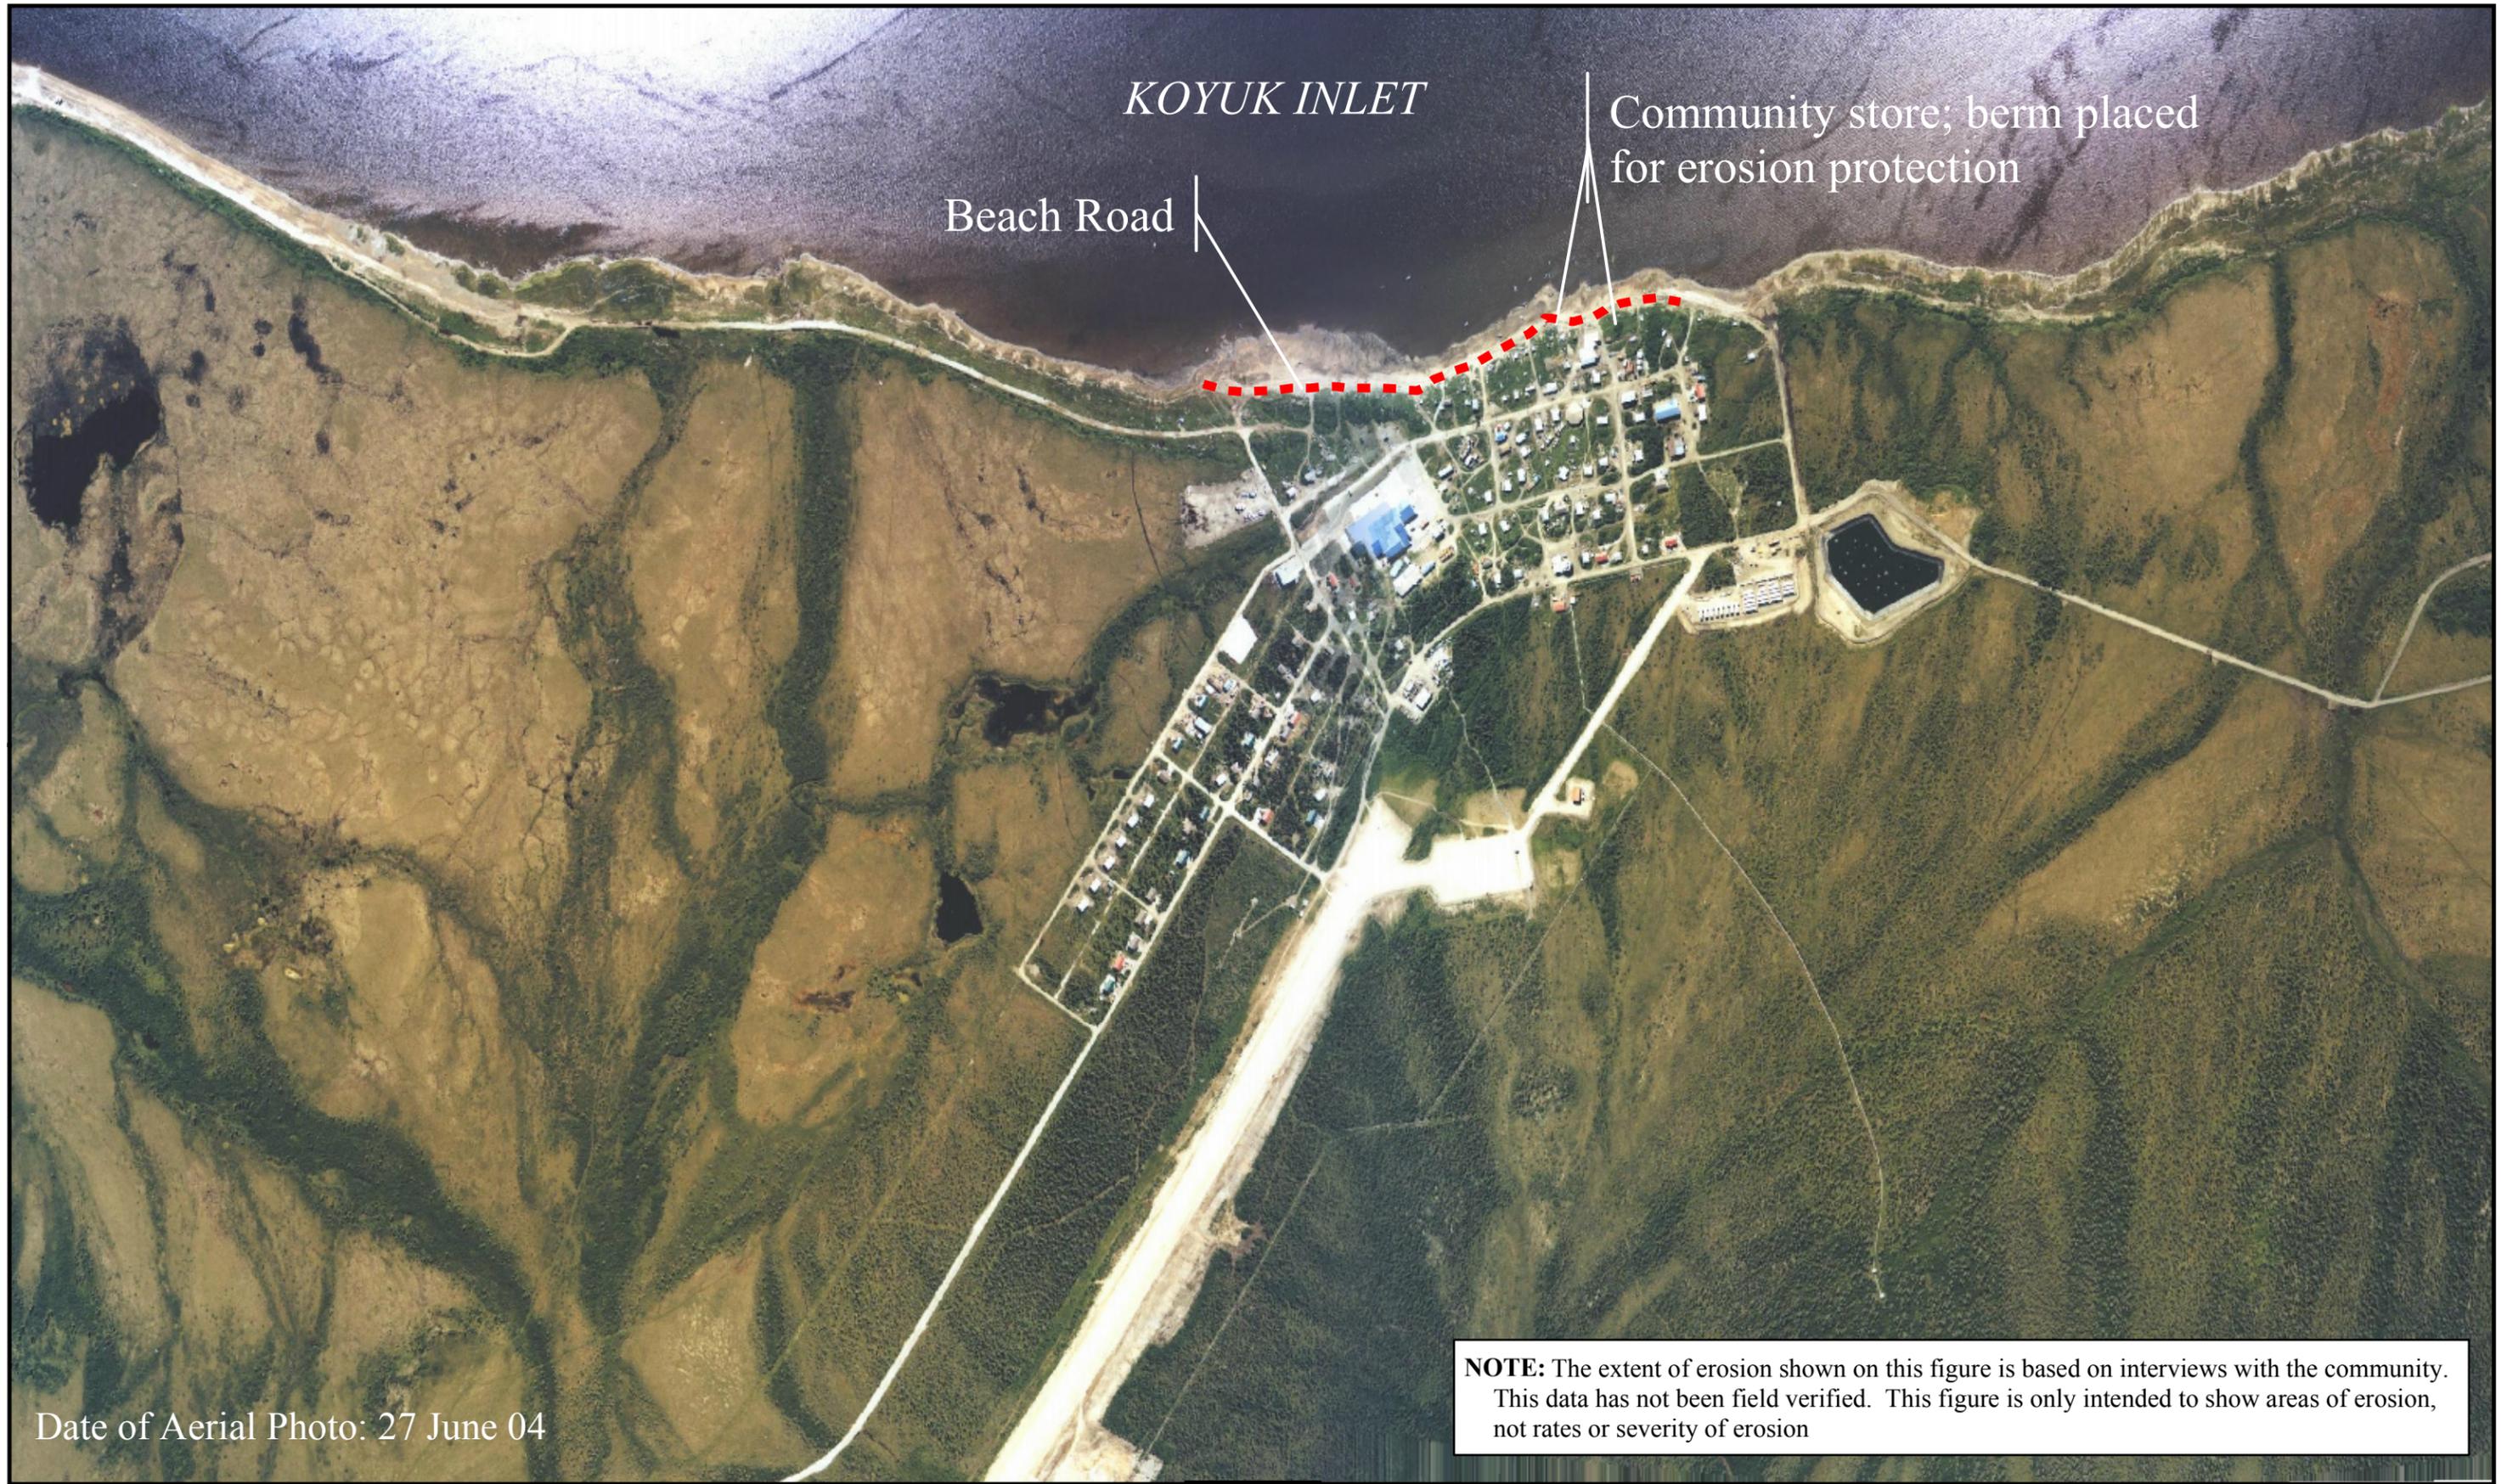
Alaska Baseline Erosion
Koyuk, Alaska

--- Linear Extent of Erosion
