U.S. Army Corps
of Engineers
Alaska District

ALASKA BASELINE EROSION ASSESSMENT

Erosion Information Paper – Larsen Bay, Alaska

Current as of October 12, 2007

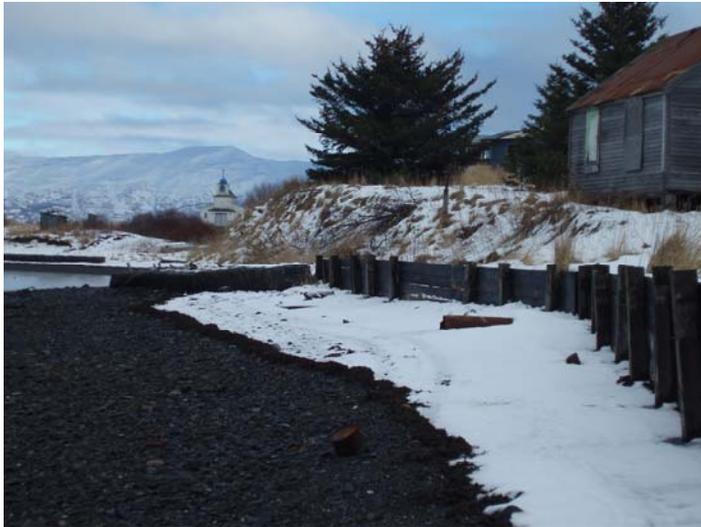
Photo 1: Larsen Bay Seawall, February 2006.

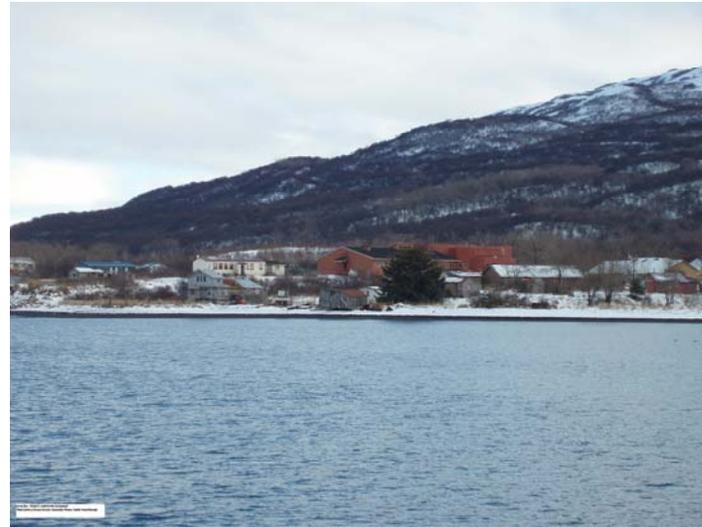
Photo 2: Larsen Bay; school in background, February 2006.

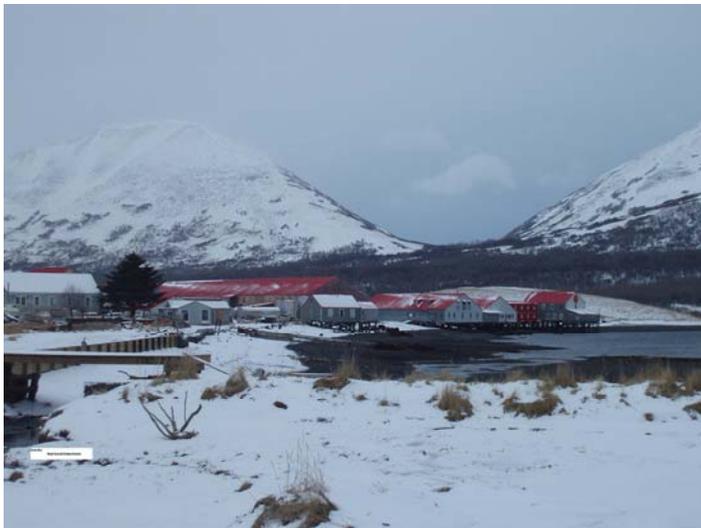
Photo 3: Wood Seawall & gabion baskets, February 2006.

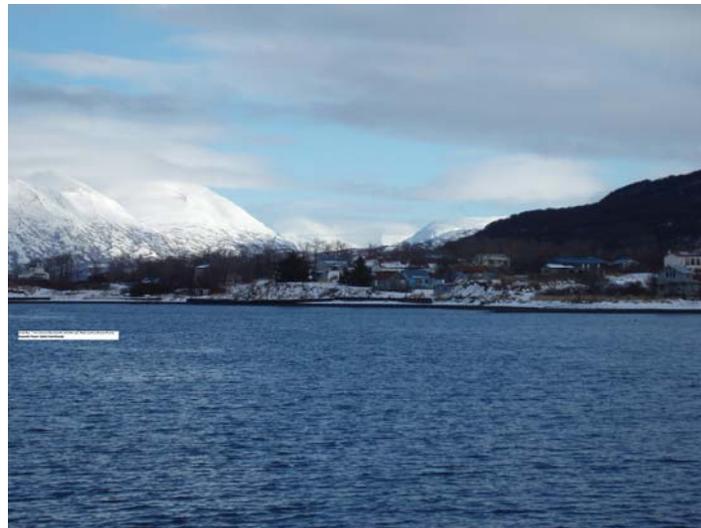
Photo 4: Larsen Bay from end of spit, February 2006.

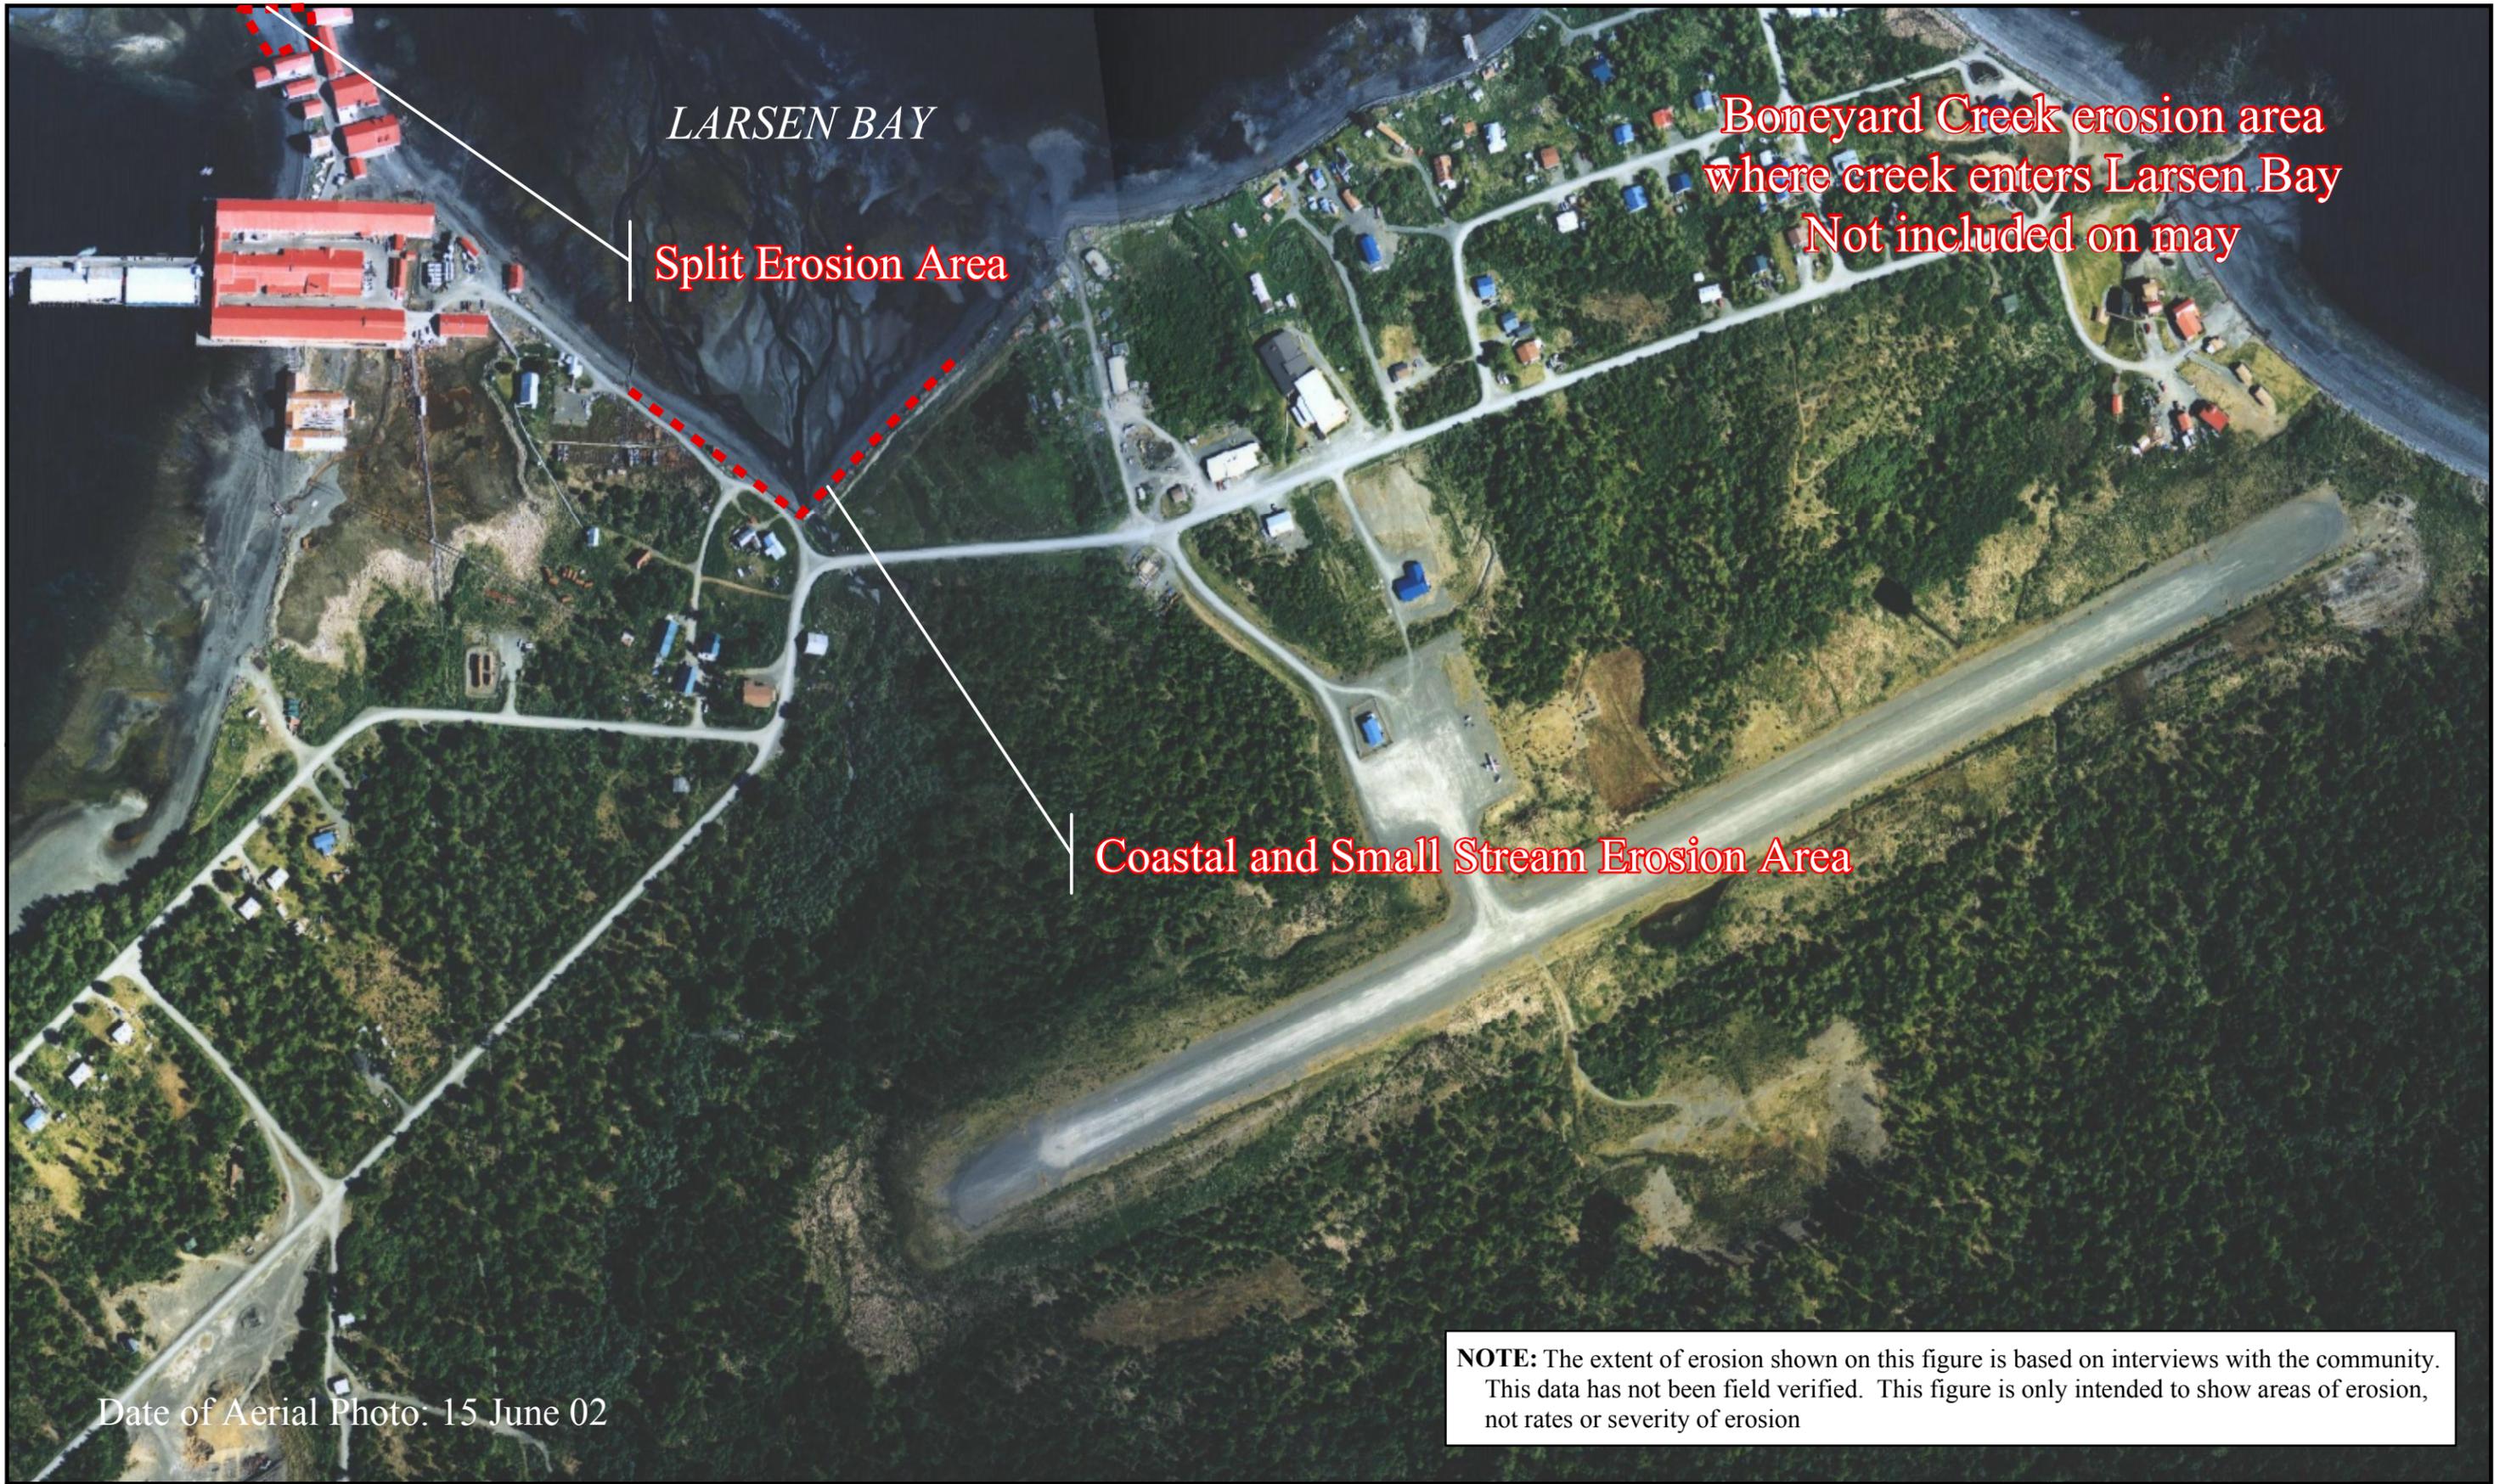
<p>Alaska District Corps of Engineers Civil Works Branch</p>	<p>--- Linear Extent of Erosion Part 2</p>		<p>0 200 400 800 Feet 1 inch equals 400 feet</p> <p>N</p>	<p>Alaska Baseline Erosion Larsen Bay, Alaska</p>
--	--	--	--	---	---

Coastal and Small Stream Erosion Area
