ALASKA BASELINE EROSION ASSESSMENT

Erosion Information Paper - Levelock, Alaska

Current as of November 10, 2007

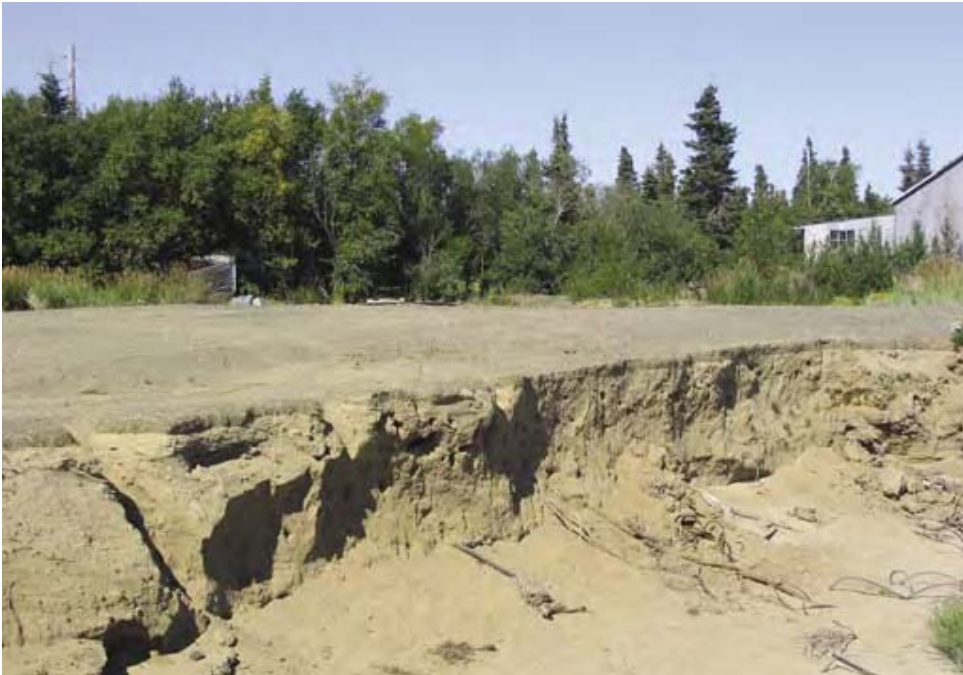
**Photo 1: The eroded west bank of the Kvichak River by Levelock's dock.
(Agnew::Beck 2005 Levelock watershed final summary report)**

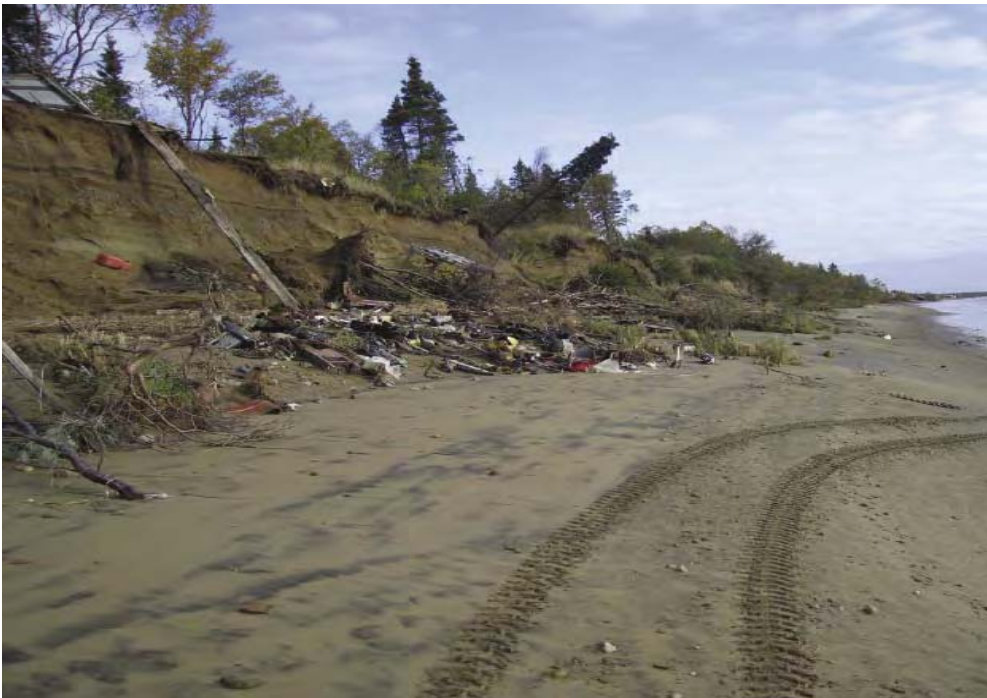
**Photo 2: Outbuildings succumbed to bank erosion (Agnew::Beck 2005 Levelock
watershed final summary report)**

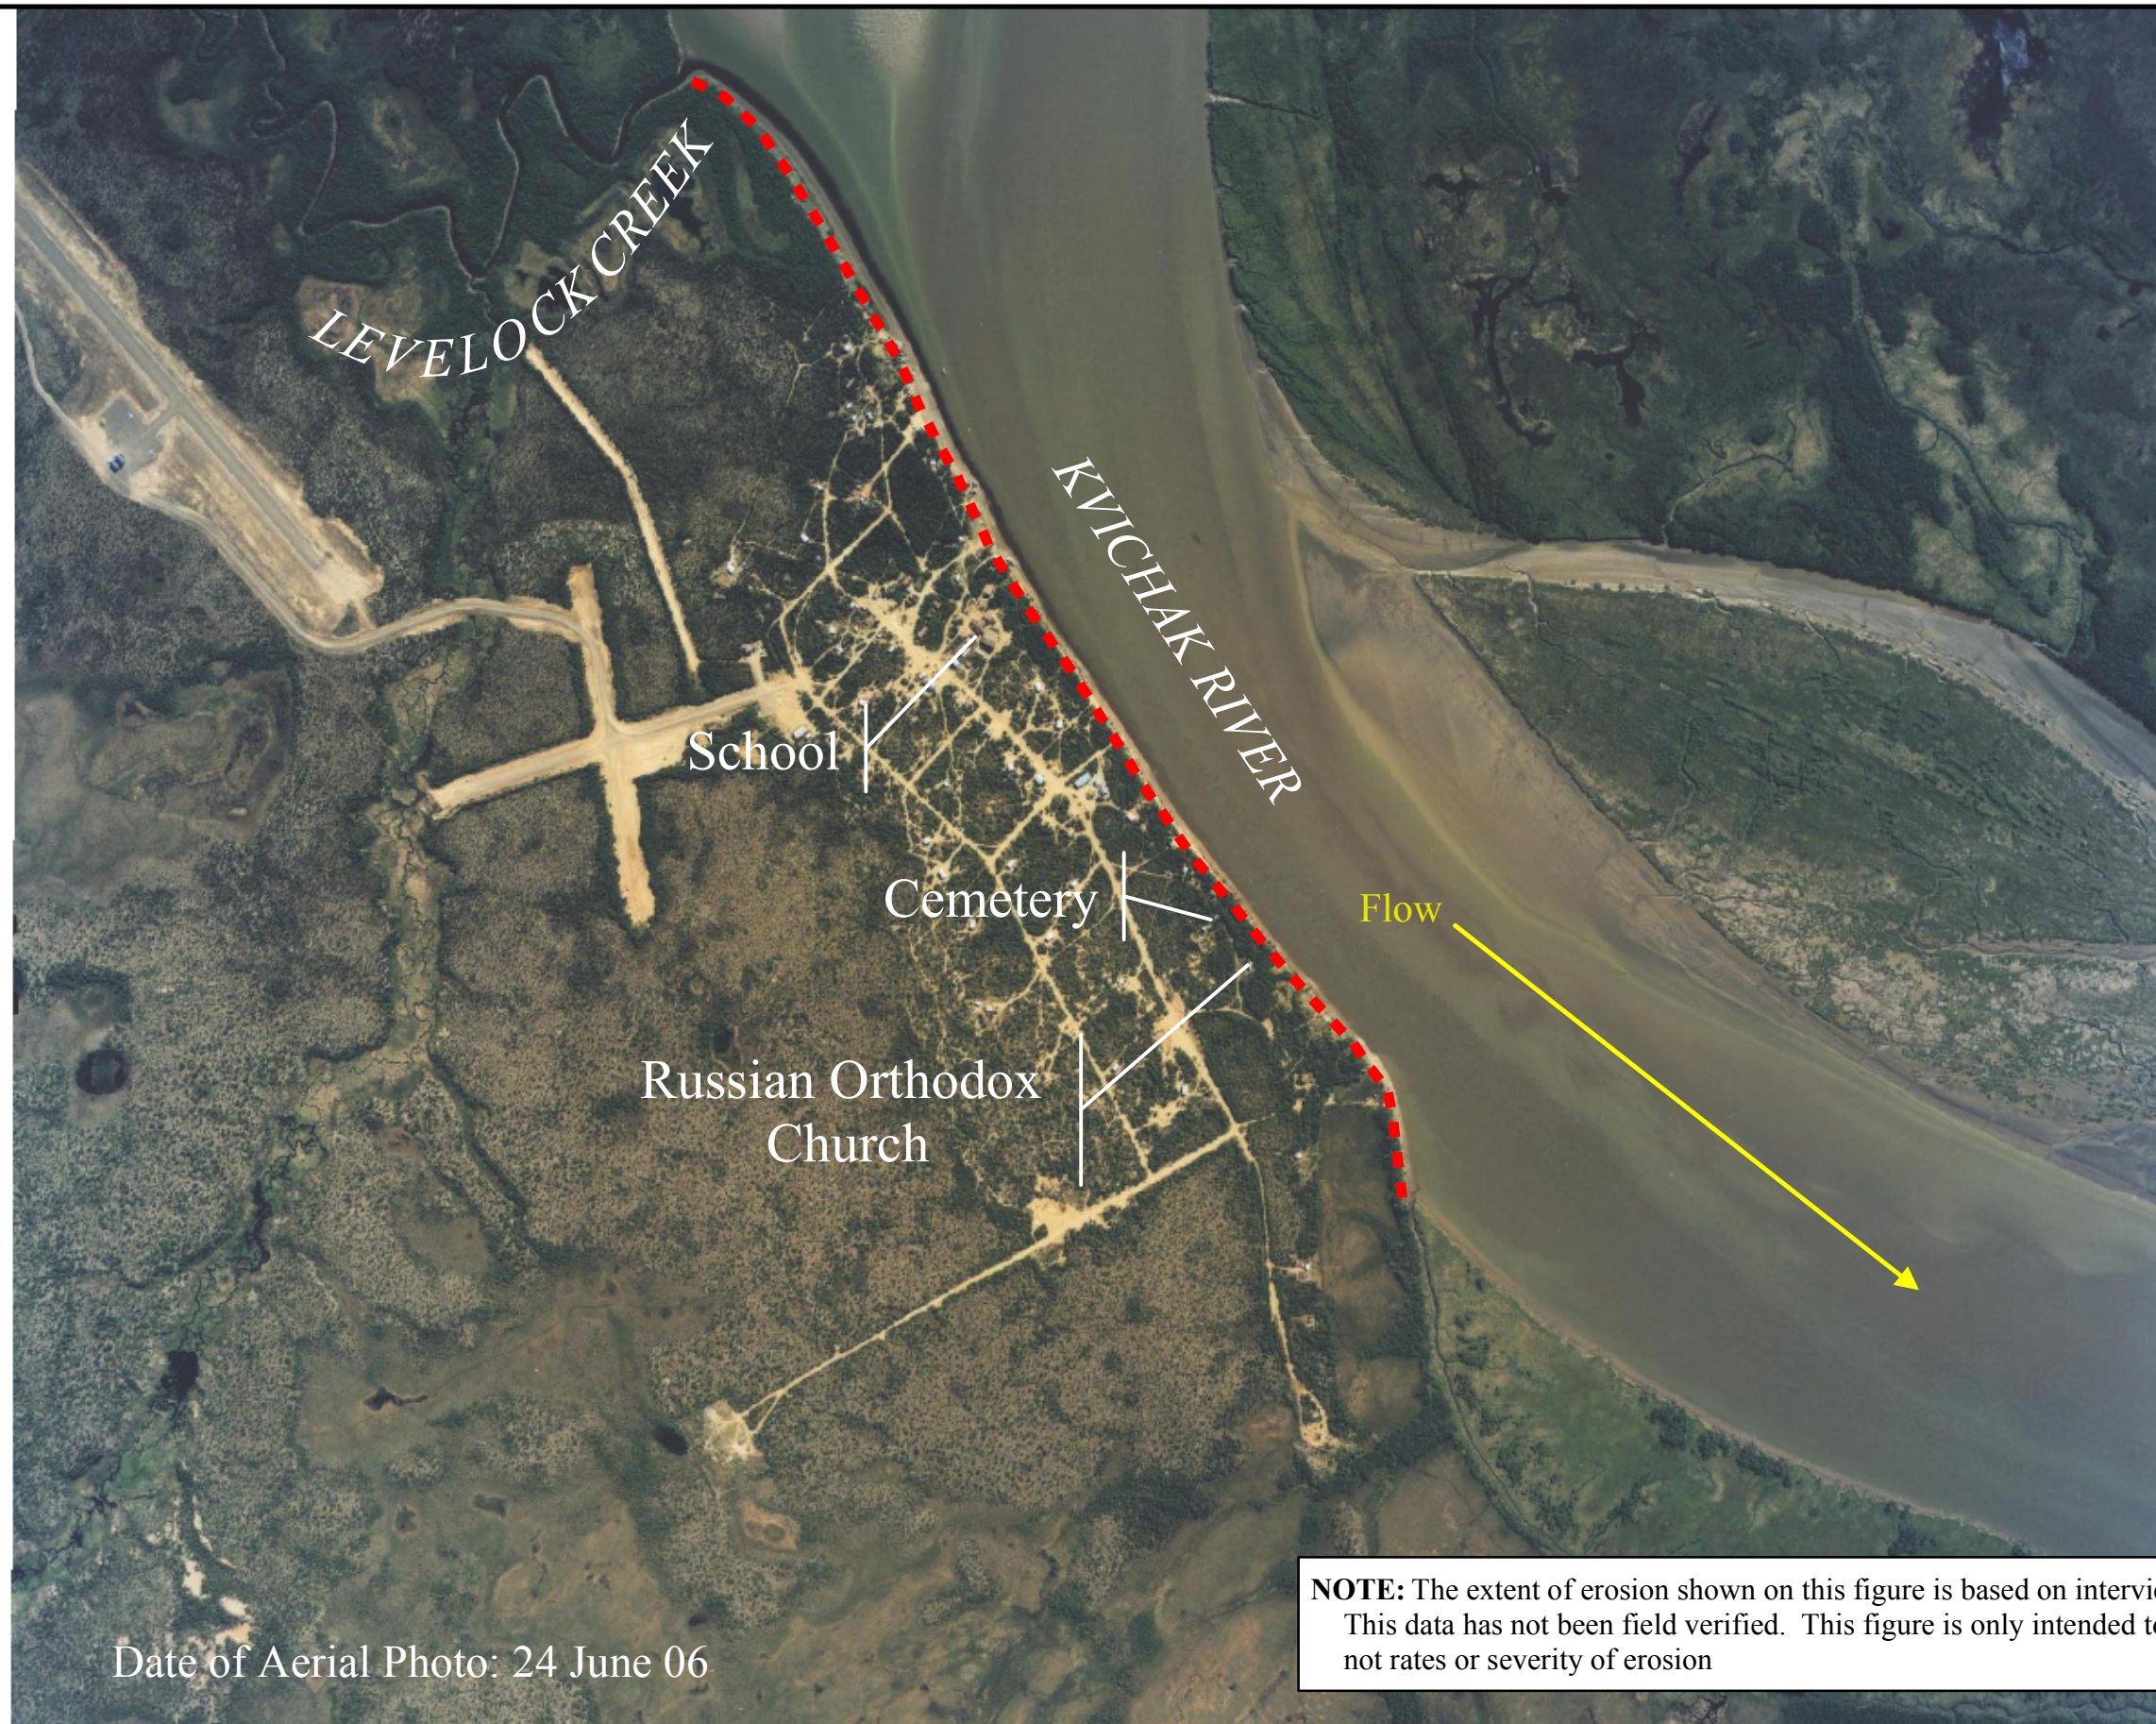
--- Linear Extent of Erosion

A portion of Levelock is flooded about once every 10 years. Primary causes of erosion are high tides and strong winds. In the 1980 record flood 6 homes were flooded and the dock was lost. Erosion associated with major events has not been measured. The community reports that every fall when big storms come in they can lose 1 to 3 feet of bank. Within the last 20 years approximately 30 to 40 feet of riverbank was lost.
