ALASKA BASELINE EROSION ASSESSMENT

Erosion Information Paper - Lime Village, Alaska

Current as of January 22, 2008

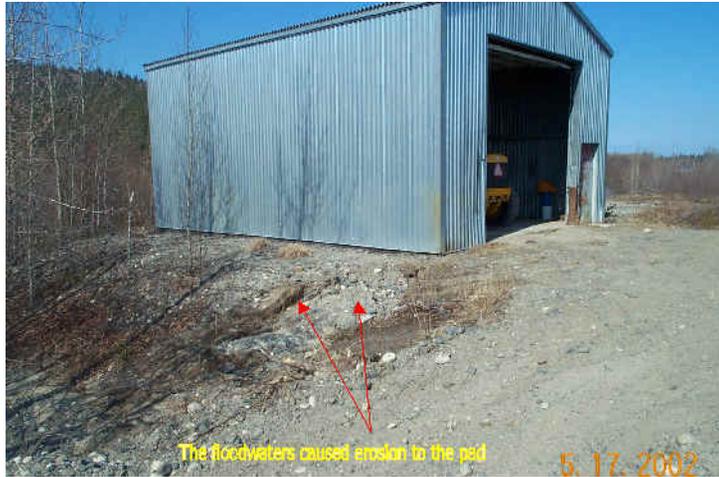
Photo 1: Airport maintenance shop building pad erosion, May 17, 2002.

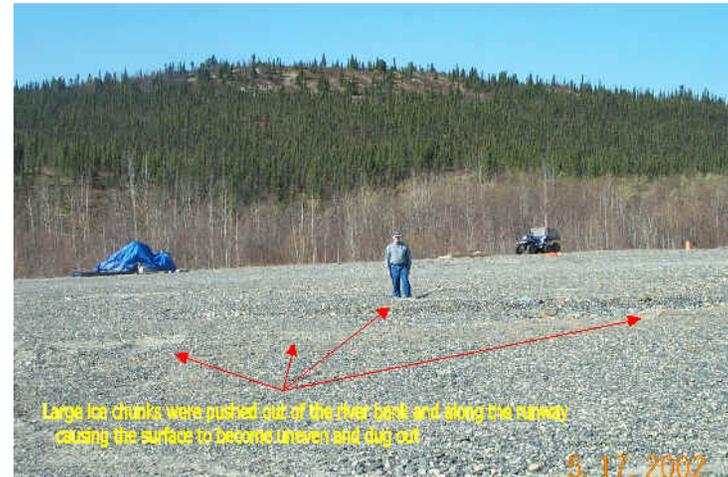
Photo 2: During the spring break up 2002 flood, large chunks of ice caused erosion of the gravel airport surface, May 17, 2002.

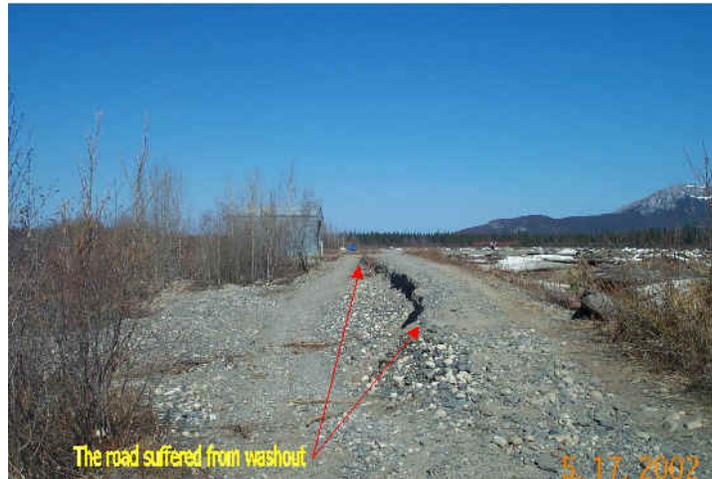
Photo 3: The airport access road erosion damage, May 17, 2002.

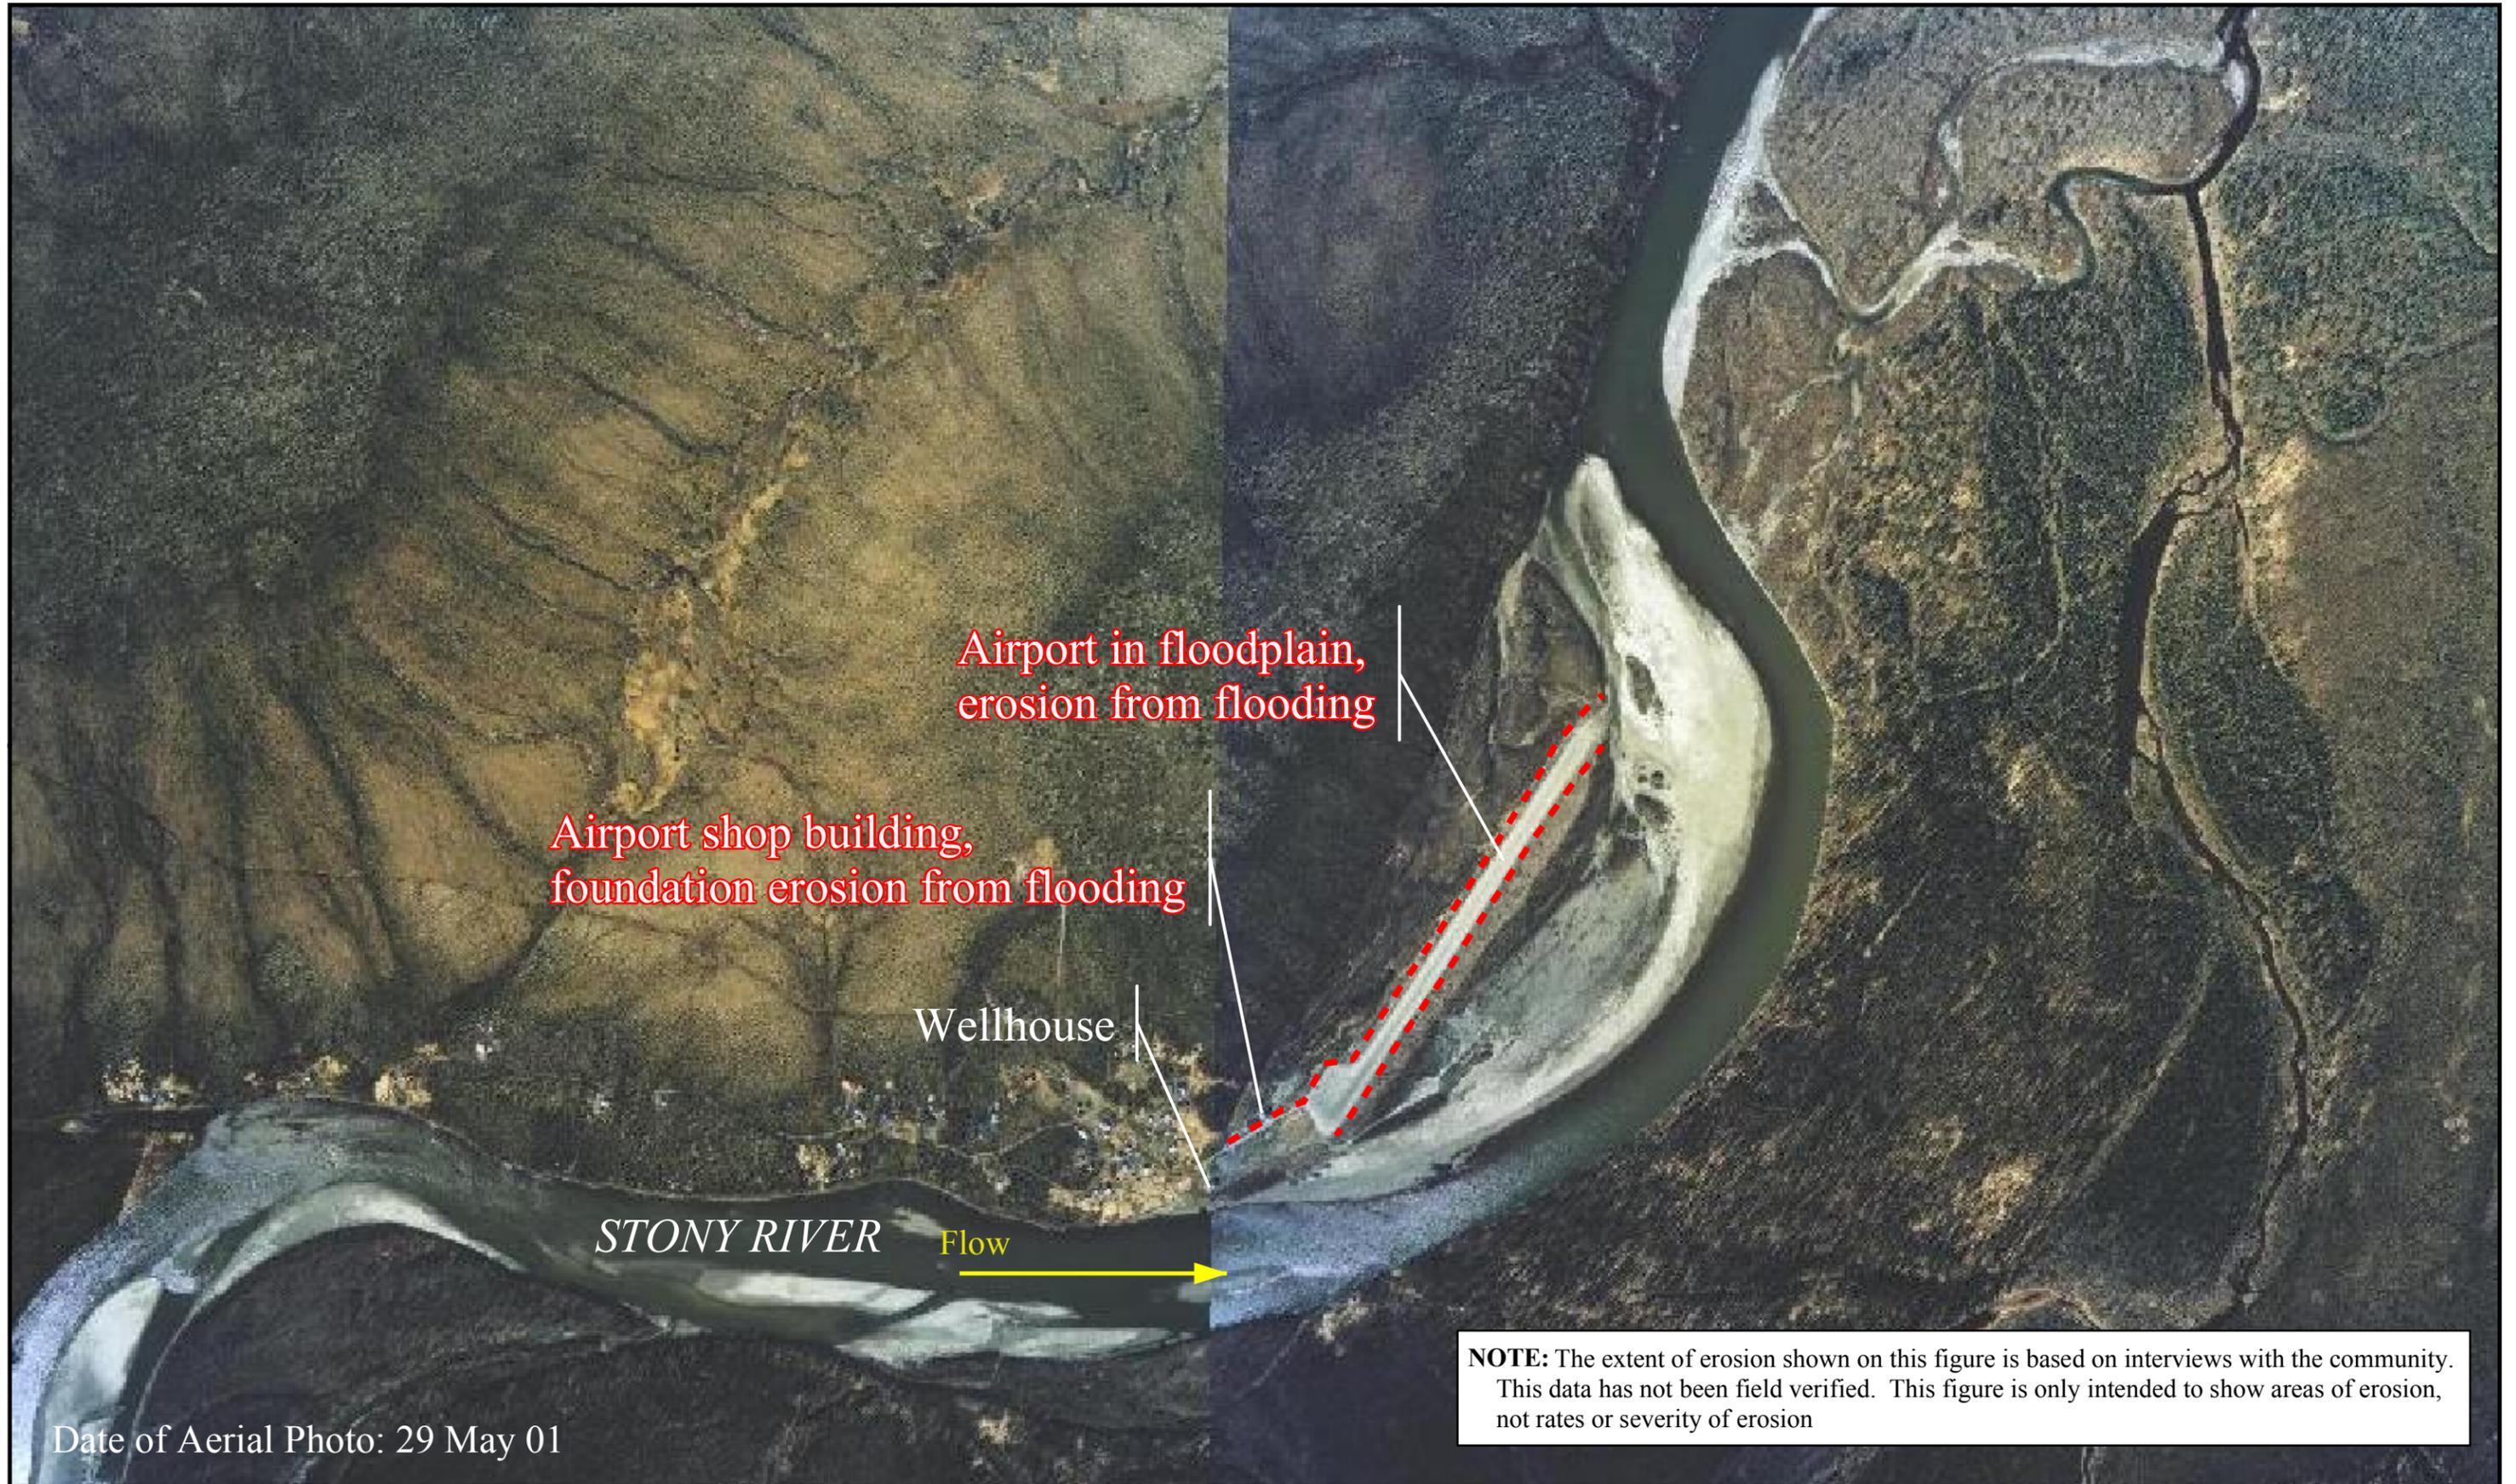
Alaska Baseline Erosion
Lime Village, Alaska

Ice jams along Stony River push water and ice into the community airport area during spring break up. This area has the lowest topographic elevation in the vicinity and is within the floodplain of the river. The airport access road, the fill material supporting the apron and runway, and the Alaska Department of Transportation and Public Facilities (DOT&PF) airport maintenance building have been damaged during past break up events due to periodic intrusions of water and ice. Fixed wing aircraft could not provide access to the community until the runway and facilities were restored during one of the 8 break-ups in the last 20 years that resulted in considerable erosion. Most of the Stony River bank adjacent to the community is stable and somewhat protected by natural rocks with some locations subject to under-cutting where the bank then sloughs into the river and is carried away. The under-cutting and sloughing is not a concern to the community.

Erosion is a threat to fuel tanks on the edge of the airport apron near the DOT&PF maintenance building. Fuel lines between the tanks, the generator building, and the school are threatened by periodic erosion in the floodplain. No protective measures have been attempted. The remainder of the community infrastructure is reported to be in no danger from erosion.
