## ***ALASKA BASELINE EROSION ASSESSMENT***

# **Erosion Information Paper – Municipality of Anchorage, Alaska**

Current as of October 10, 2007

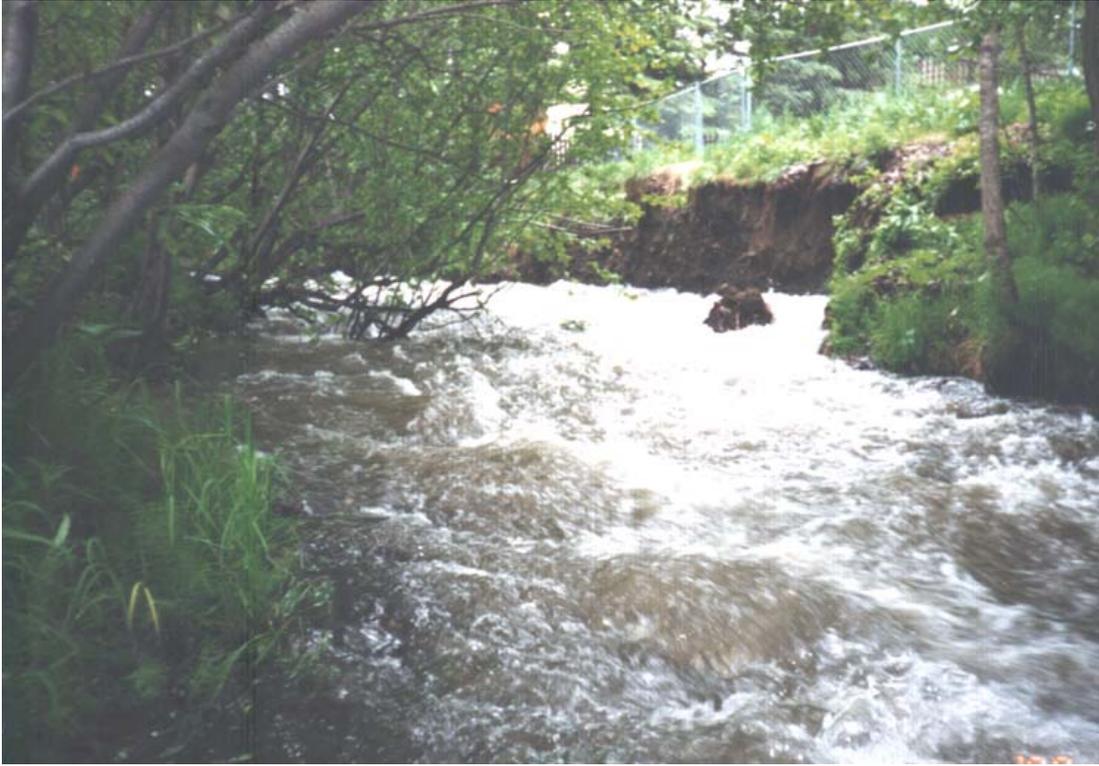
**Photo 1: Meadow Creek, no date.**

At Wickersham Park and Dimond Drive, electrical poles and gas line were relocated to prevent loss from erosion. The Meadow Creek Subdivision on Meadow Creek in Eagle River was platted with lot lines encroaching on and crossing the stream corridor in many locations. Meadow Creek between Eagle River Loop Road and Old Glenn Highway has eroded within 15 feet of several homes in the Meadow Creek Subdivision.

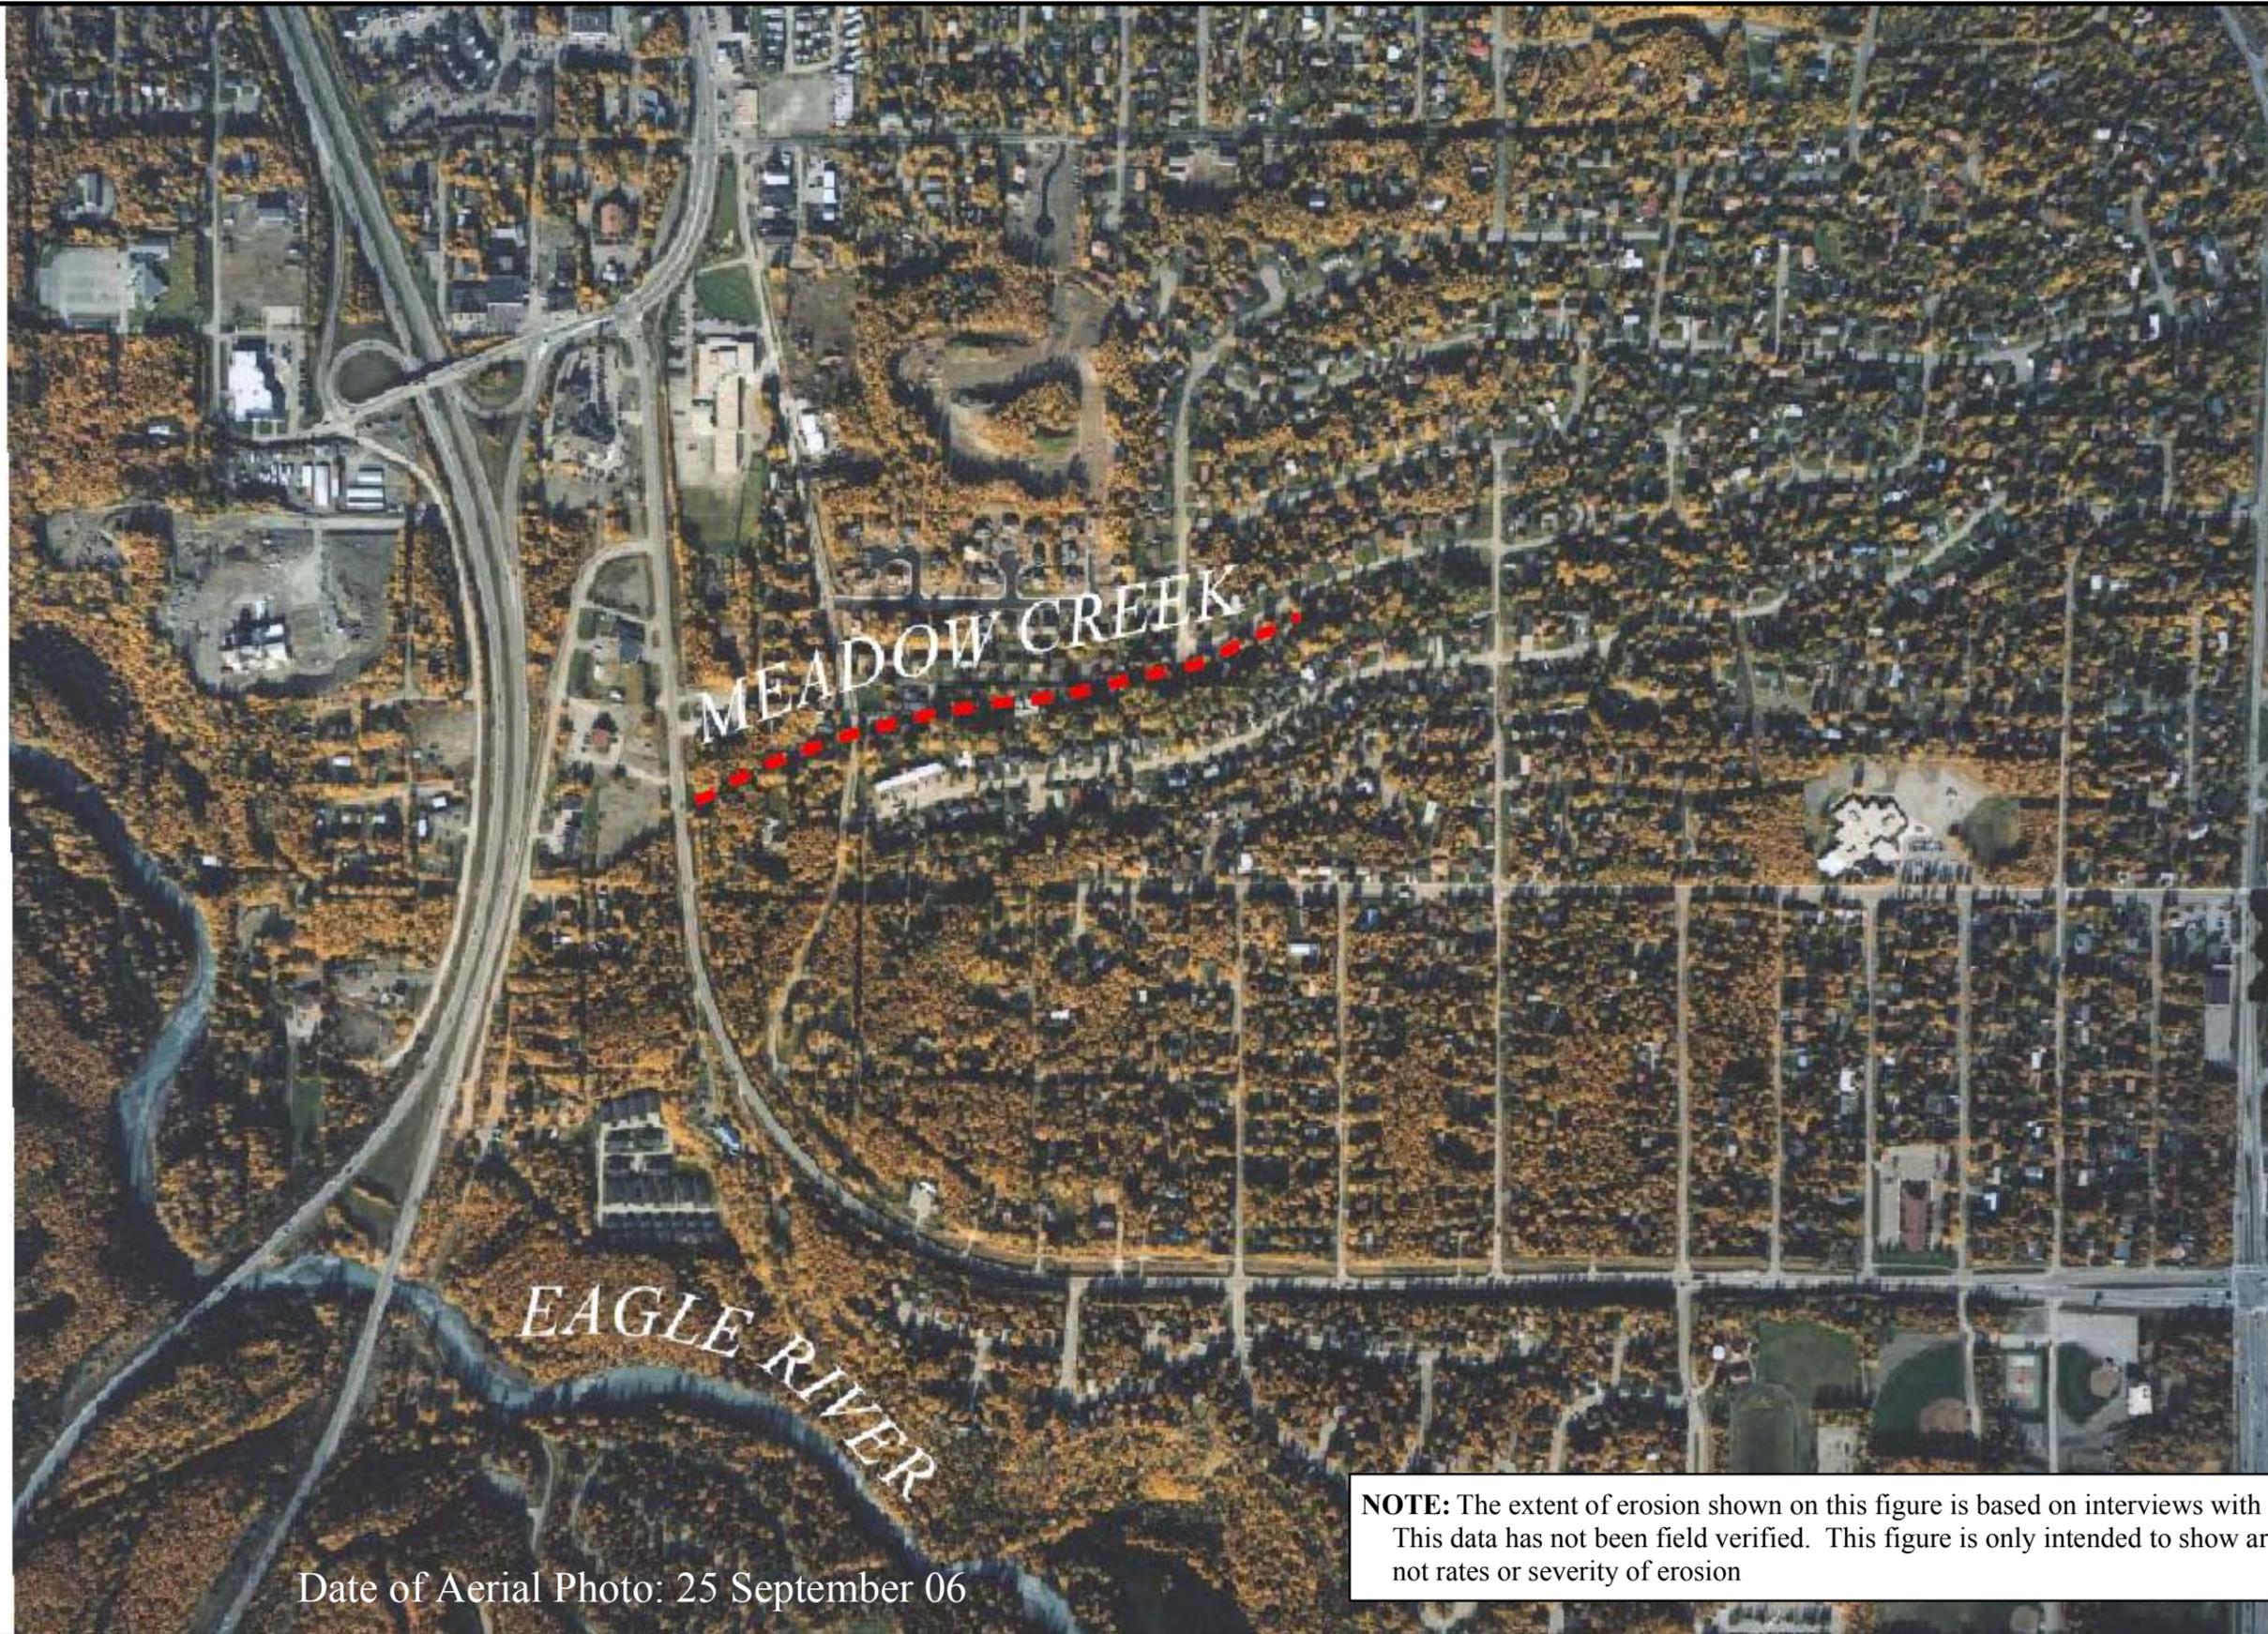
Alaska Baseline Erosion  
Eagle River, Alaska

Photos of erosion provided by the MOA watershed management division are attached. The attached diagram depicts the linear extent of erosion along Meadow Creek in Eagle River.
