U.S. Army Corps
of Engineers
Alaska District

ALASKA BASELINE EROSION ASSESSMENT

Erosion Information Paper - Manley Hot Springs, Alaska

Current as of February 4, 2008

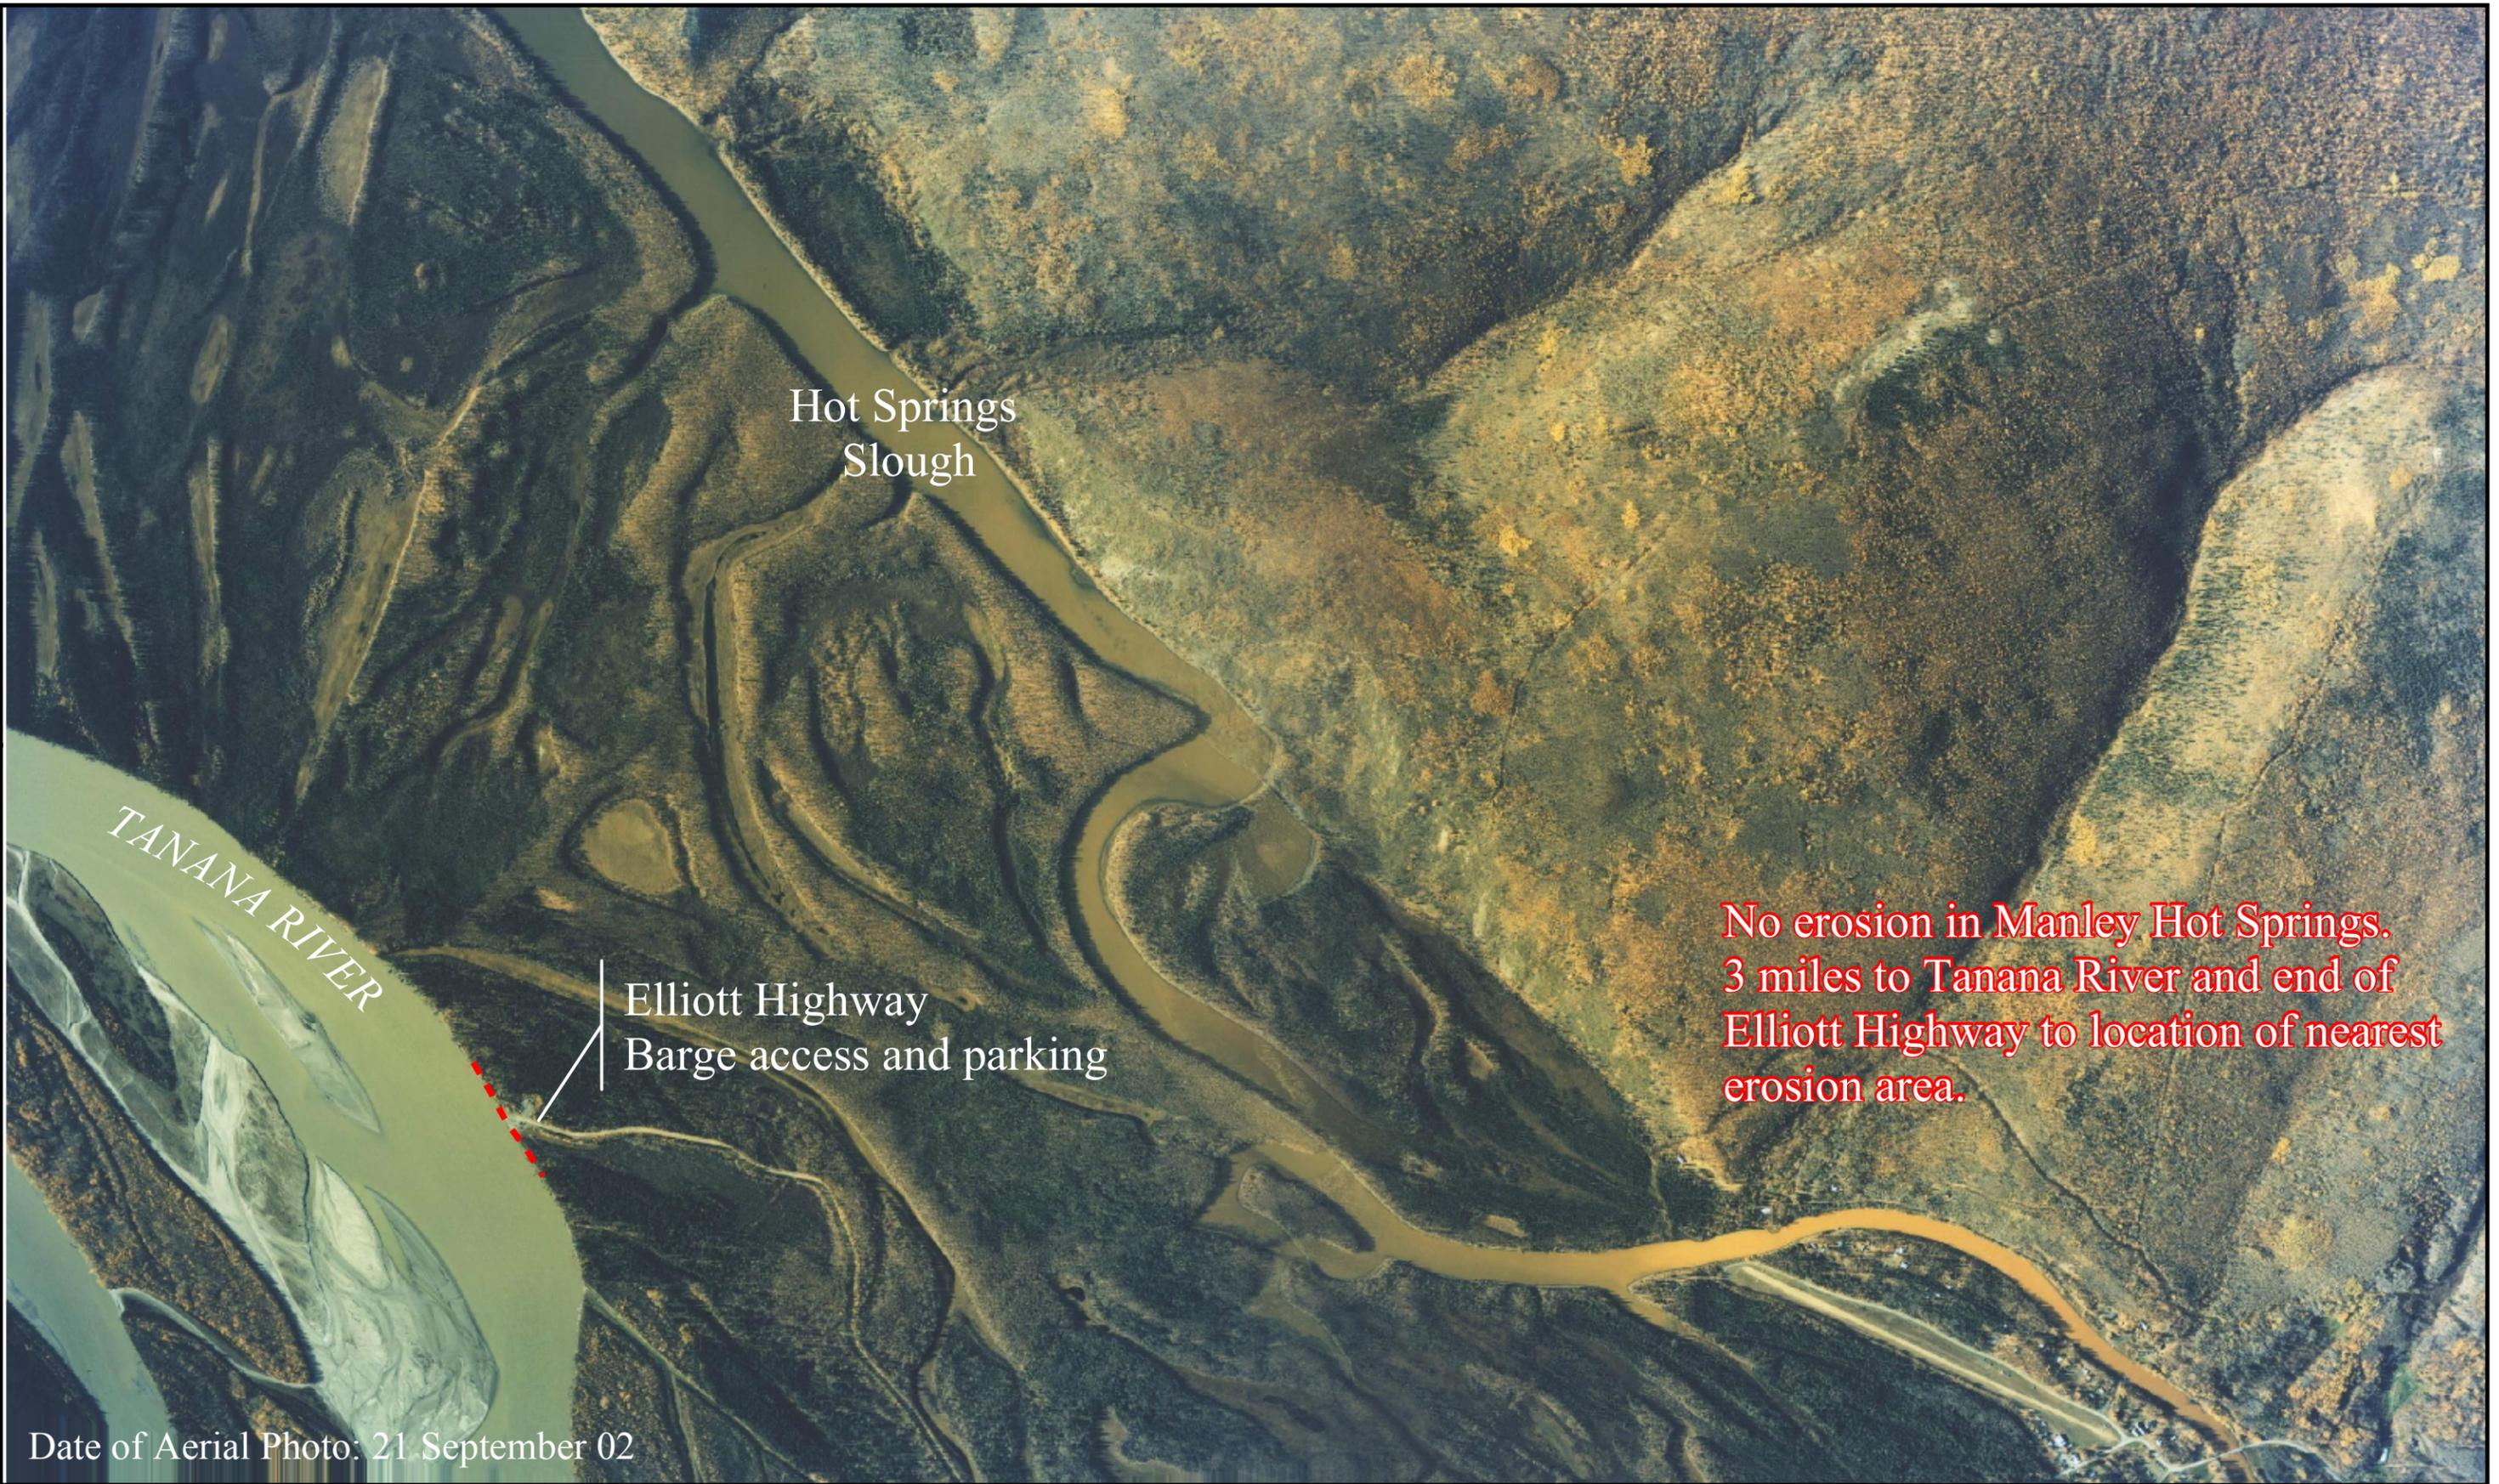
Alaska Baseline Erosion
Manley Hot Springs, Alaska

In the erosion survey the community reported there are no erosion problem areas along Hot Springs Slough and the only significant erosion occurs periodically at the end of the Elliott Highway where it terminates at the Tanana River, approximately 3 miles south of the community development. Conditions causing and contributing to the erosion include seasonal fluctuations in river flows and water levels, and ice movements associated with spring break up. It was estimated by the community that the length of the area eroding at the end of the highway is approximately 10,000 feet long and the bank is approximately 10 feet high. No major erosion events were reported to have occurred in the last 20 years. The erosion was described as ongoing at an estimated rate of 20 feet a year inland.

No photos were provided by community or other sources. The attached diagram depicts the linear extent of erosion.
