U.S. Army Corps
of Engineers
Alaska District

ALASKA BASELINE EROSION ASSESSMENT

Erosion Information Paper - Mekoryuk, Alaska

Current as of January, 2008

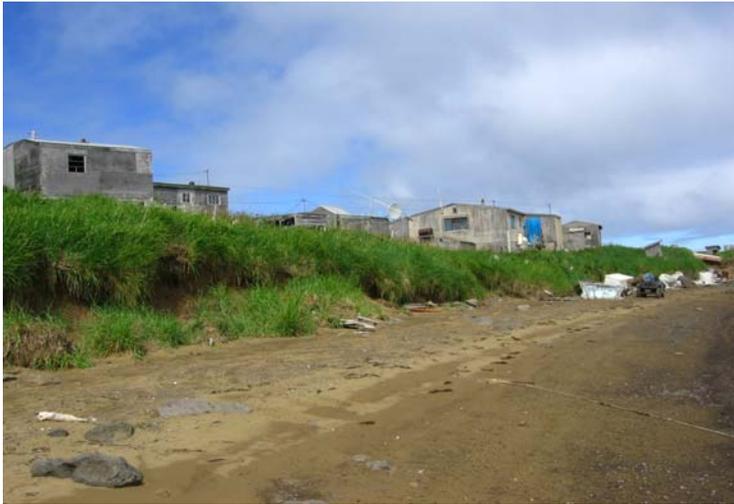
Photo 1: Proximity of Mekoryuk home to eroding shoreline, August 2007.

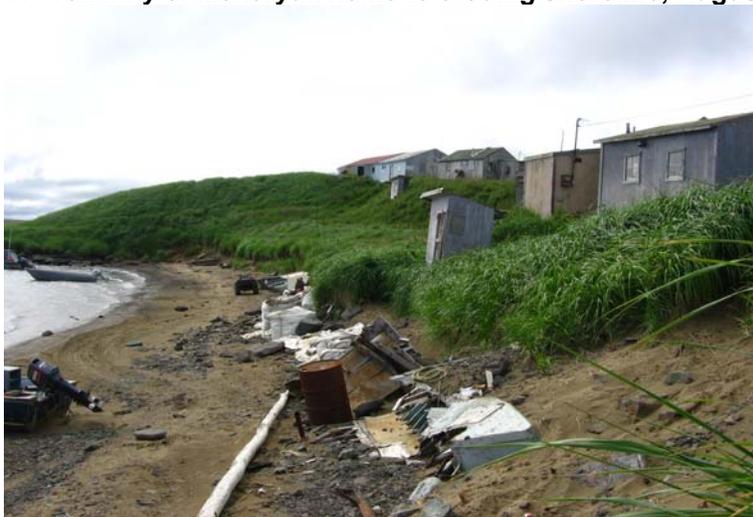
Photo 2: Mekoryuk shoreline erosion, August 2007.

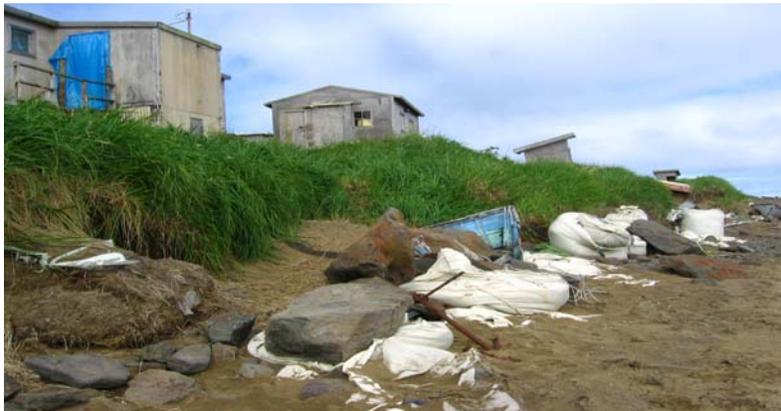
In addition to erosion protection from the breakwater, the Corps is reported to have provided sandbags at a cost of \$1,000. The sandbags have been destroyed by erosion and there have been no reported repair or maintenance costs.

Photo 3: Sandbags for erosion protection front a small portion of Mekoryuk, August 2007.

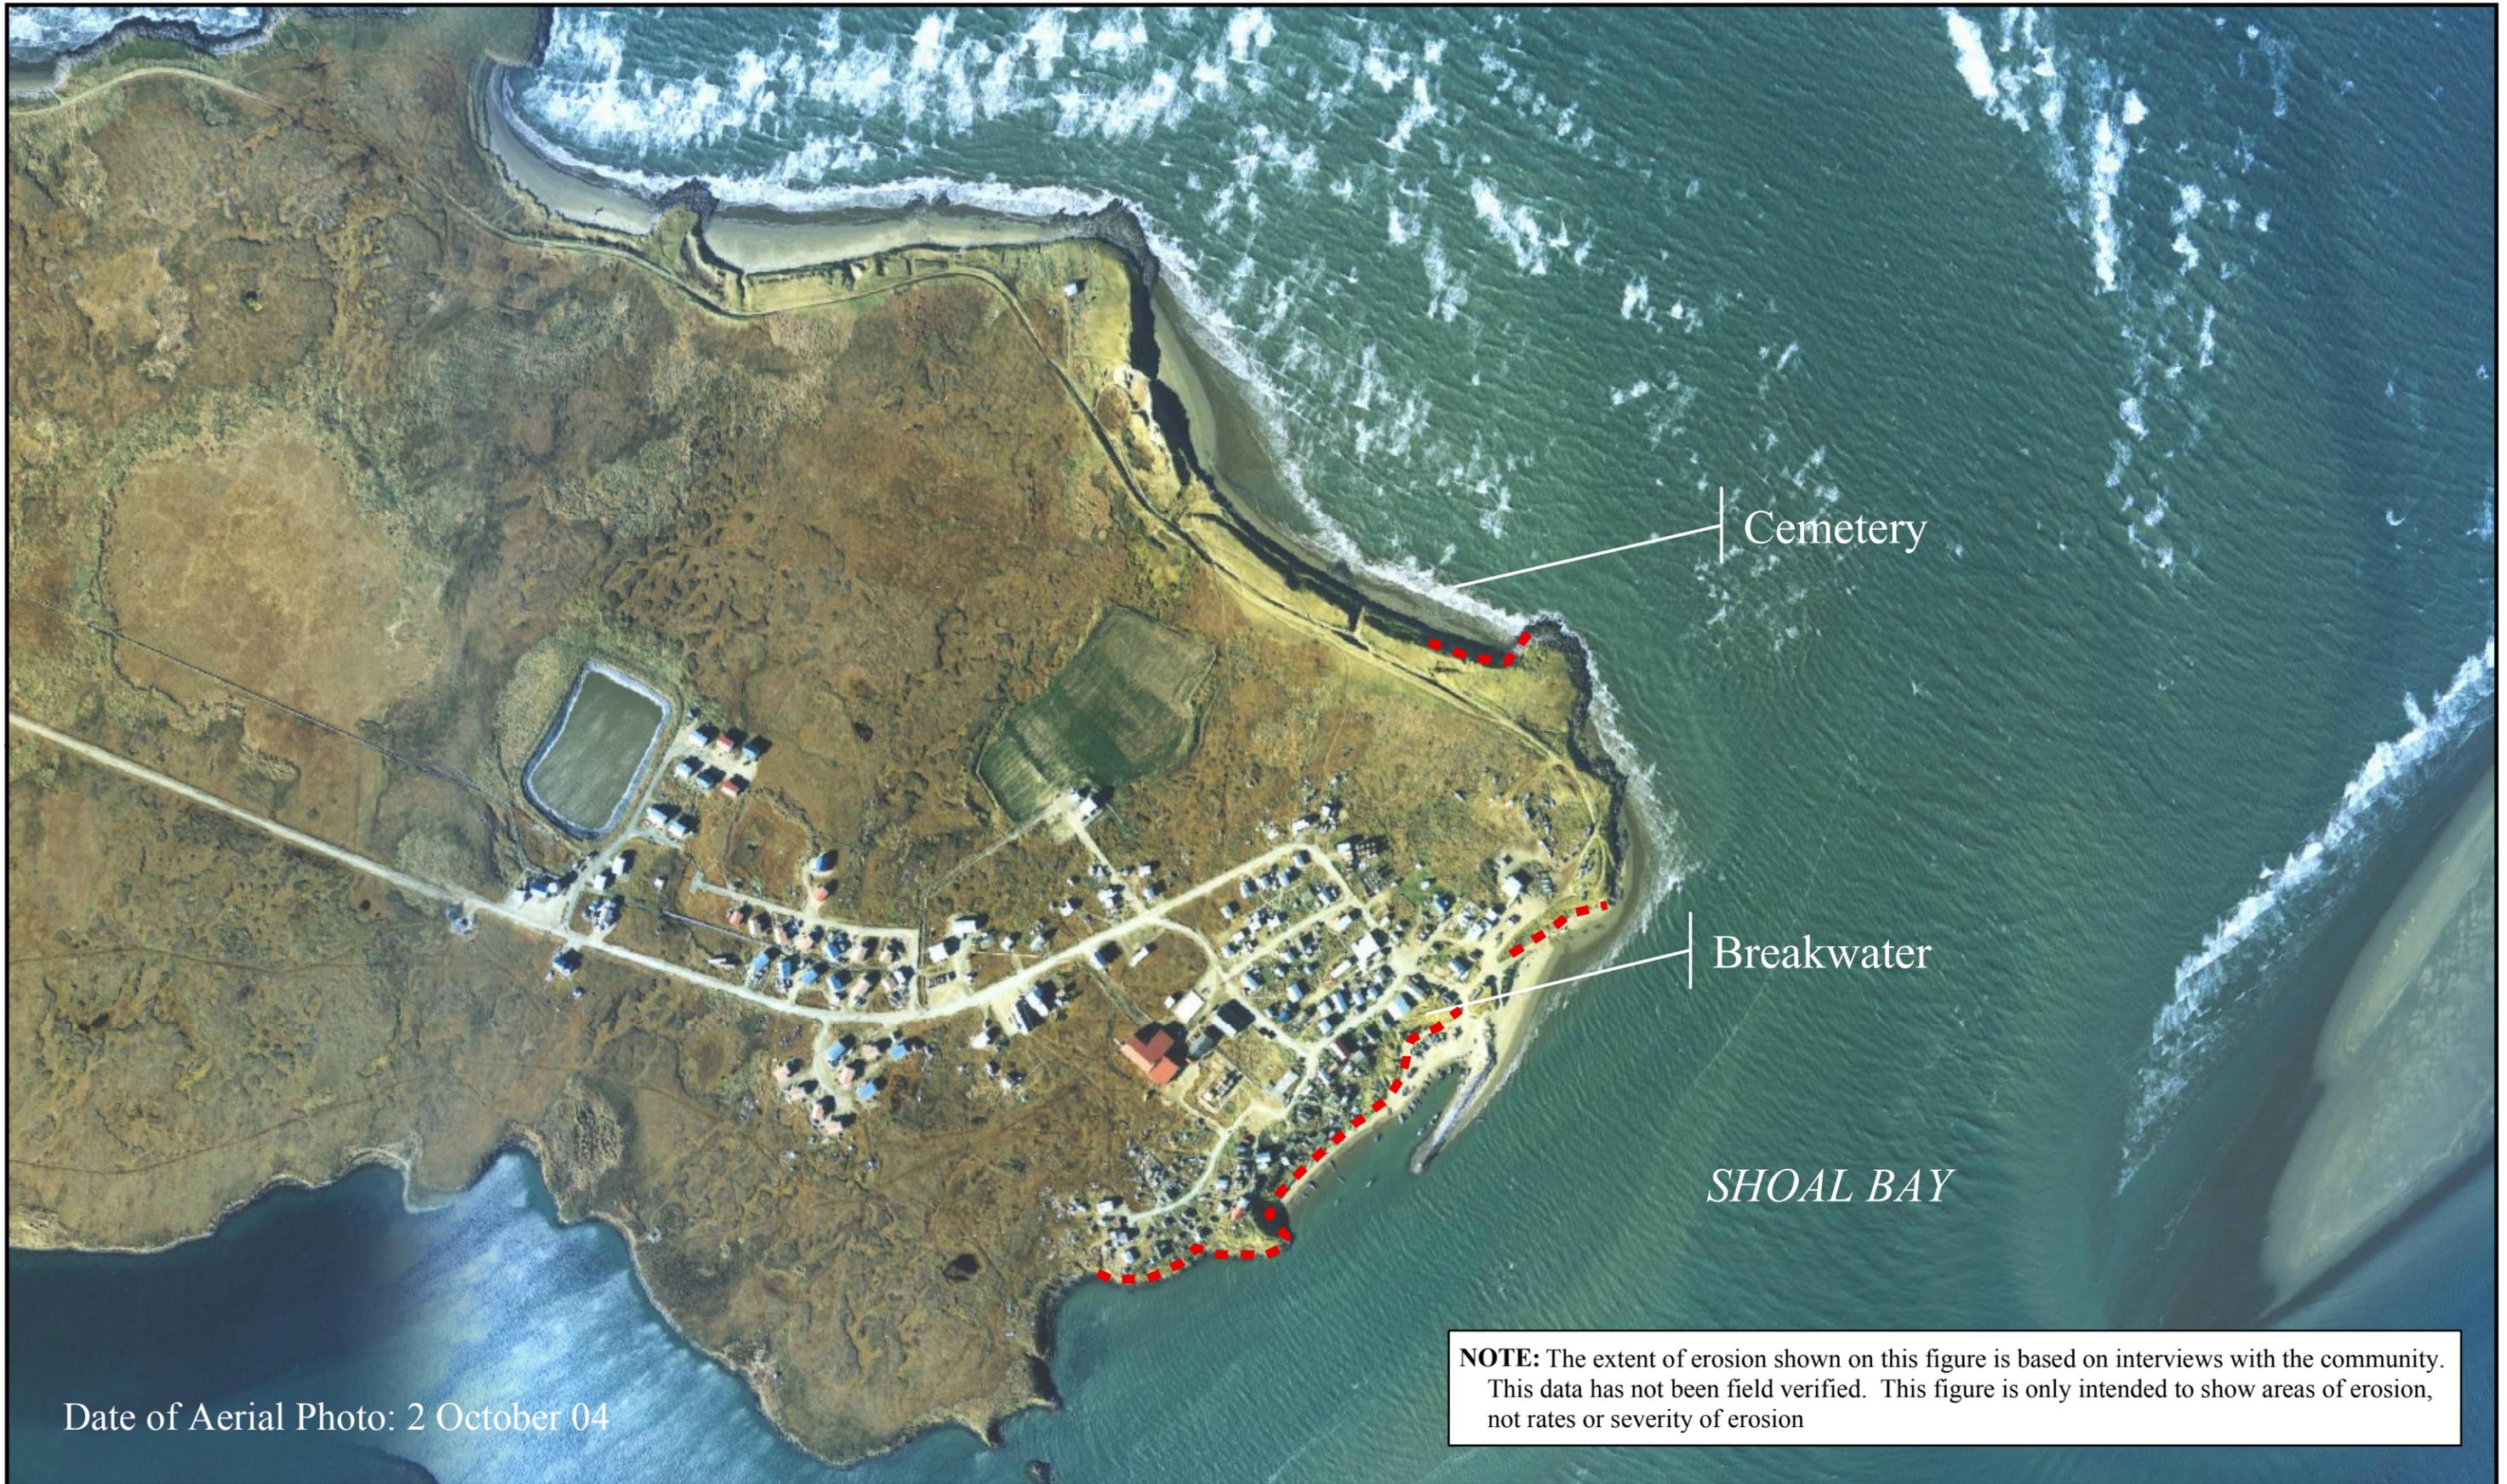
Alaska Baseline Erosion
Mekoryuk, Alaska

--- Linear Extent of Erosion
