U.S. Army Corps
of Engineers
Alaska District

ALASKA BASELINE EROSION ASSESSMENT

Erosion Information Paper - Nanwalek, Alaska

Current as of June 2, 2008

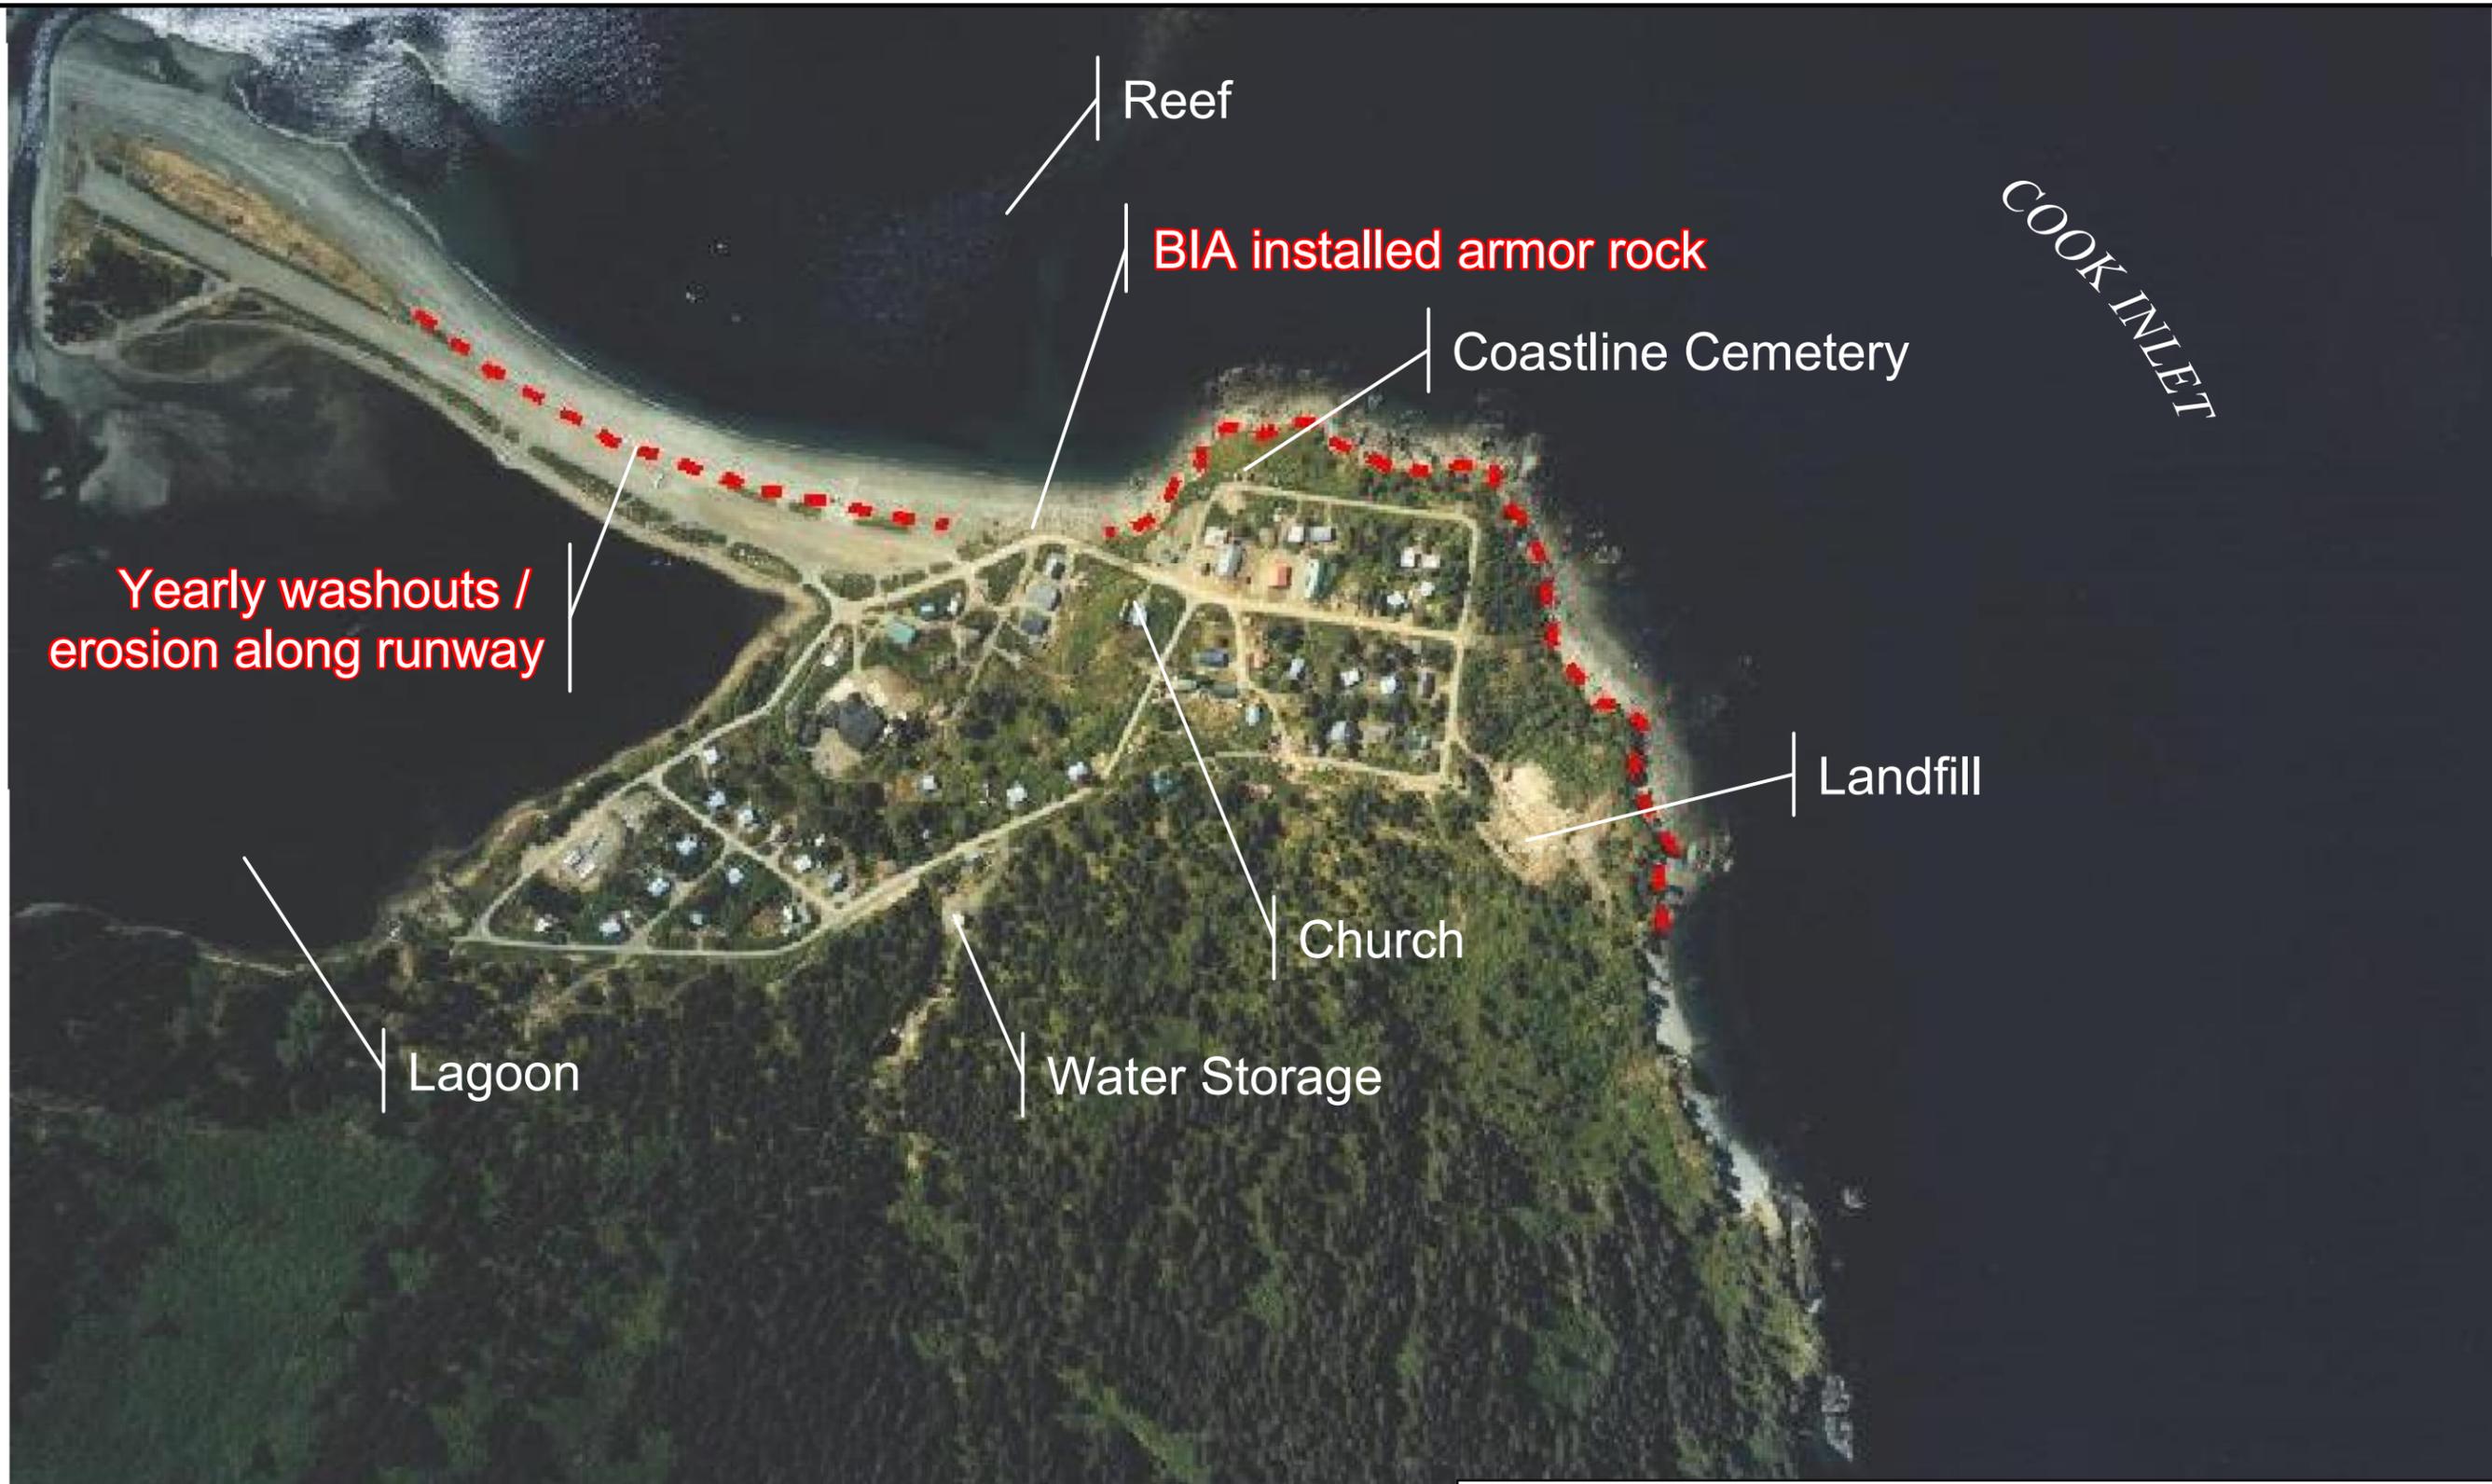
Nanwalek is on an exposed coastline in lower Cook Inlet. High tides, storm surges, wind and waves erode the spit separating English Bay Lagoon from Cook Inlet and high bluffs that rise 20 to 50 feet above the inlet. The bluffs are eroding at an estimated rate of 1 to 2 feet per year. The spit is eroded by winter storms.

No photos of erosion were provided by community or other sources. The attached diagram shows linear extent of erosion.
