## **ALASKA BASELINE EROSION ASSESSMENT**

### **Erosion Information Paper - Noorvik, Alaska**

Current as of February 23, 2009

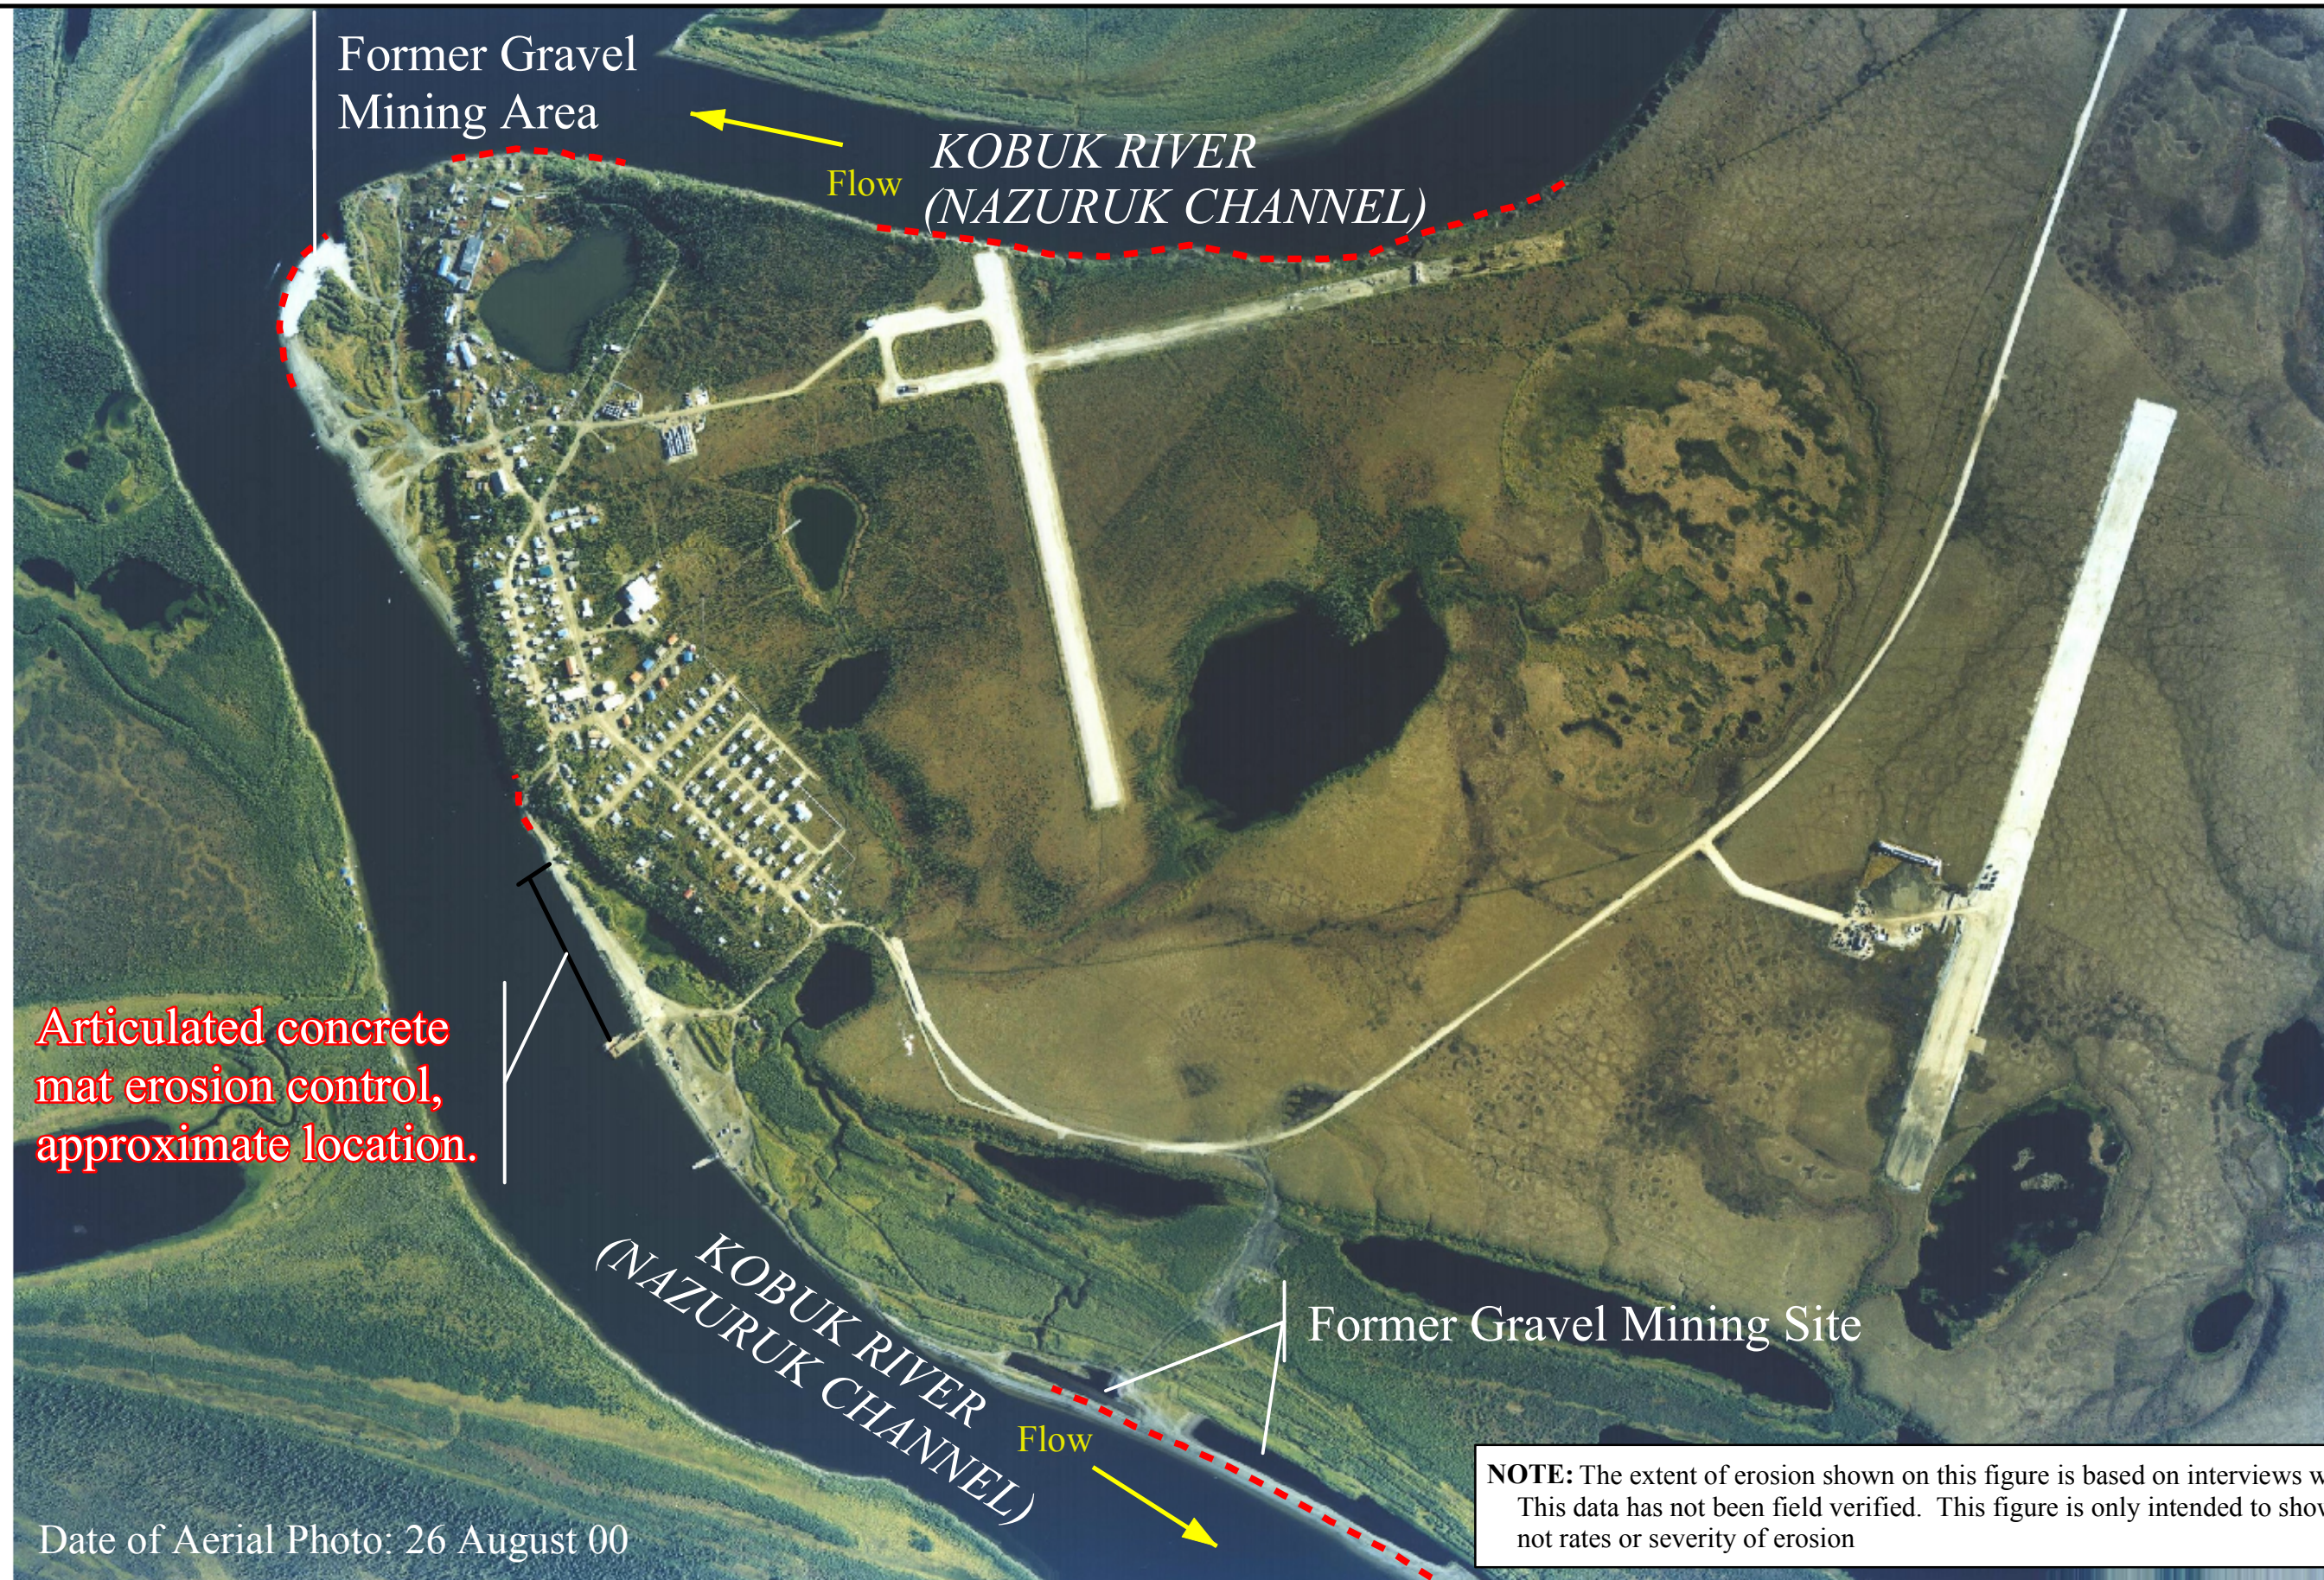
No photos were provided by the community or other sources. The attached diagram shows the approximate linear extent of erosion.
