U.S. Army Corps
of Engineers
Alaska District

ALASKA BASELINE EROSION ASSESSMENT

Erosion Information Paper – Northway, Alaska

Current as of March 3, 2008

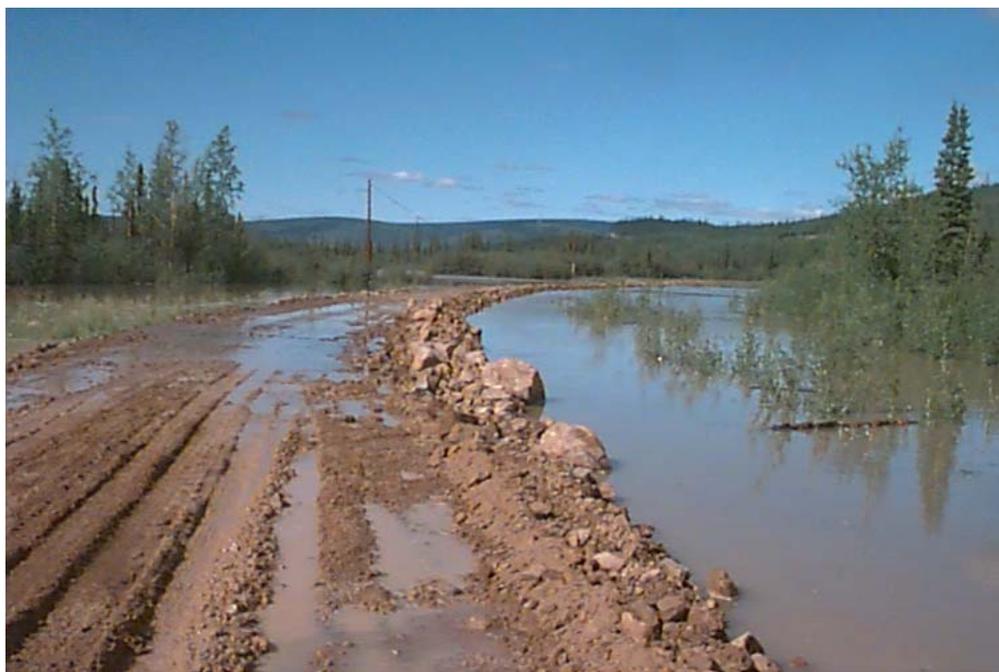
Photo 1: Northway area roads during 1998 flooding, photo courtesy of Michael L. Bird, November 2, 1998.

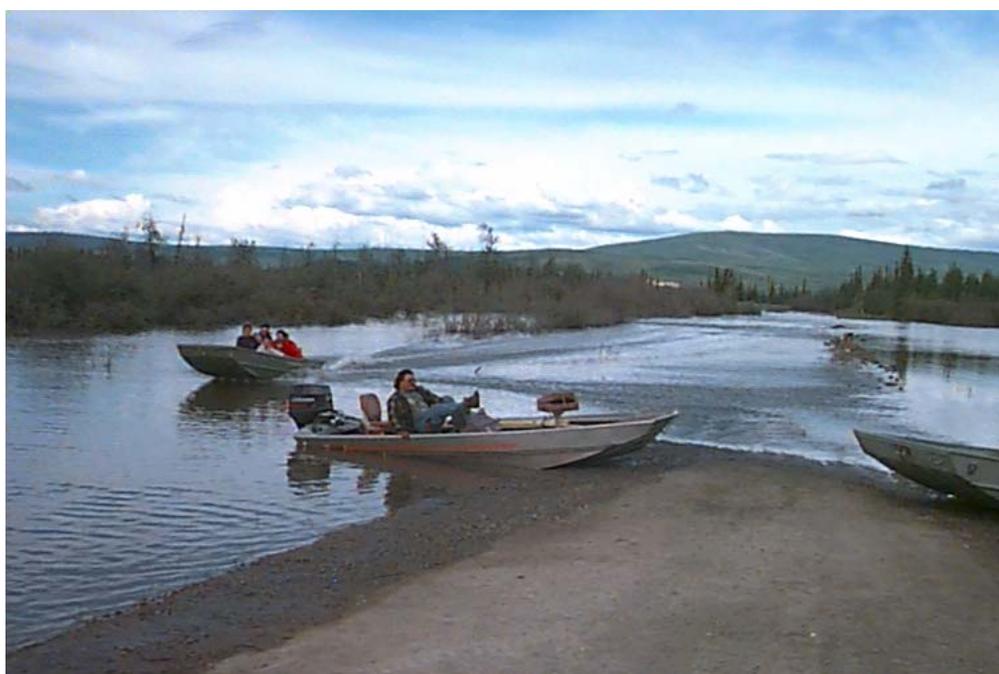
Photo 2: Skiffs were more efficient than the Northway area roads during 1998 high water, photo courtesy of Michael L. Bird, November 2, 1998.

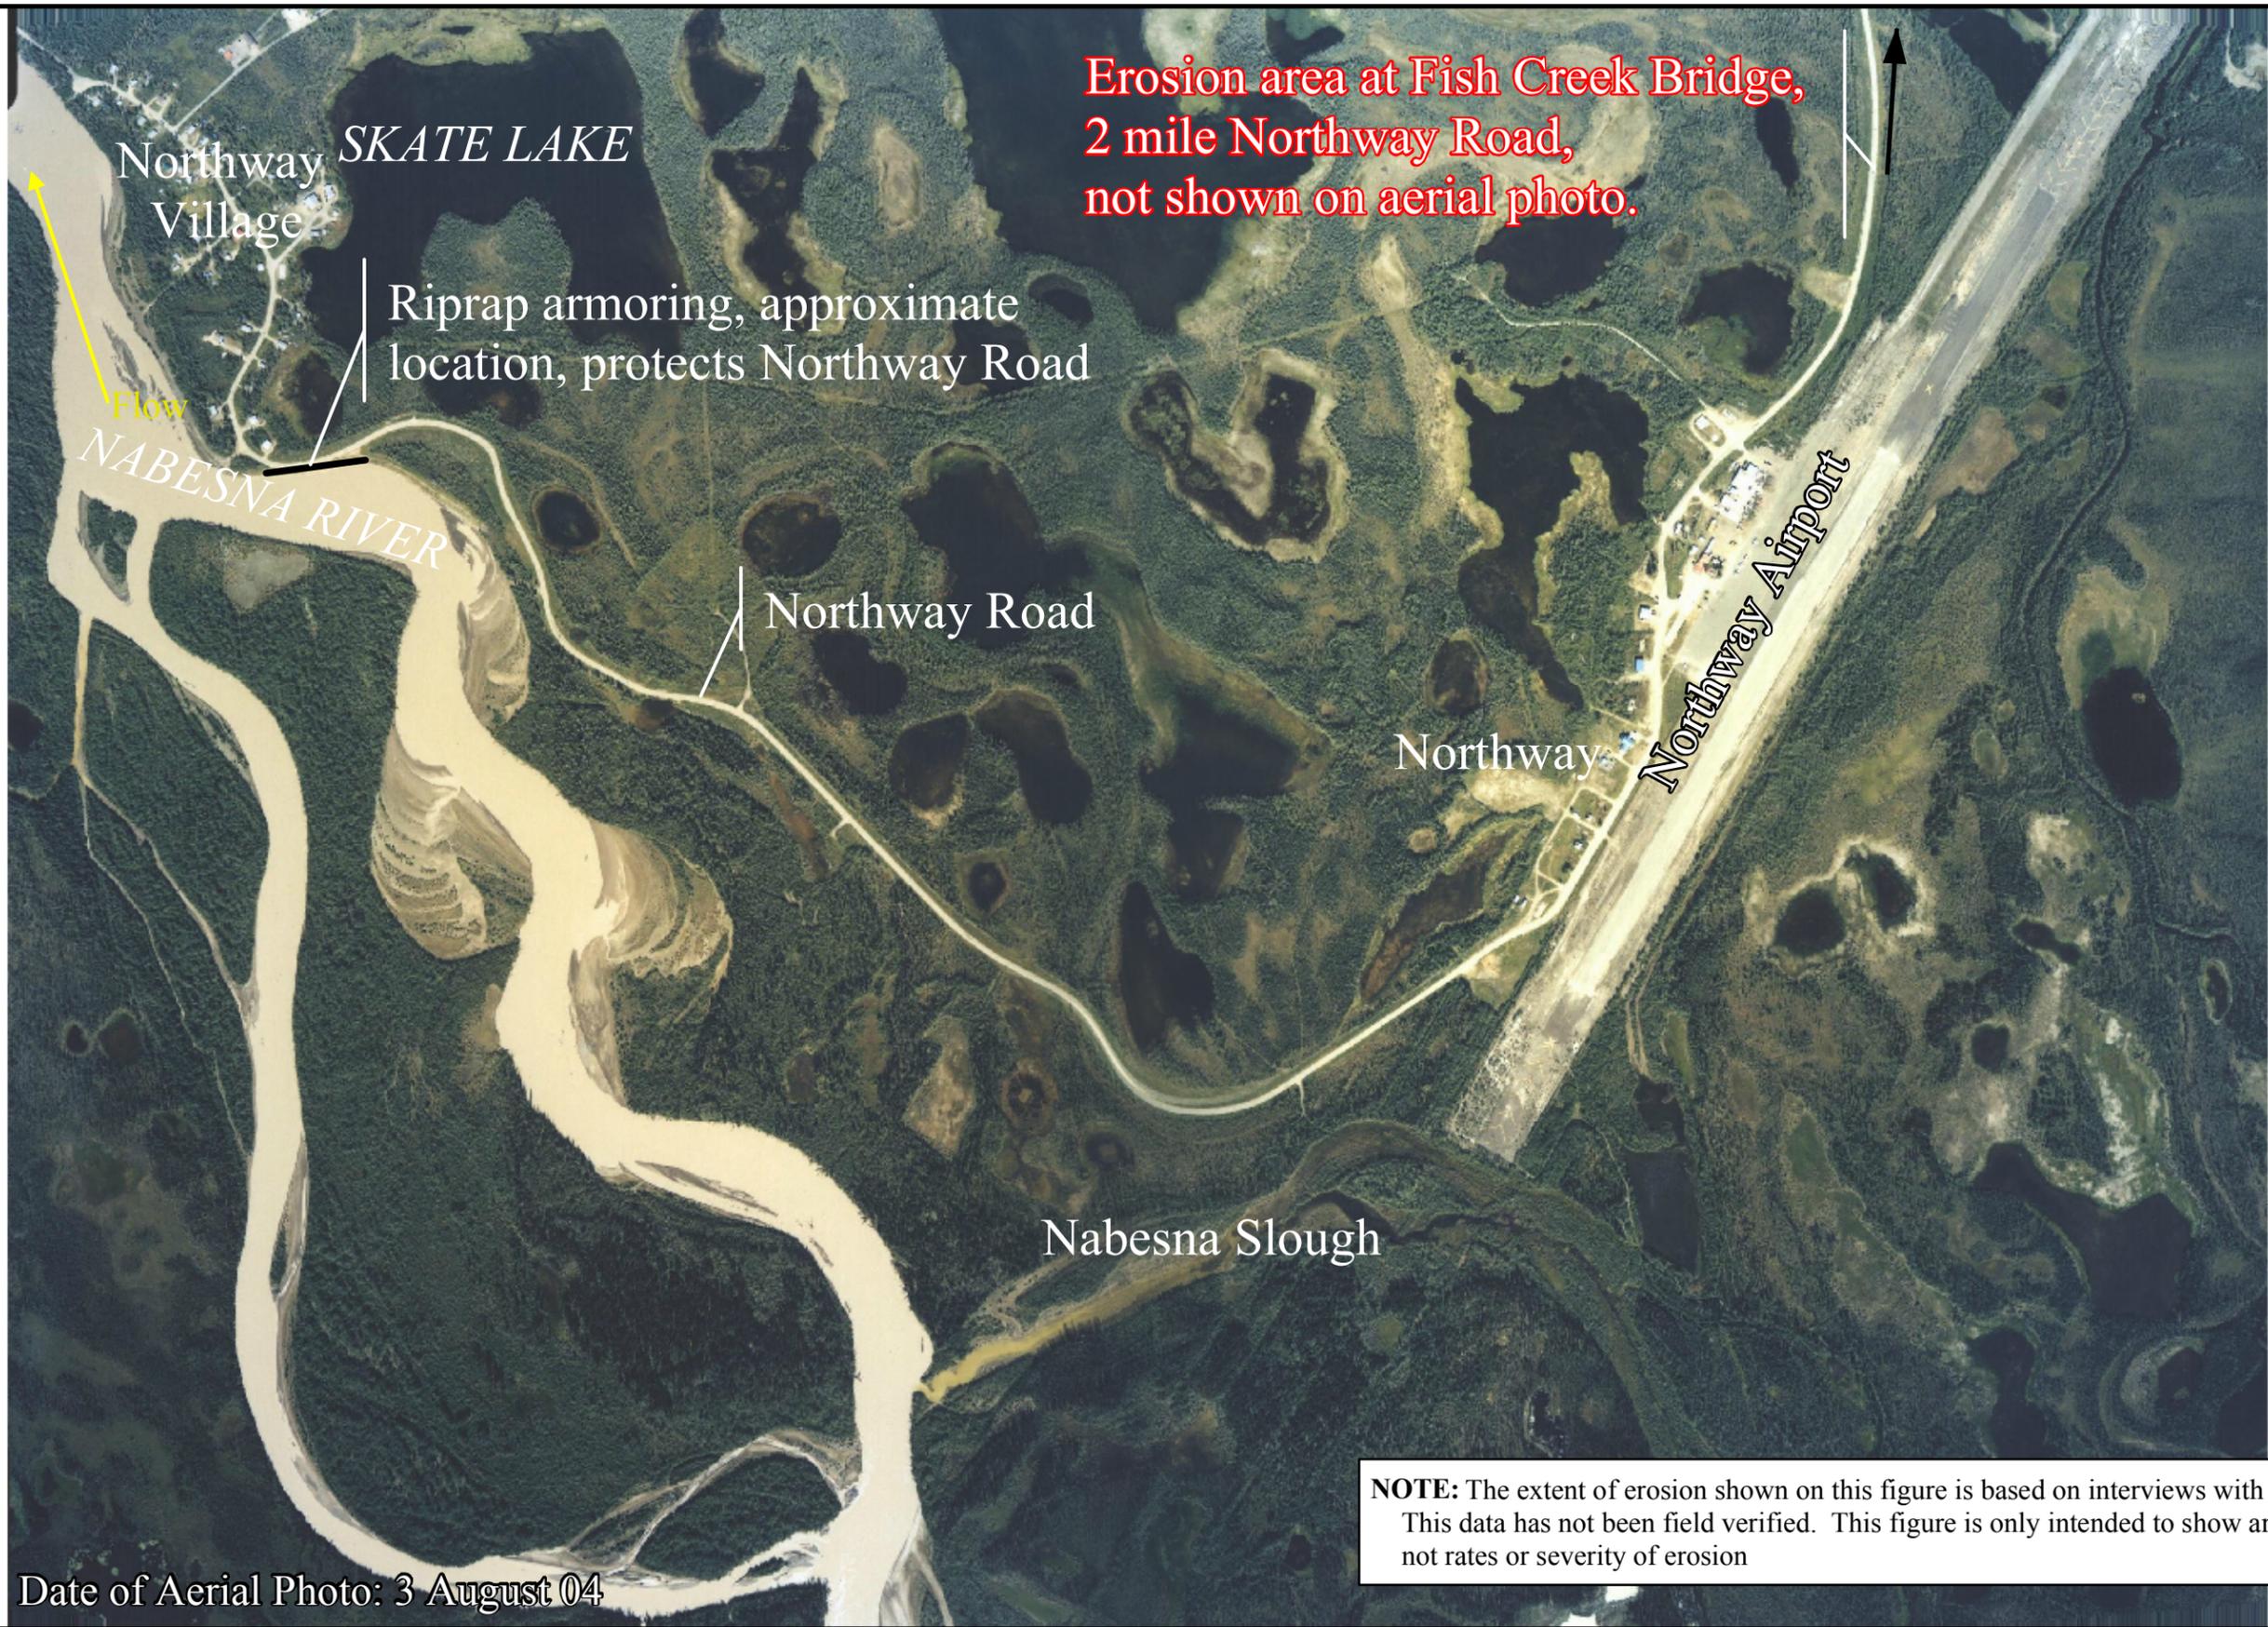
Alaska Baseline Erosion
Northway, Alaska

--- Linear Extent of Erosion
