ALASKA BASELINE EROSION ASSESSMENT

Erosion Information Paper - Nuiqsut, Alaska

Current as of February 23, 2009

Alaska Baseline Erosion
Nuiqsut, Alaska

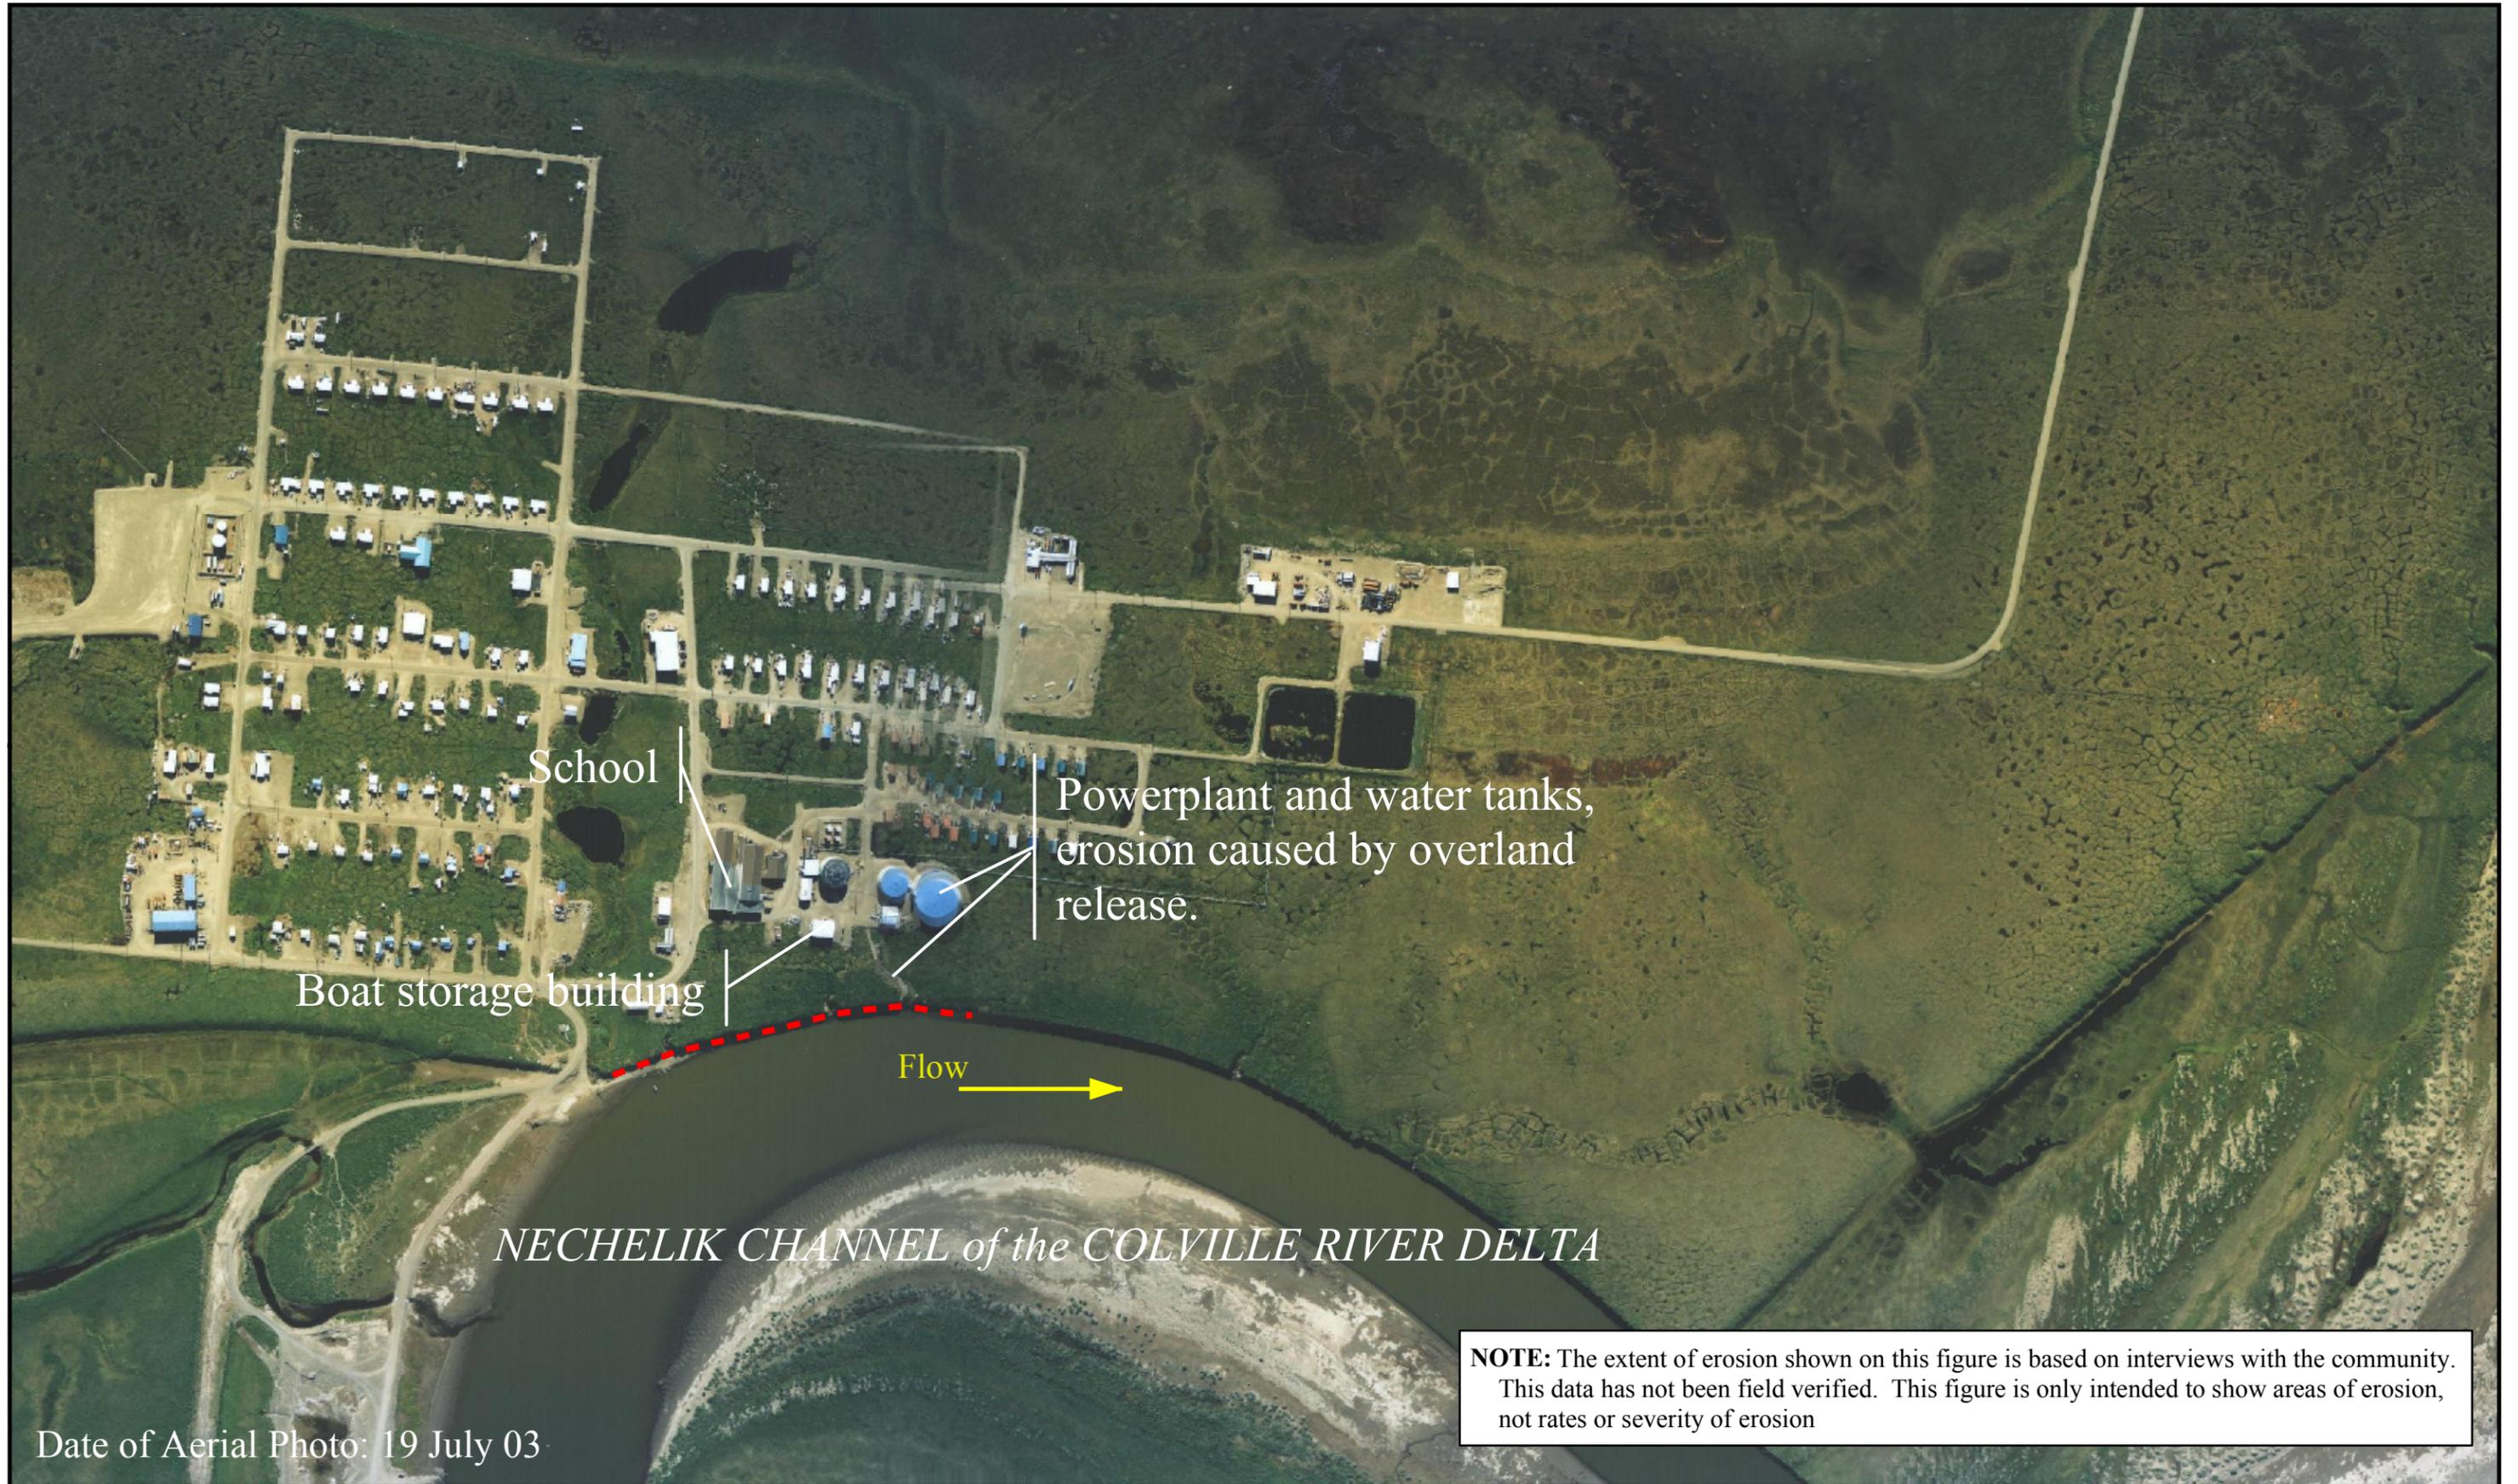
Nuiqsut has occasional minor erosion along the west bank of the Nechelik Channel, which is a branch of the Colville River. Periodic fluctuations in river flow and water levels, melting permafrost, ice jams, and spring break-up water runoff all contribute to erosion. Water from the water plant storage tank recently discharged and ran across the tundra into the Nechelik Channel, accelerating permafrost melt and erosion rate. The eroding area along the channel bank is approximately 100 feet long and 30 feet wide with a drop estimated at 100 vertical feet. An estimated 3 to 5 feet per year has eroded along the bank down-slope of the water tanks. A deep cave has formed along the bank and under the tundra where mammoth tusks were excavated. The holes left in the bank pose dangerous drop-offs and areas vulnerable to accelerated erosion. In addition, the road to the boat dock is eroded and washes out every year when the ice breaks and the river rises at the small creeks and culverts, gravel is placed over the culverts each year.

NOTE: The extent of erosion shown on this figure is based on interviews with the community. This data has not been field verified. This figure is only intended to show areas of erosion, not rates or severity of erosion
