ALASKA BASELINE EROSION ASSESSMENT

Erosion Information Paper - Nunam Iqua (Sheldon Point), Alaska

Current as of February 17, 2009

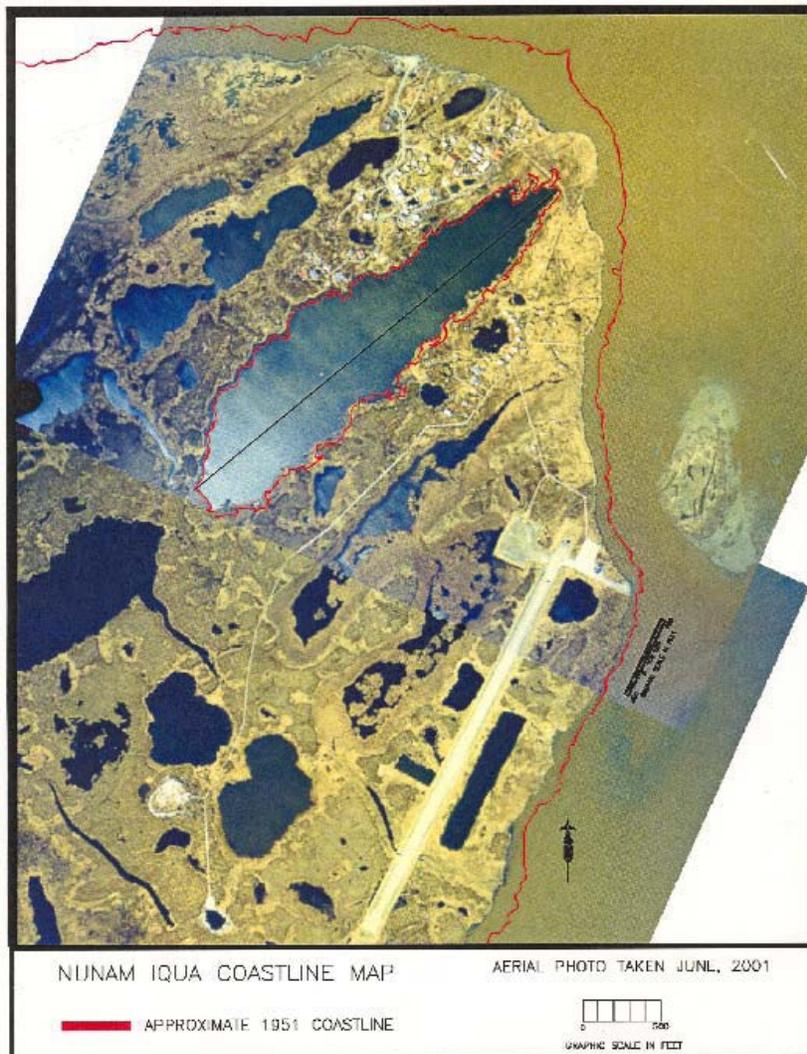
The 2007 DOT/PF report notes that grass assemblages on the river bank substantially affect vulnerability to erosion. Areas with more homogeneous grasses tend to be more stable than areas where vegetation is more varied. The small sloughs emptying into Kwemeluk Pass have increased erosion and silt build-up on the nearby riverbanks. DOT/PF prepared a map (attached) that compares the shorelines in 2001 to the shorelines in 1951.

Photo 1: Location of shoreline in 2001 aerial photo compared to approximate 1951 (redline) location, from Appendix F of the *Nunam Iqua Hazard Mitigation Plan*; map prepared by DOT/PF.

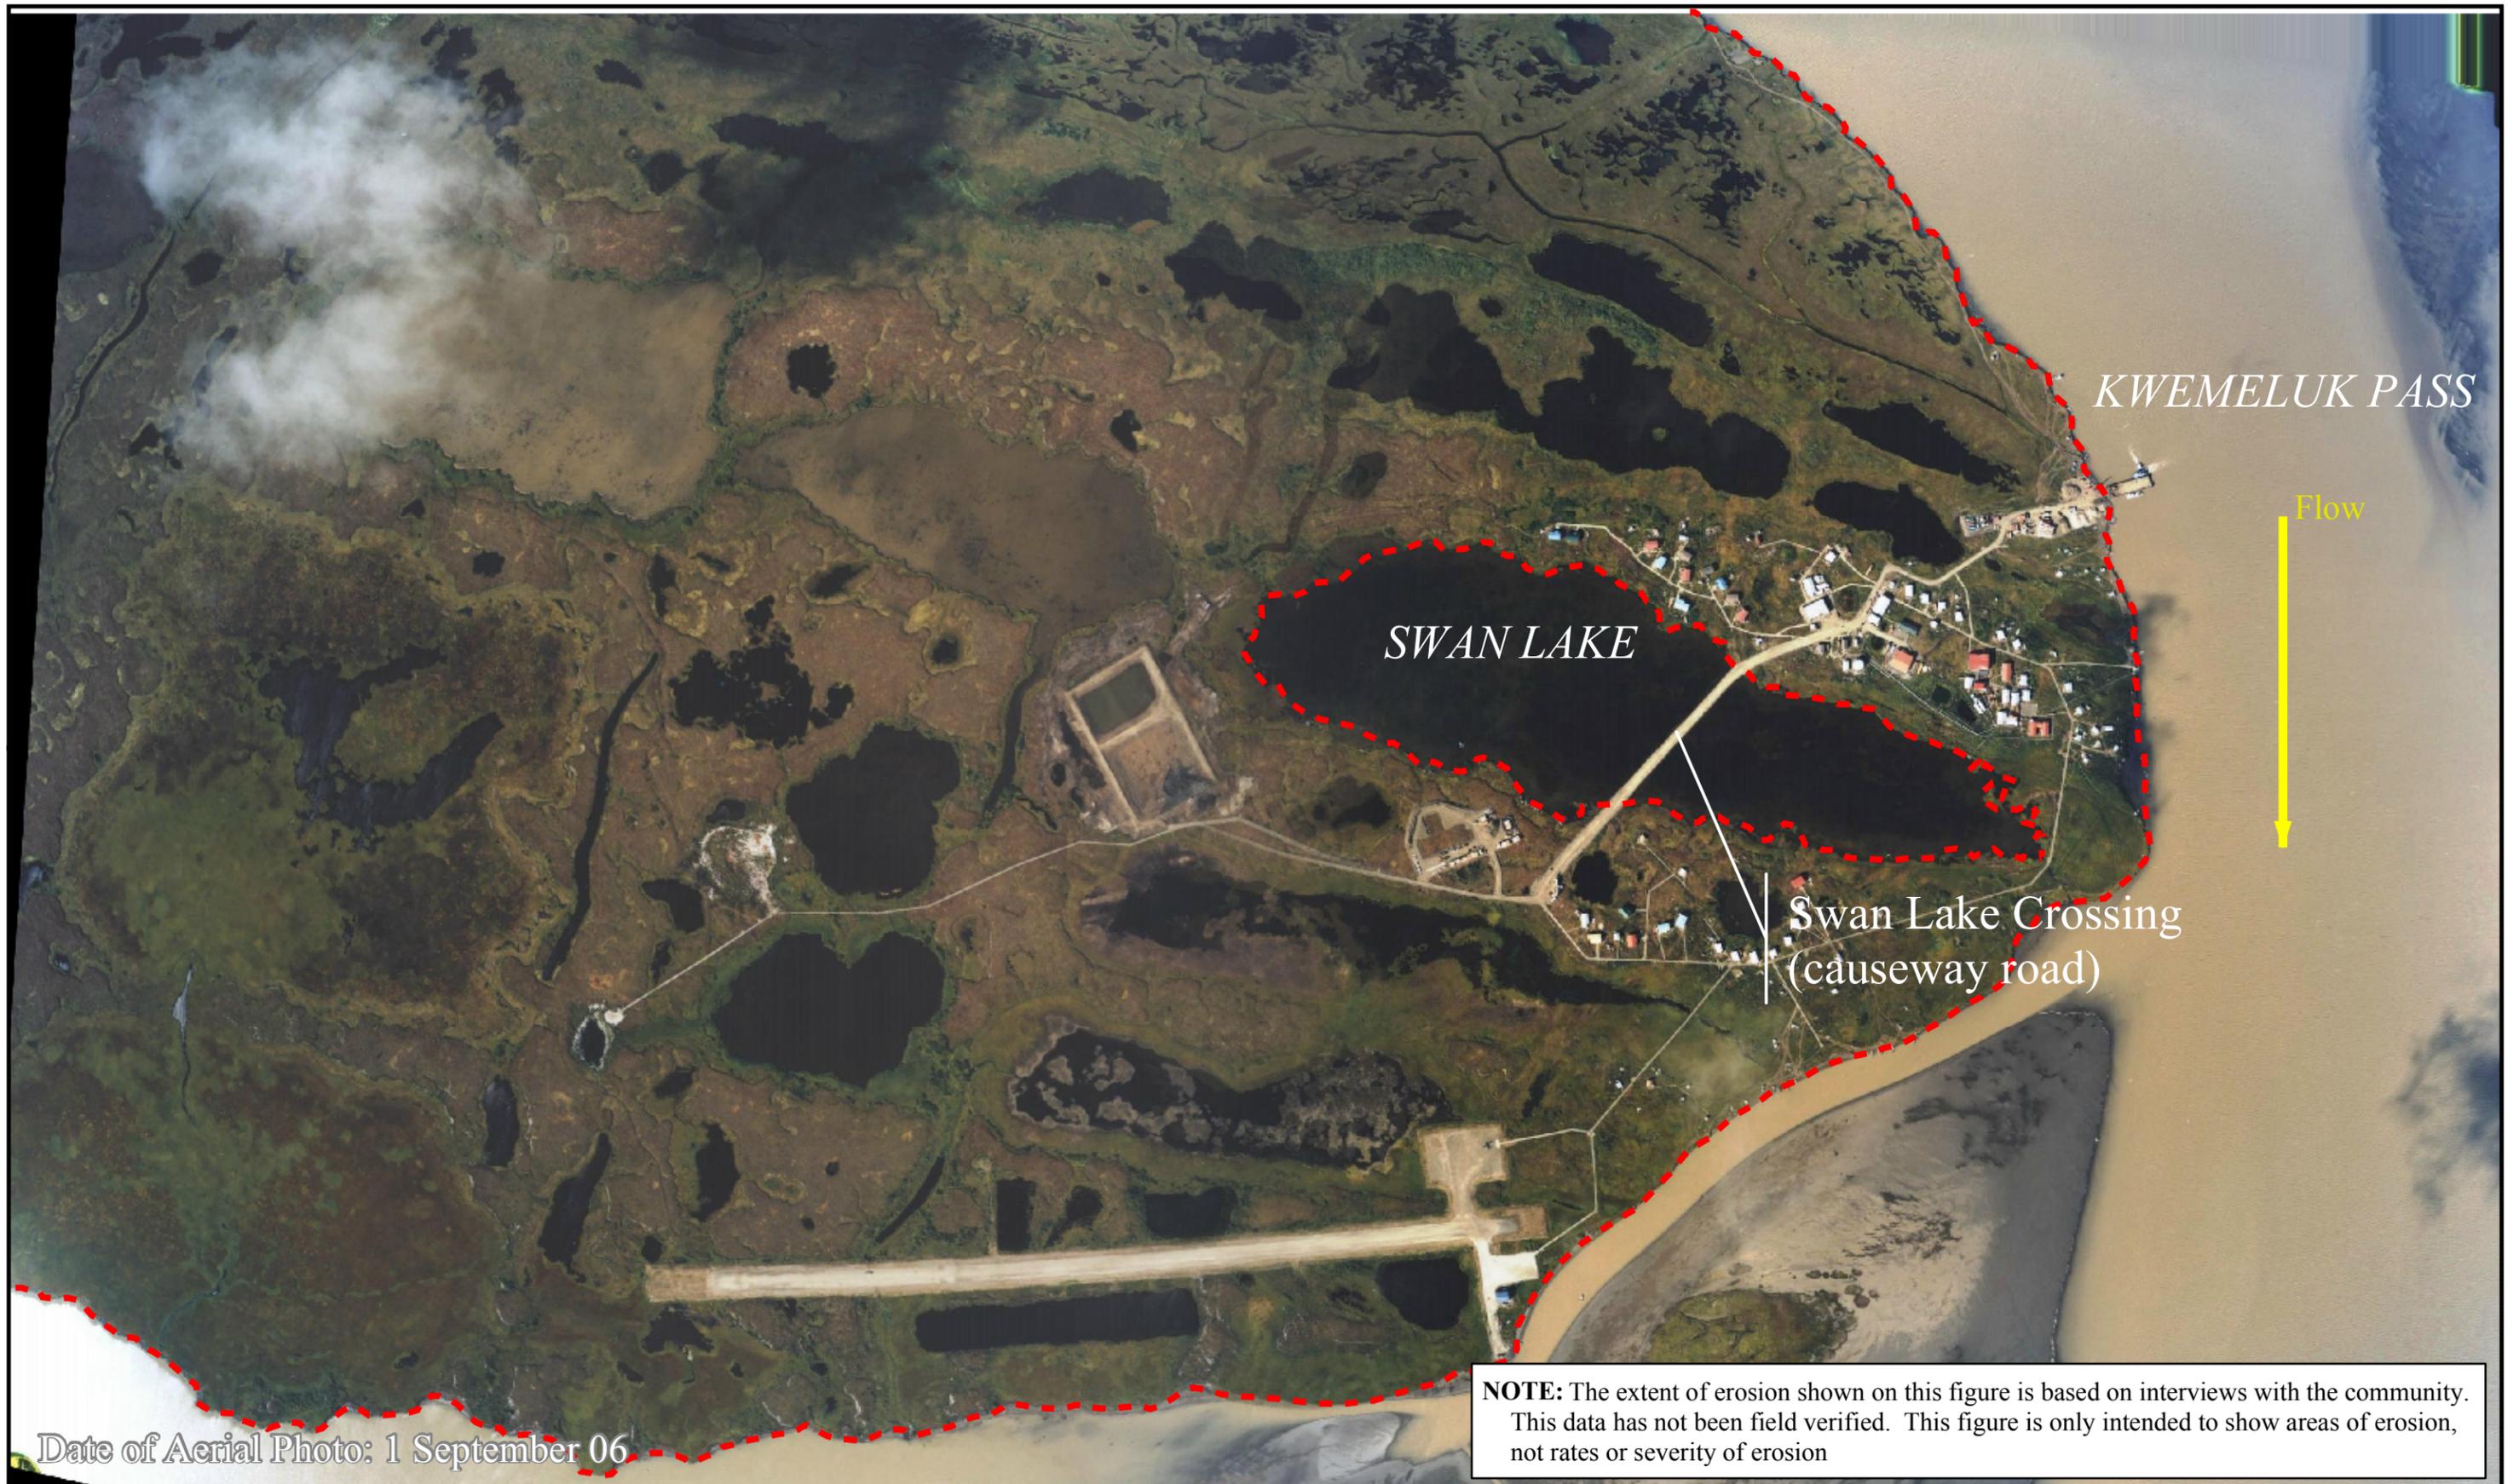
A map prepared by DOT/PF that compares shorelines between 1951 and 2001 is attached. Also, attached is a diagram depicting the linear extent of erosion in the community.

--- Linear Extent of Erosion
