U.S. Army Corps  
of Engineers  
Alaska District

## **ALASKA BASELINE EROSION ASSESSMENT**

### **Erosion Information Paper – Nunapitchuk, Alaska**

Current as of August 23, 2007

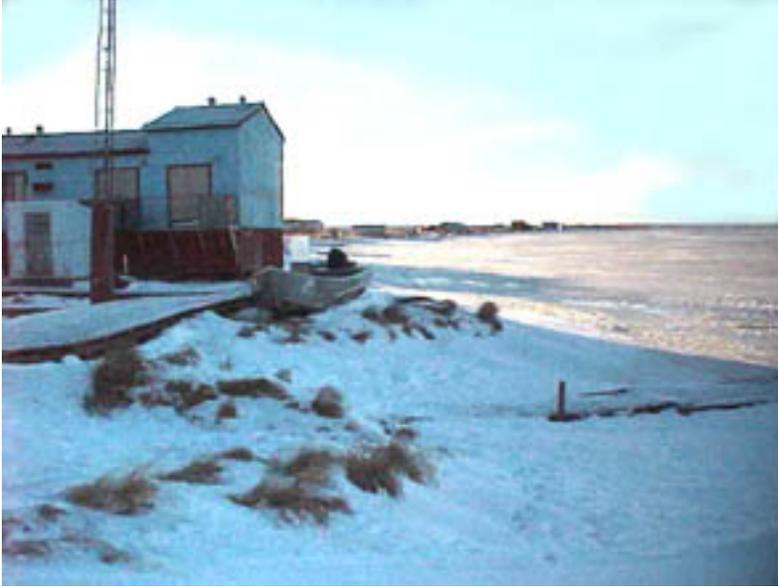
**Photo 1: Looking down the river bank, Winter 2002.**

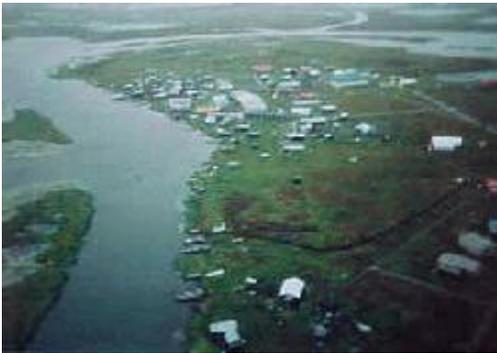
**Photo 2: Nunapitchuk from the air, Summer 2004.**

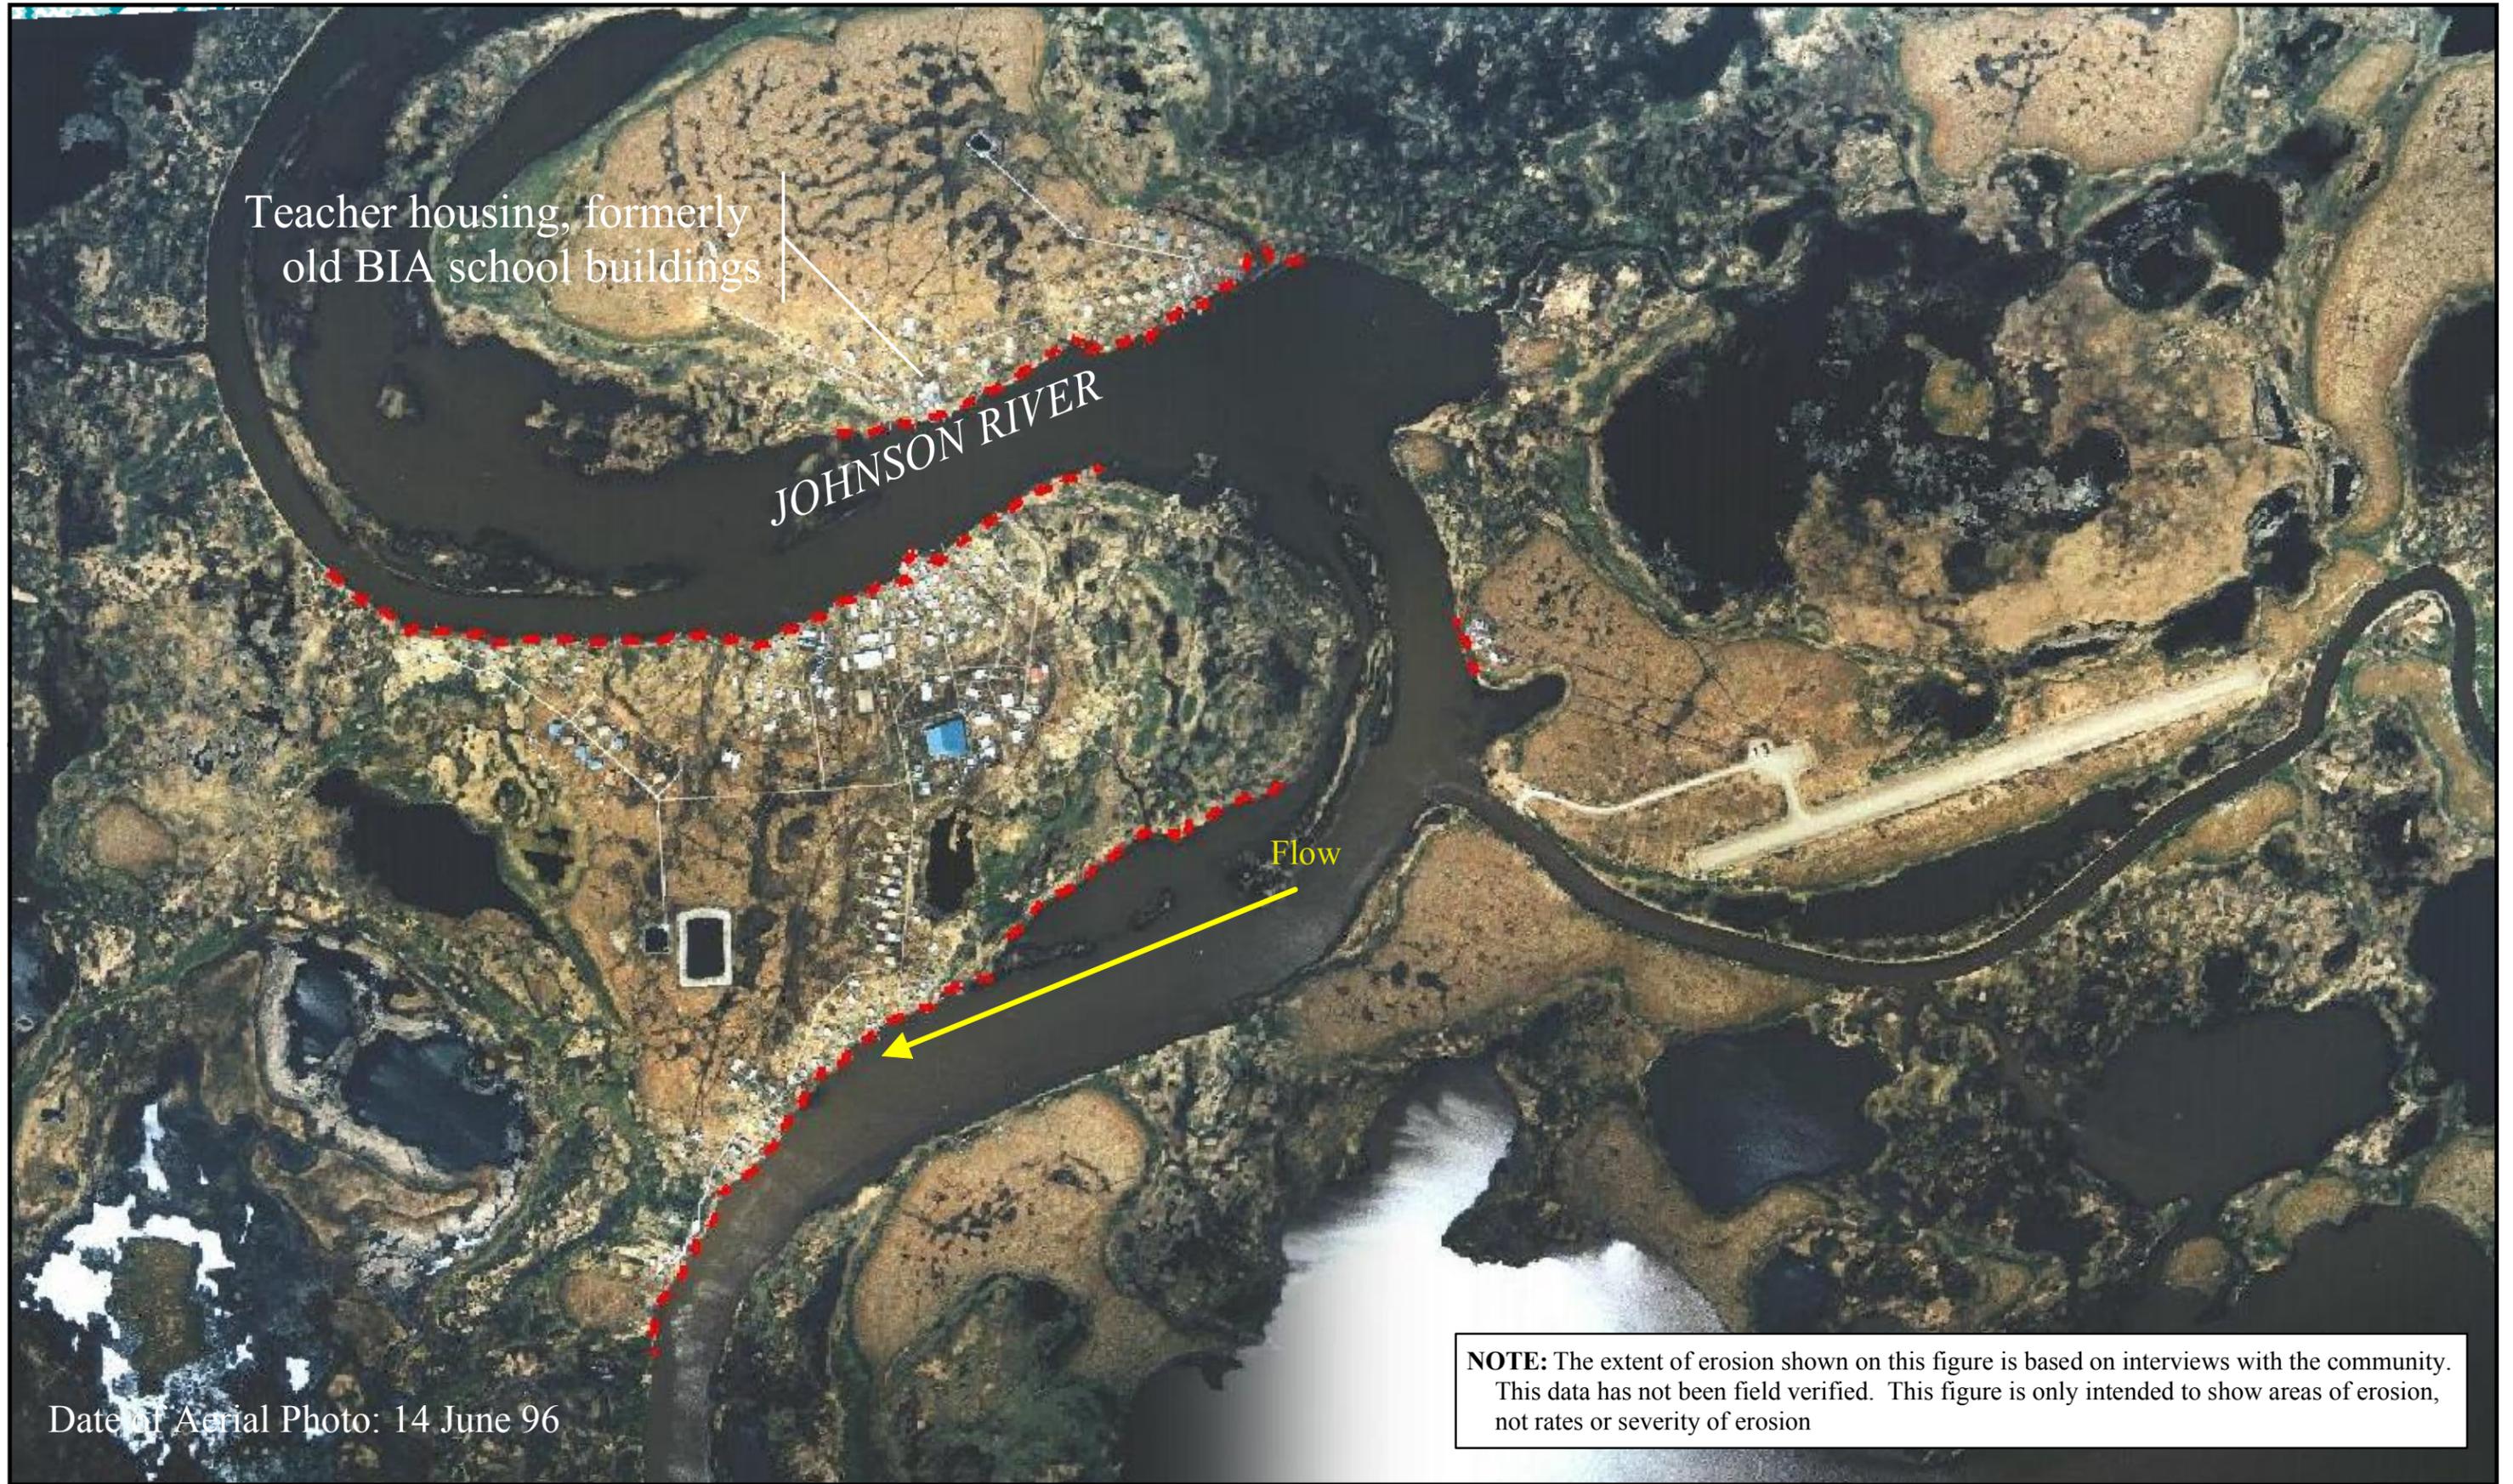
Alaska Baseline Erosion  
Nunapitchuk, Alaska

--- Linear Extent of Erosion
