U.S. Army Corps
of Engineers
Alaska District

ALASKA BASELINE EROSION ASSESSMENT

Erosion Information Paper – Old Harbor, Alaska

Current as of April 1, 2008

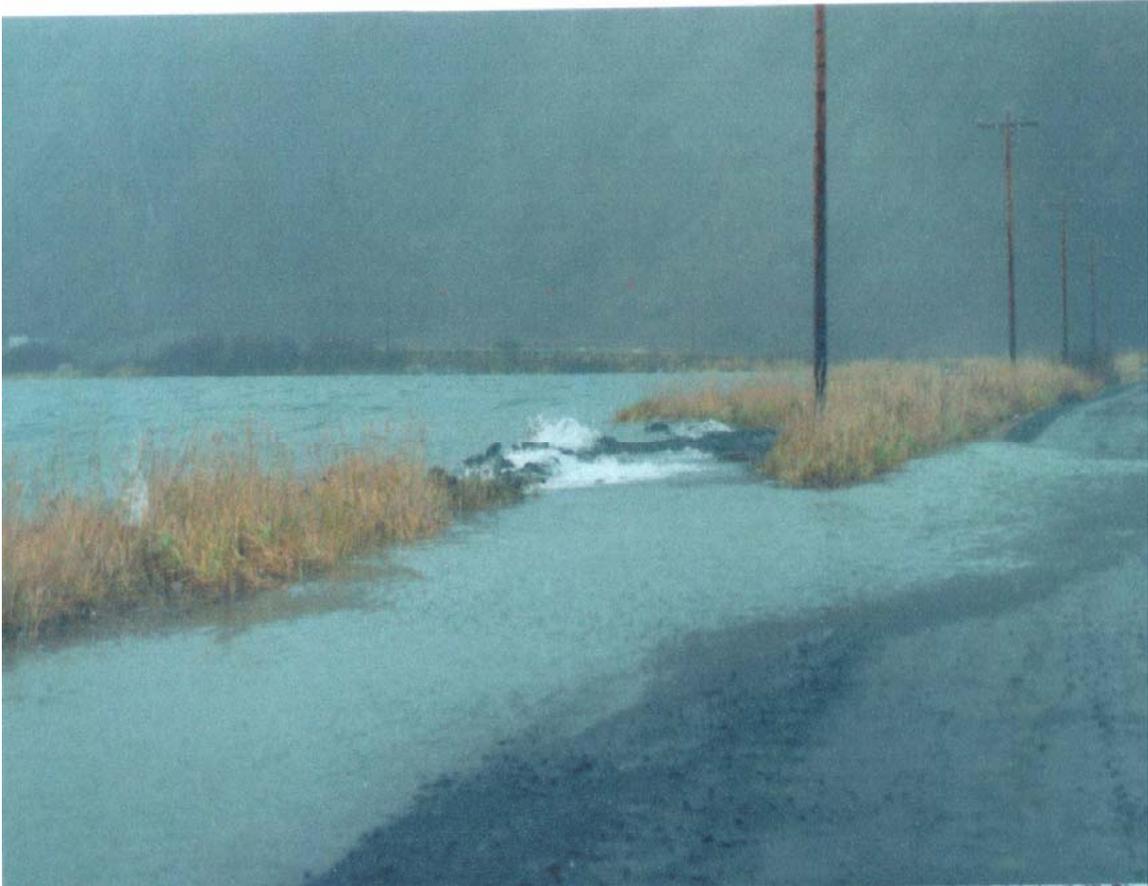
The beach adjacent to the road on the spit is eroding. Storm surges, high tides, and wind-driven waves reportedly cause and contribute to erosion. The affected area is approximately 700 to 800 feet long, ranging from about 4 feet high at the west end to 10 feet high at the east end. The Kodiak Island Borough 2006 *Hazard Mitigation Plan, Old Harbor Annex* lists property damage from erosion as a moderate risk.

Culverts that allow water flow under the road between the estuary and the strait have become filled at the east end of the roadway and reportedly are causing erosion. Utilities, including power poles that support electric power lines and a buried community water line have been placed adjacent to and under the road. There are no residences or other structures along the spit.

Photo 1: Old Harbor Estuary and Sitkalidak Strait nearly merge, impacting the spit road and utilities during a December 2002 storm.

The beach area along the spit roadway was impacted by erosion during storms in the fall of 2002 and 2003. The community obtained a grant from the State of Alaska, Division of Homeland Security and Emergency Management and a series of gabions were installed to reduce potential for damage from ongoing erosion. The grant was \$18,600 and a local crew completed the work. The gabions are still in place and have had a positive effect, although additional gravel has been added. The road and utility improvements are within 100 feet of the active erosion area.

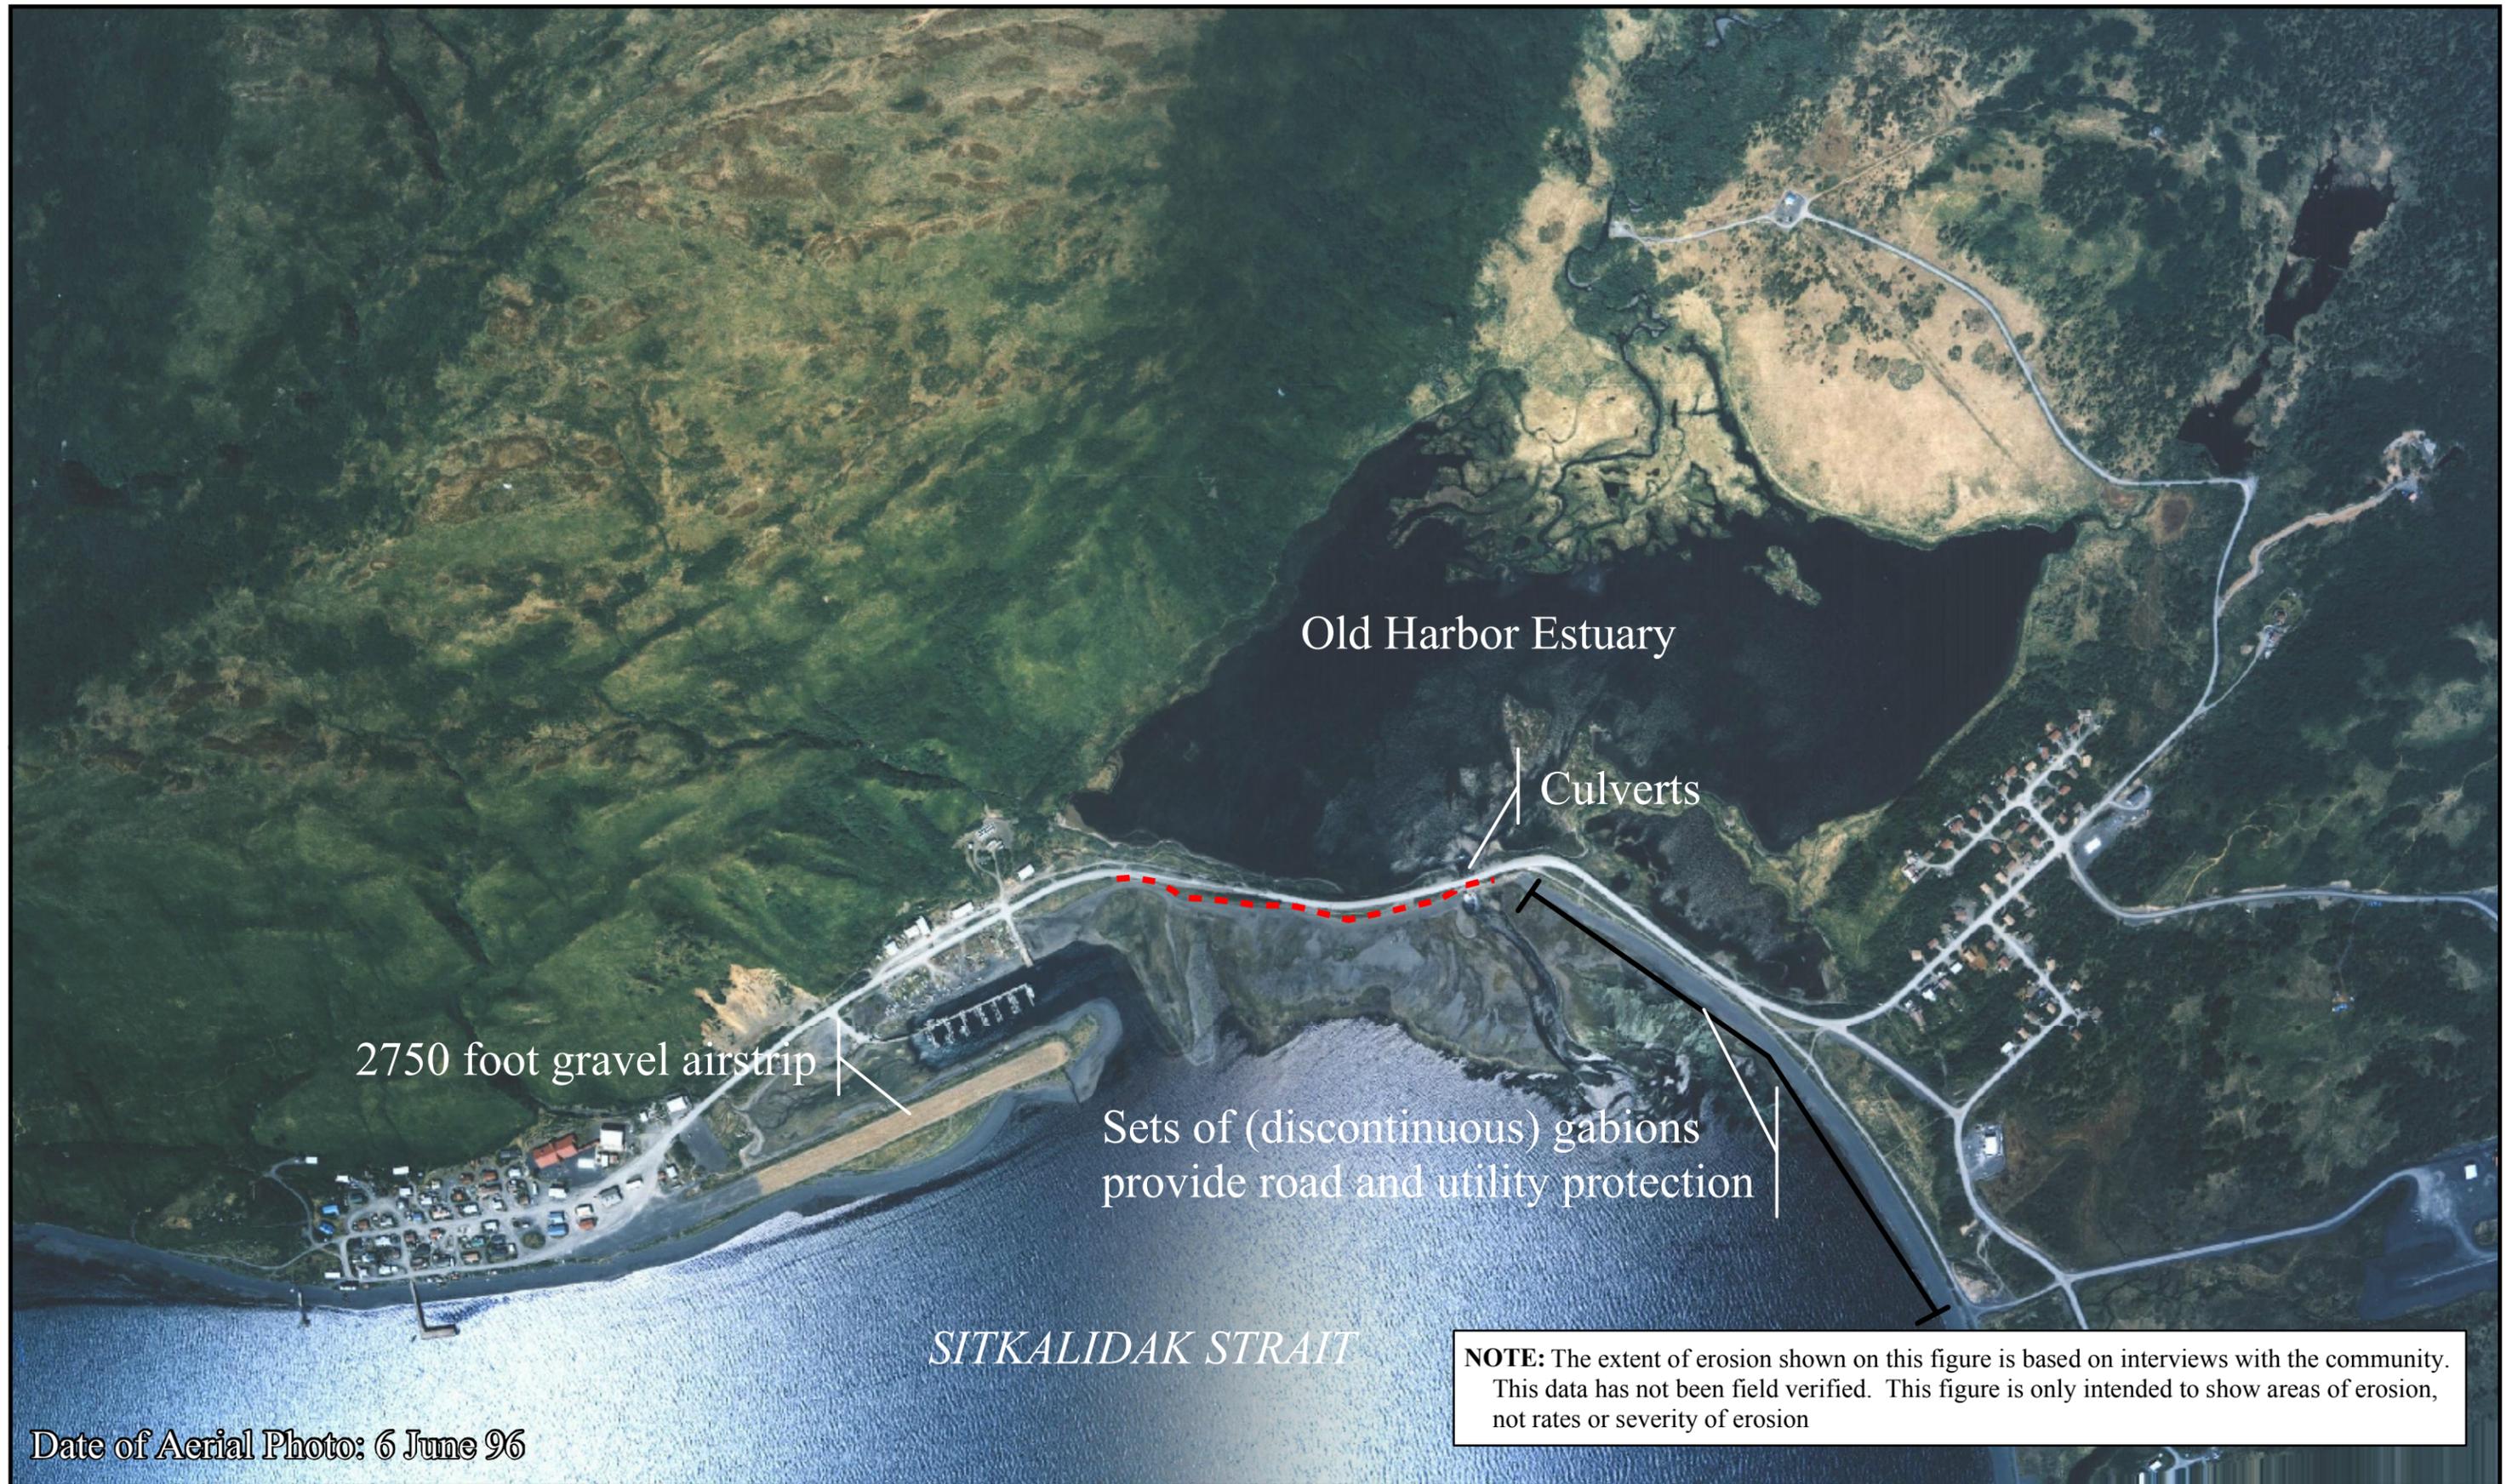
Alaska Baseline Erosion
Old Harbor, Alaska

--- Linear Extent of Erosion
