U.S. Army Corps
of Engineers
Alaska District

ALASKA BASELINE EROSION ASSESSMENT

Erosion Information Paper - Oscarville, Alaska

Current as of March 27, 2008

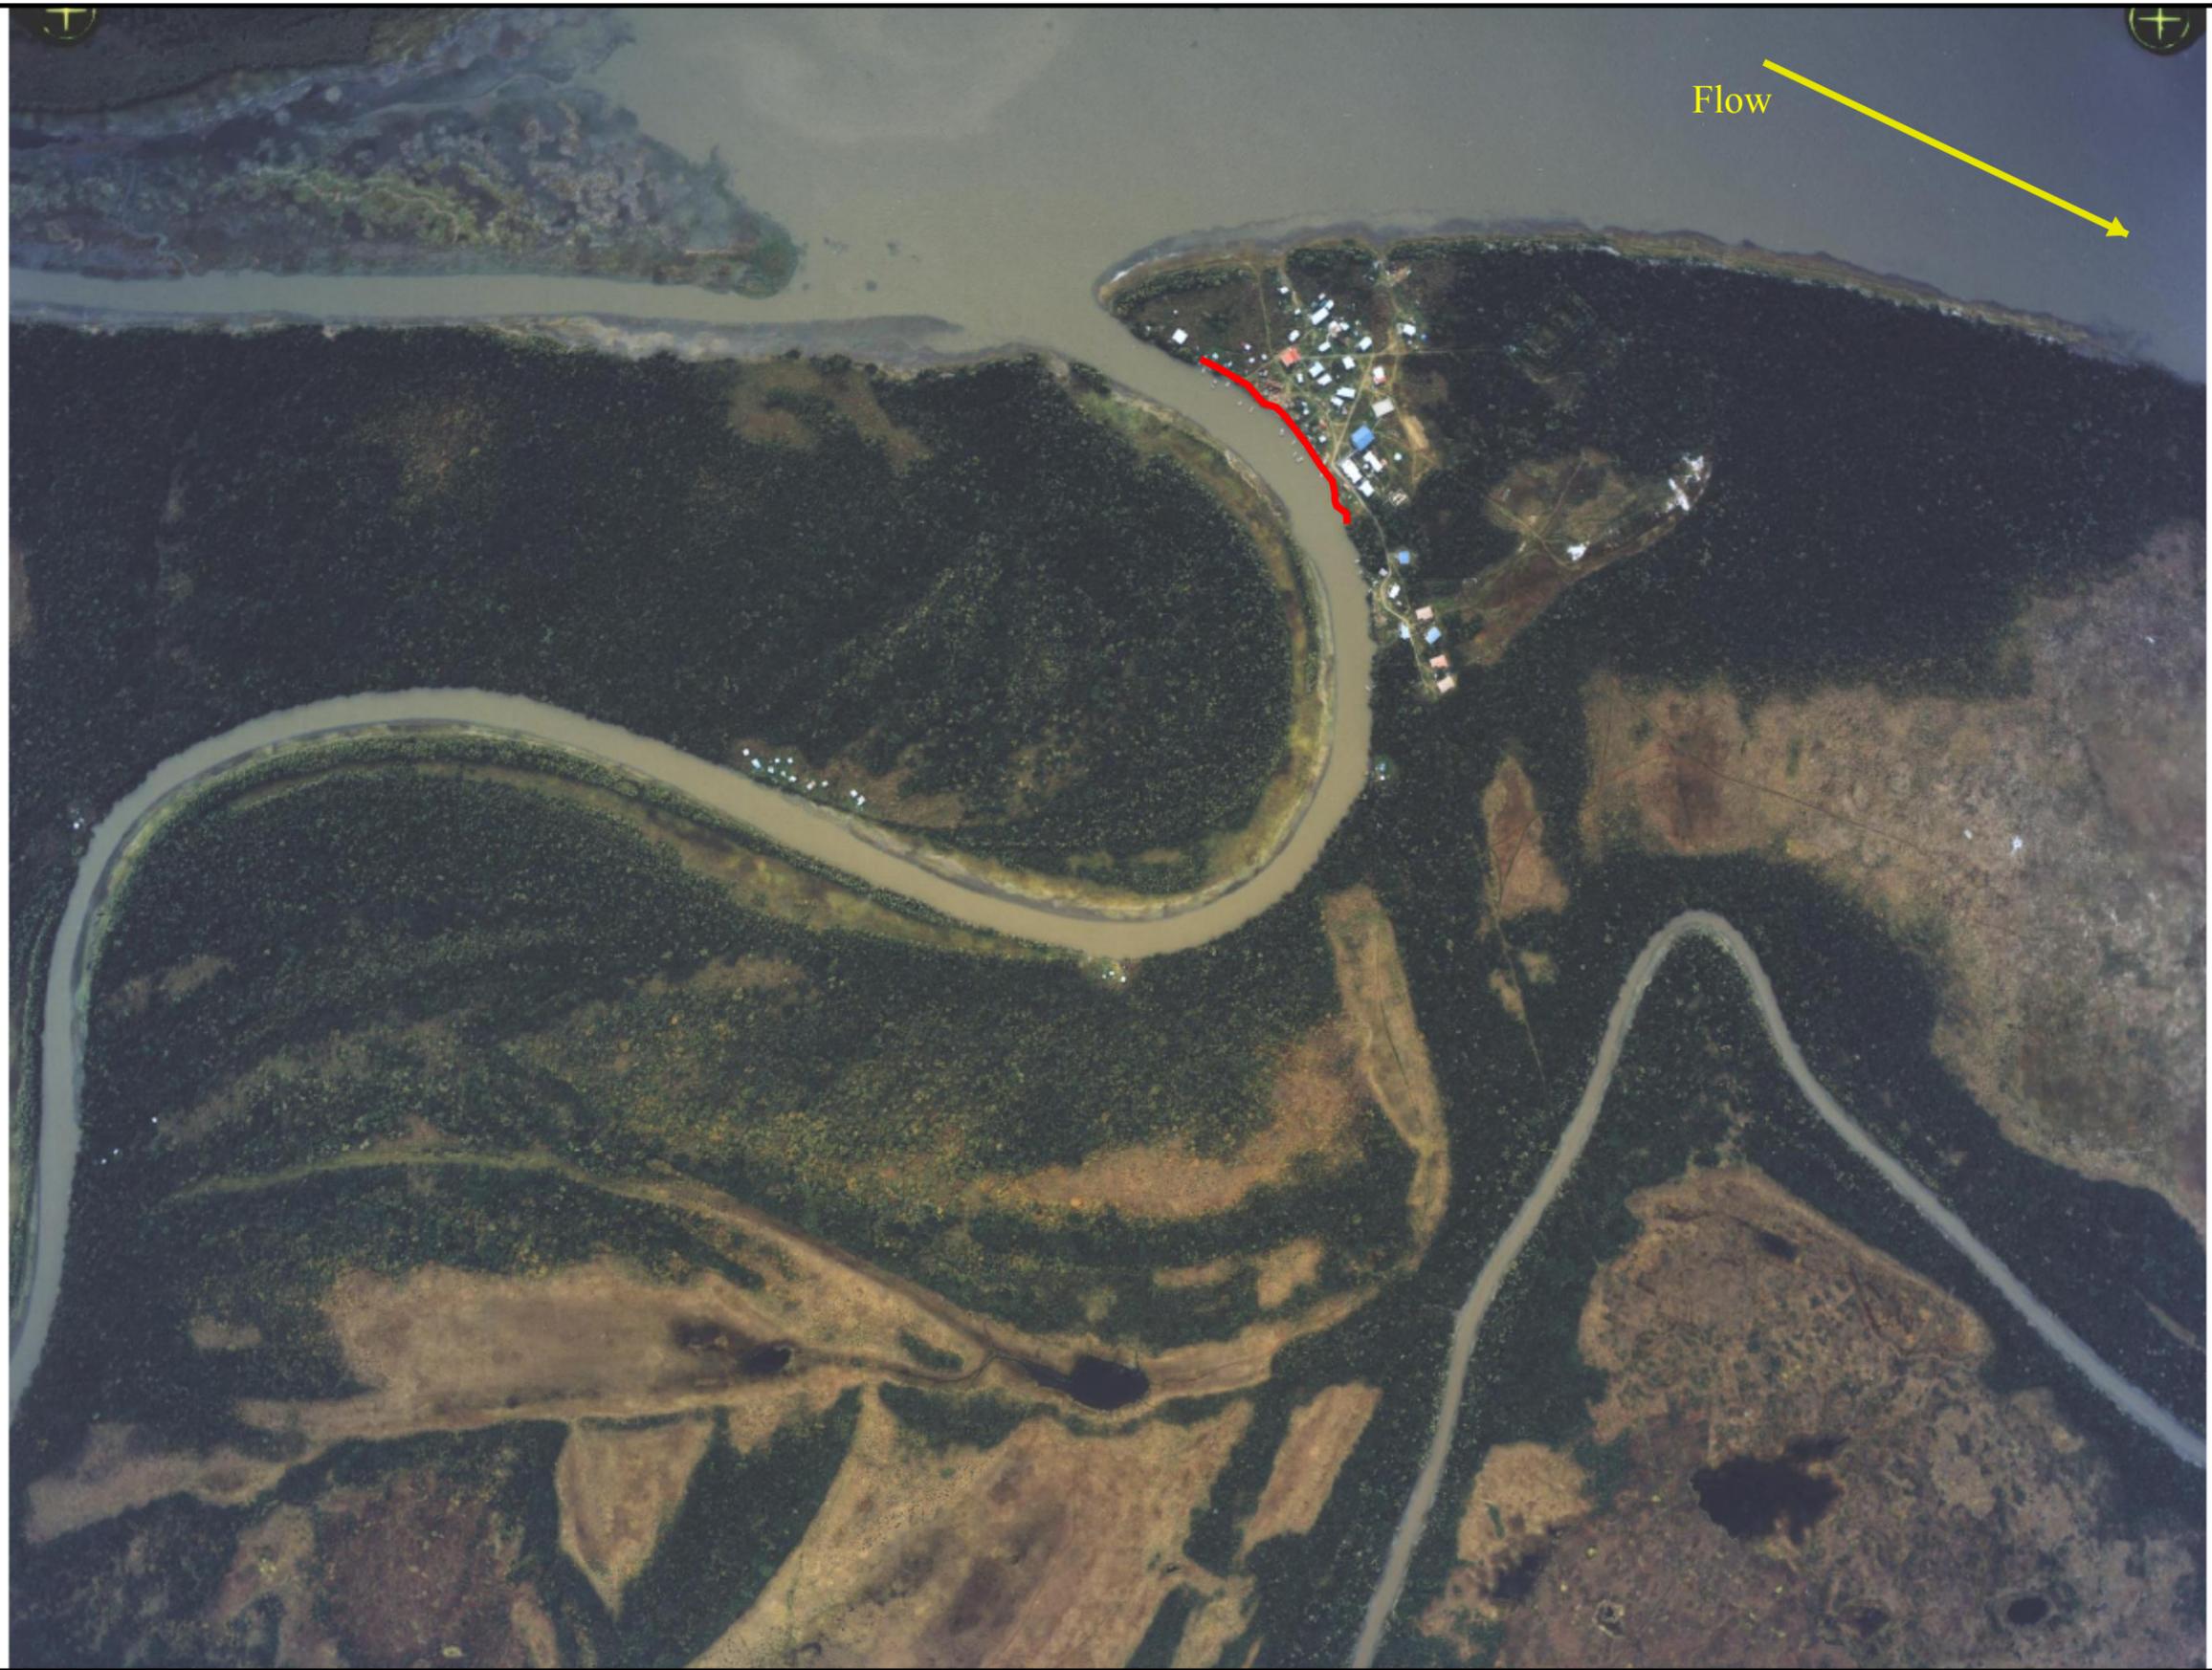
Extent of Erosion

No photos were provided by community or other sources. The attached diagram shows the linear extent of erosion.
