U.S. Army Corps
of Engineers
Alaska District

ALASKA BASELINE EROSION ASSESSMENT

Erosion Information Paper - Pilot Point, Alaska

Current as of March 3, 2008

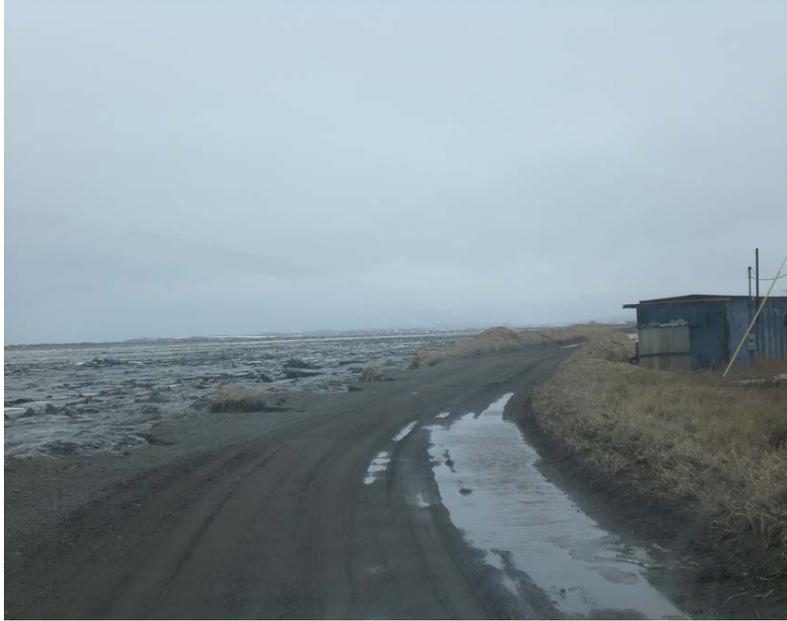
Photo 1: Pilot Point Road along Ugashik Bay leading to the bulkhead dock is threatened by erosion, April 2008.

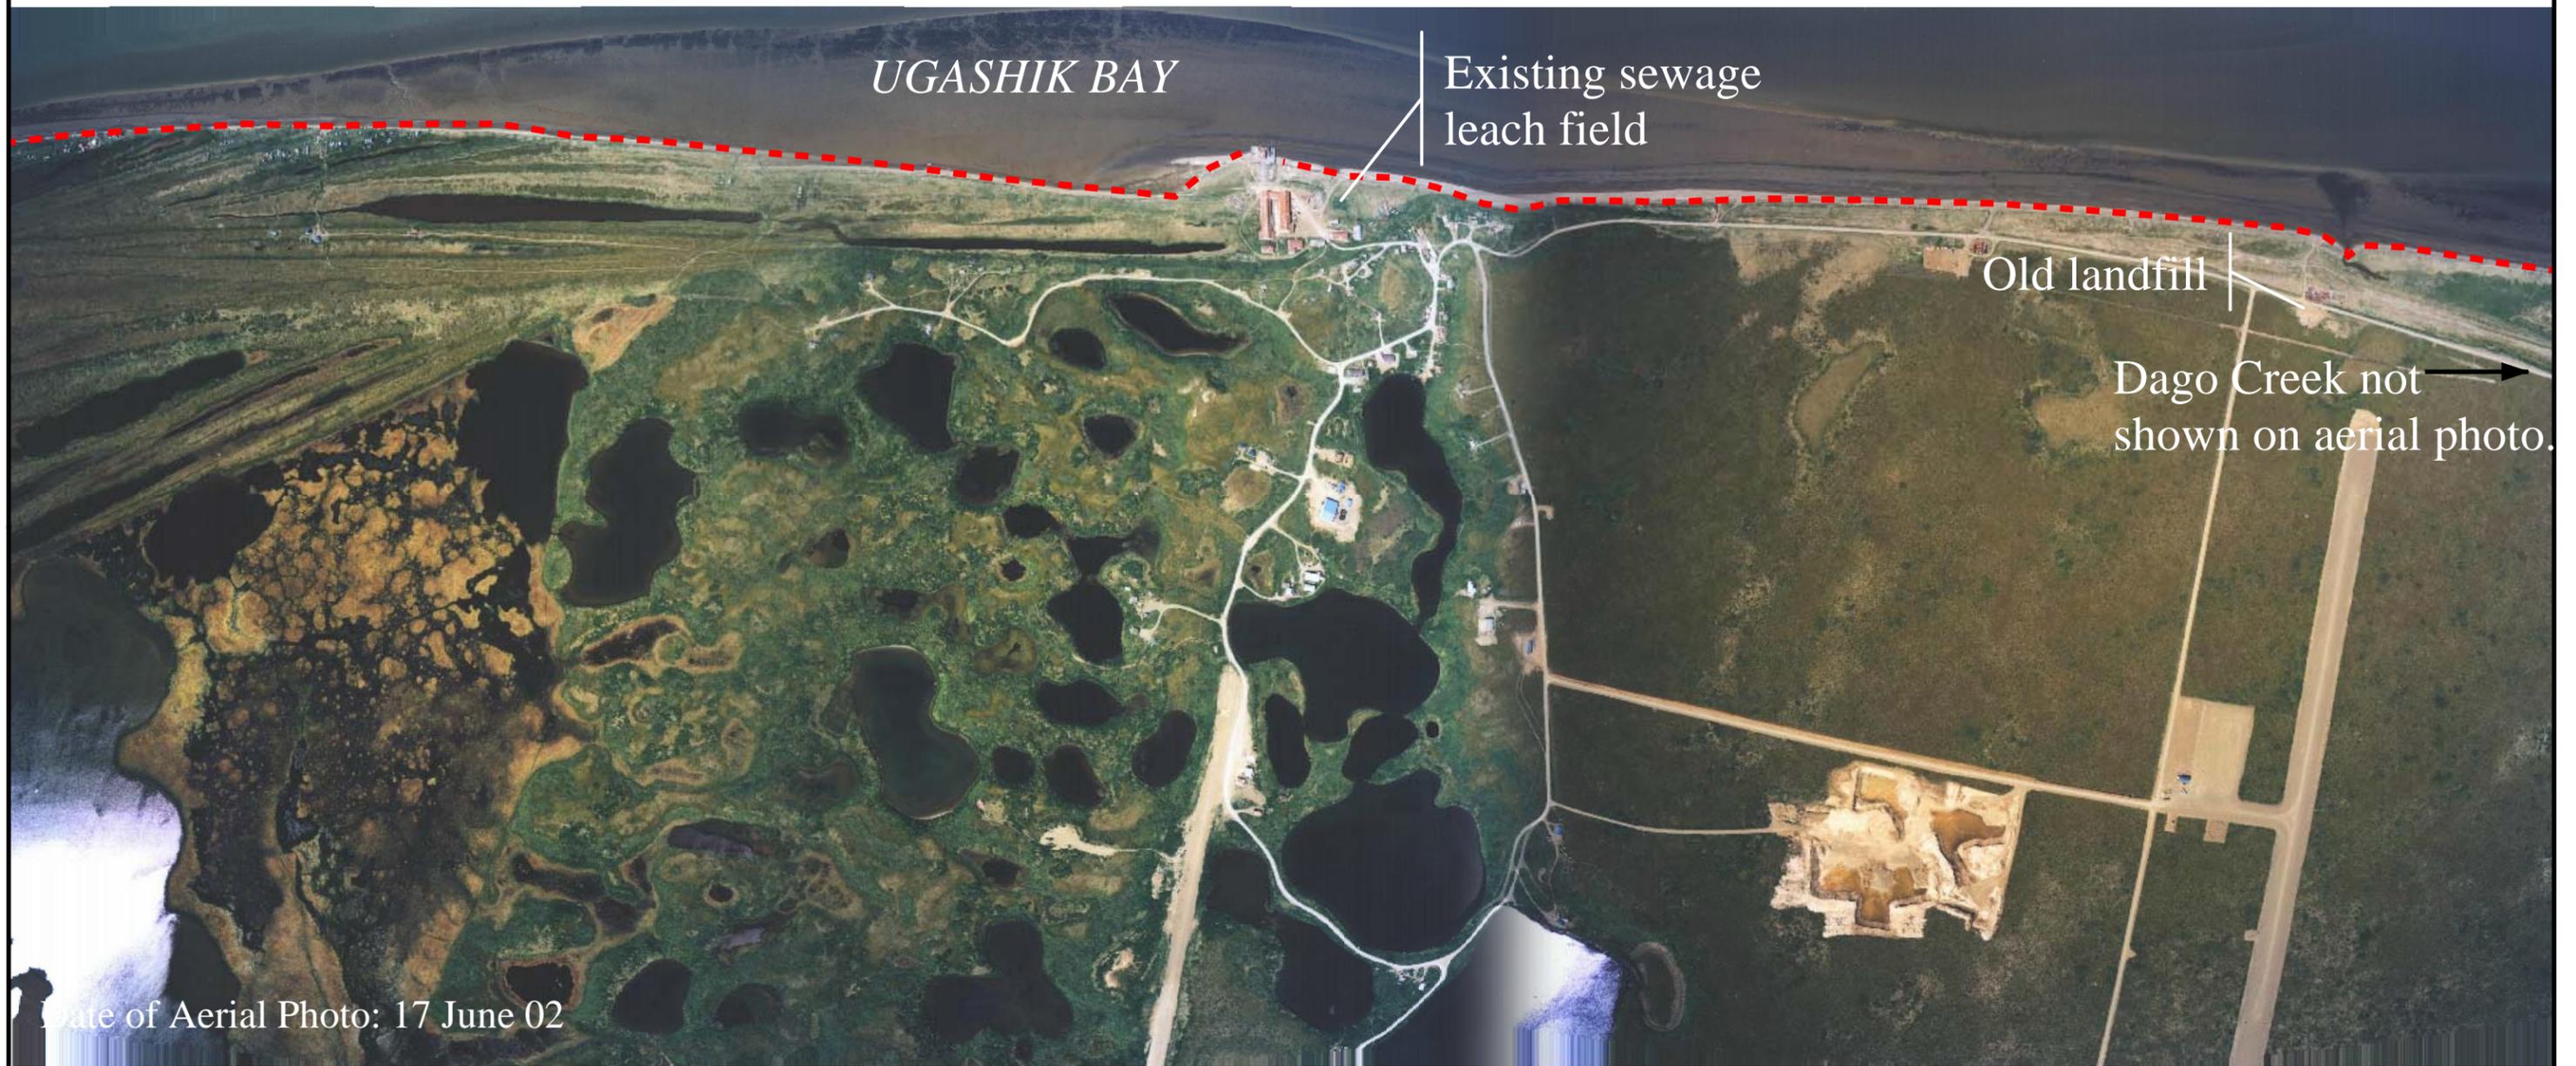
Alaska Baseline Erosion
Pilot Point, Alaska

The mouth of the Ugashik River as it enters Ugashik Bay at Pilot Point is eroded periodically, primarily by storm surge associated with southwest and westerly storms. Pilot Point has 6- to 8-foot waves during large storms. Major erosion events were recorded in 2005 and 2007. The 2007 event resulted in approximately 15 to 20 feet of erosion. The extent of erosion from the 2005 event was not reported.

The road north to Dago Creek and the area between two set net sites washed-out during a fall storm about 5 or 6 years ago. The community could lose boat access to Dago Creek if erosion continues. A washed-out road at another location is about 20 feet from the shoreline and another road is about 40 feet from the shoreline. Erosion in the south beach area is near some set net cabin sites. Roads also are at risk south of the old cannery. Waves and ice driven over the dock during storms have damaged buildings.
